Main Beach Shoreline Project

Technical Report: Condition Assessment
Report No: E2020/12114 (P19010TN02)
Date: 20 February 2020

This Technical Report presents the findings of a coastal engineering condition assessment undertaken on the coastal protection structure at Main Beach, Byron Bay (also known as the Jonson Street Protection Works or JSPW).

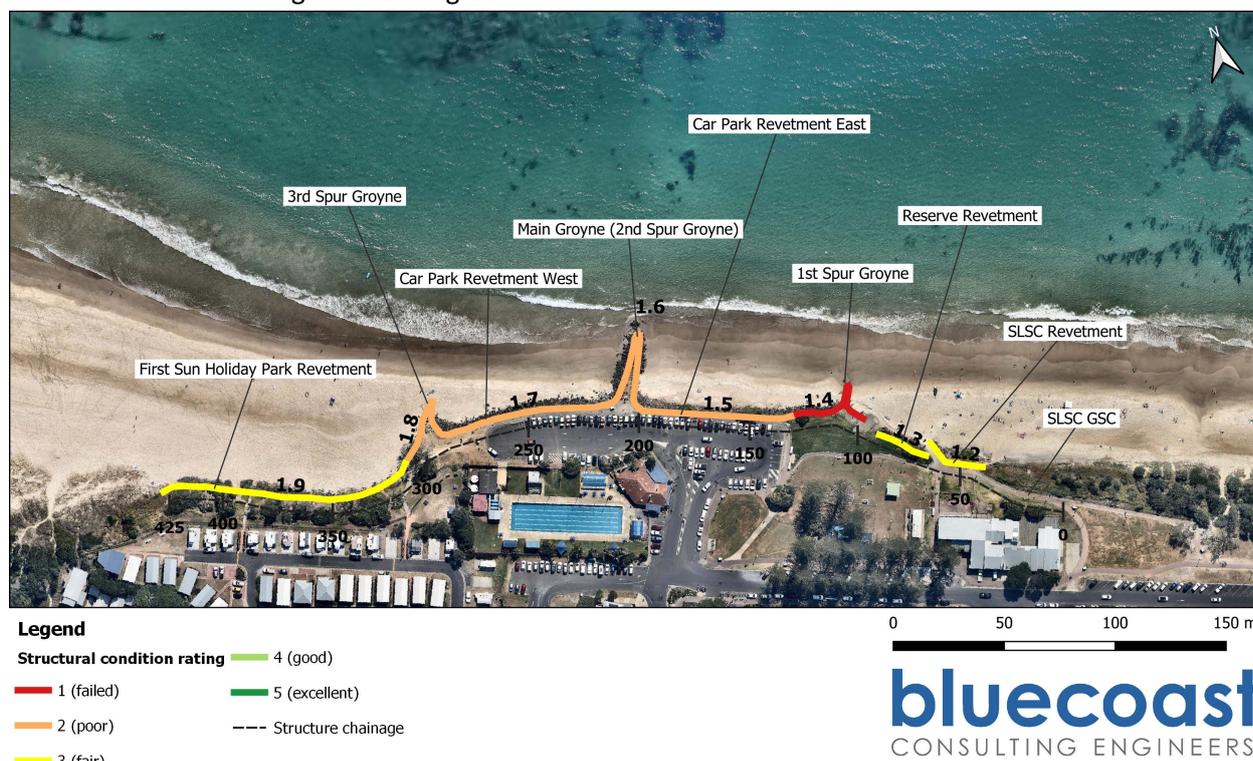
Figure 3: Structural condition rating for structure based on visual and drone inspection on 28th October 2019.

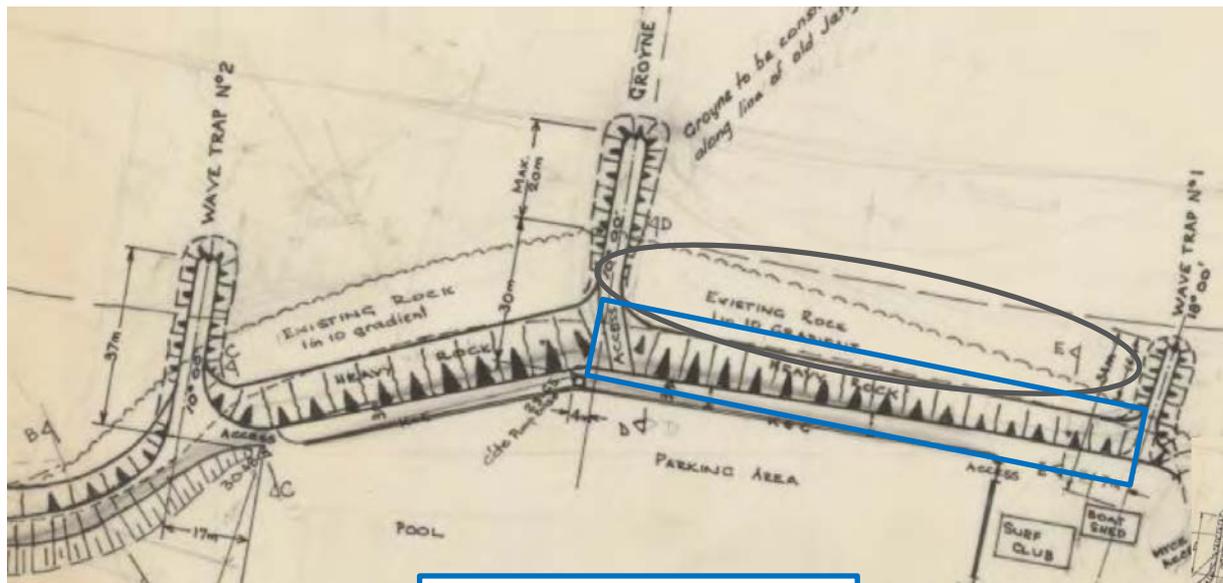
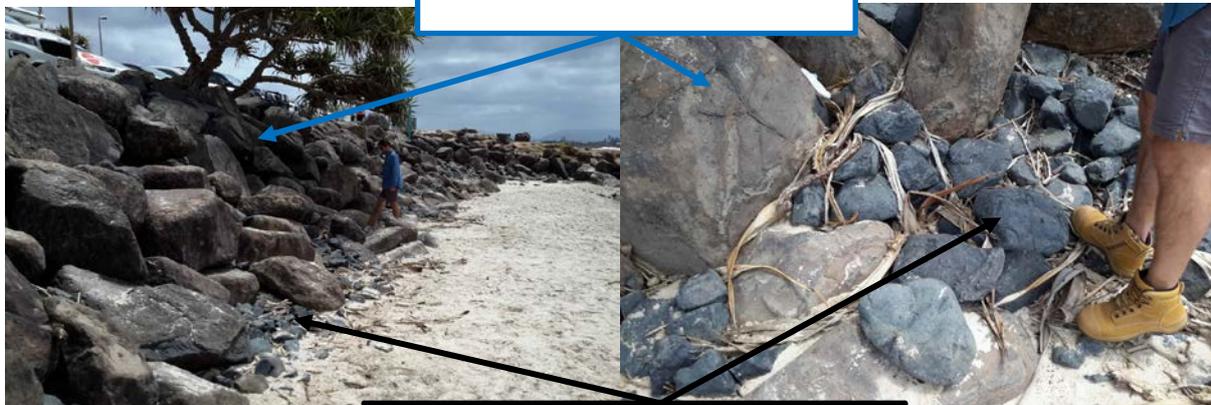
Newer, larger and lighter coloured rock

Older, darker and rounded (by wave action) rocks

Figure 5: 1975 design drawings showing apron of older failed rocks forming a gentle gradient in front of the planner 'heavy rock' placements.

Note: The flatter 'existing' rock is believed to be remnants of the structure that failed in the 1974 tropical cyclone Pam event. This rock was placed as armour and underlayer in 1963 and 1964. During design wave conditions this older and smaller rock would be mobile and the structure was likely to have been undermined by scour. Having been redistributed by wave action and shaken down to close to the scour level, this rock now forms an apron that founds the main revetments.

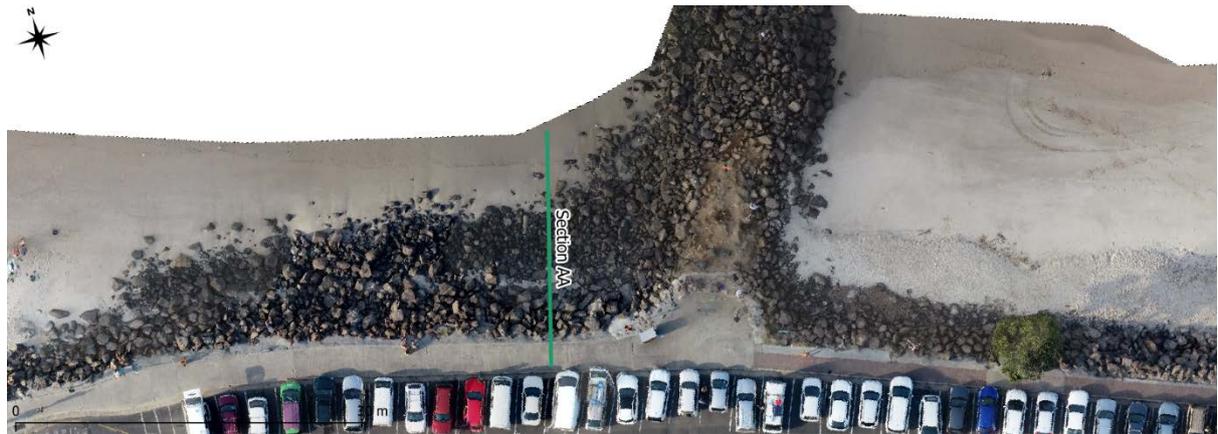
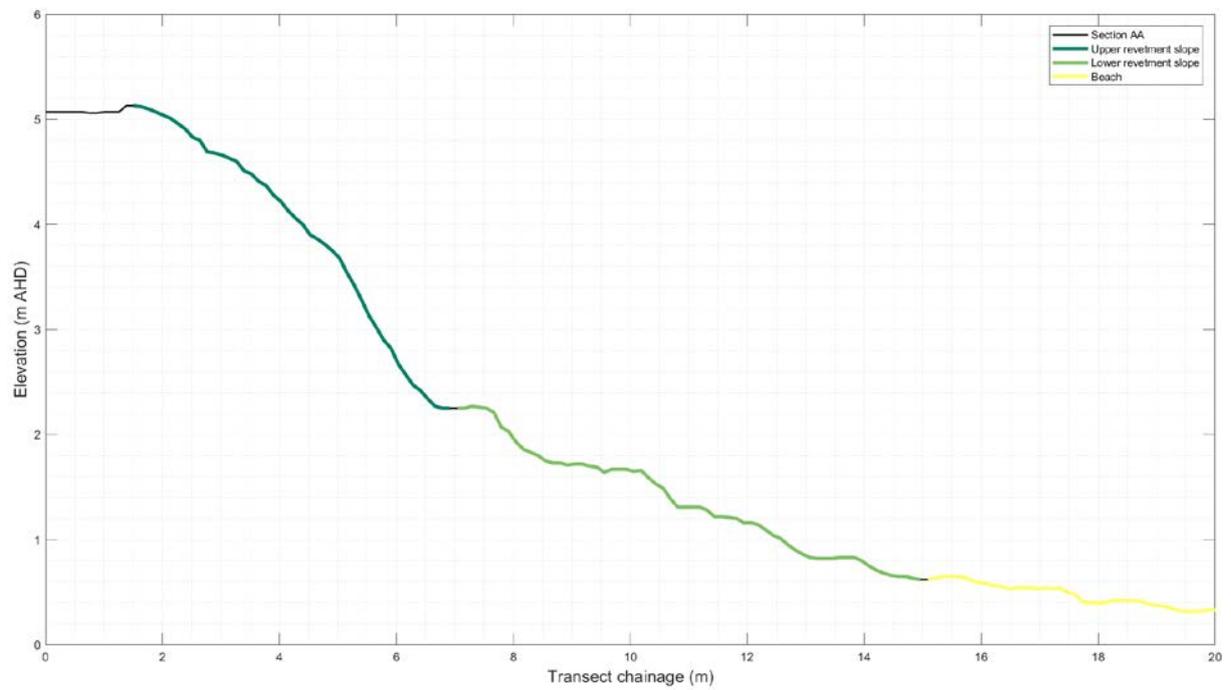
Figure 6: Section AA location and aerial photograph (top) and structure cross-section derived from drone survey on 28th October 2019.

Figure 6 provides a cross-section of the structure within segment 1.7 which highlights the existence of this older rock being lower down on the revetment and at a milder slope. The slopes in each of the coloured sections on the figure are:

- upper revetment (larger armour): 1V:2H
- lower revetment (smaller darker rocks): 1V:5H
- beach: 1V:17H

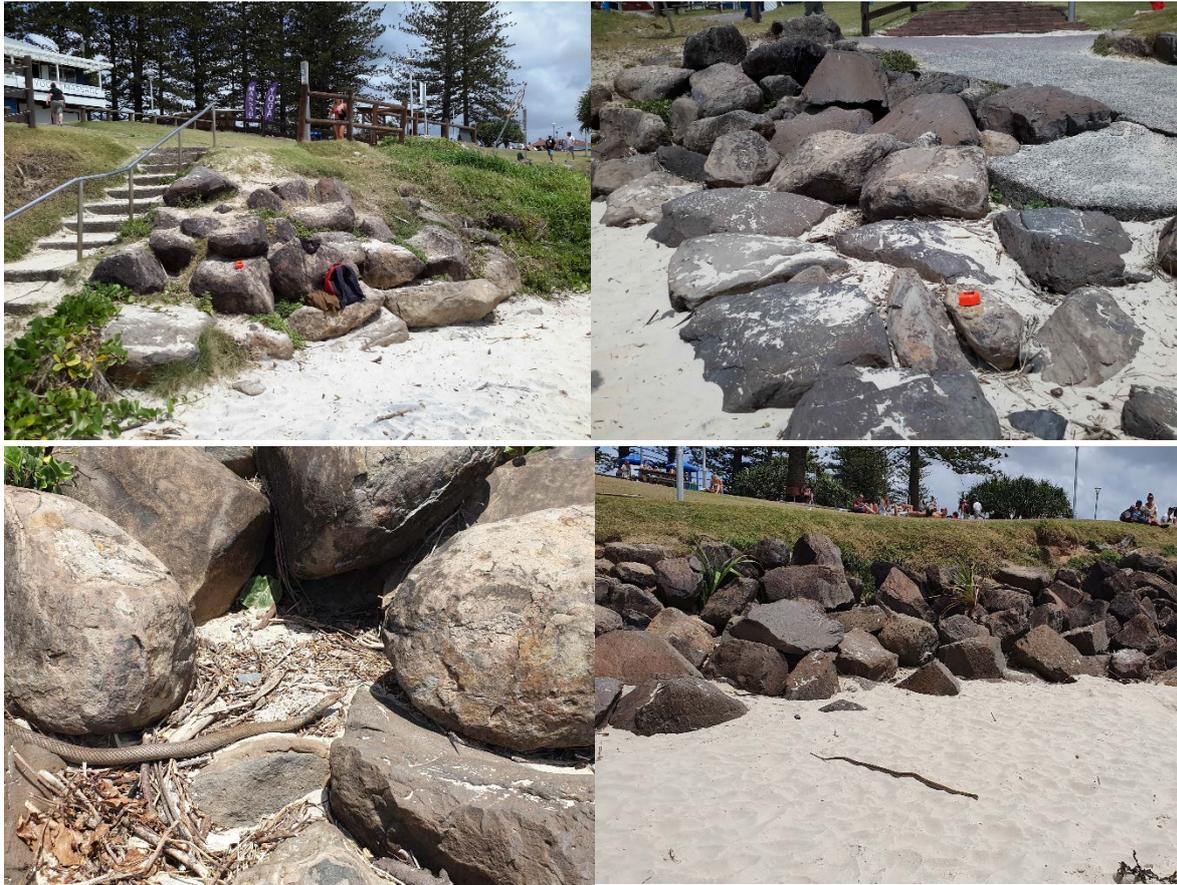
Figure 7: Fieldwork photos of segment 1.2 and brown snake

1.2 SLSC revetment Chainage: 41 to 67m	3	4	2	<p>Located further from the average shoreline this segment is less exposed and displays sand ingress and vegetation over the structure, suggesting that the seawall has not been exposed to waves for some time. Photos of this segment are provided in Figure 7.</p> <p>Two types of armour rock are evident. A lighter and more rounded stone and a darker and more angular stone. While the armour appears in fair condition, several platy and/or rectangular units were observed.</p> <p>During the inspection a large brown snake was observed to be patrolling segment 1.2 and 1.4 of the structure as well as the beach and grassed area above the structure (see Figure 7).</p> <p>Based on visual inspection in 2012, Worley Parsons (2013) assigned this segment a 'fair' condition rating and used a detailed risk assessment to assign a design standard of 10-year ARI. The</p>

Note: Brown snake in rock structure in the photo on lower-right and then again on beach nearby segment 1.3 in the photo on lower-left.

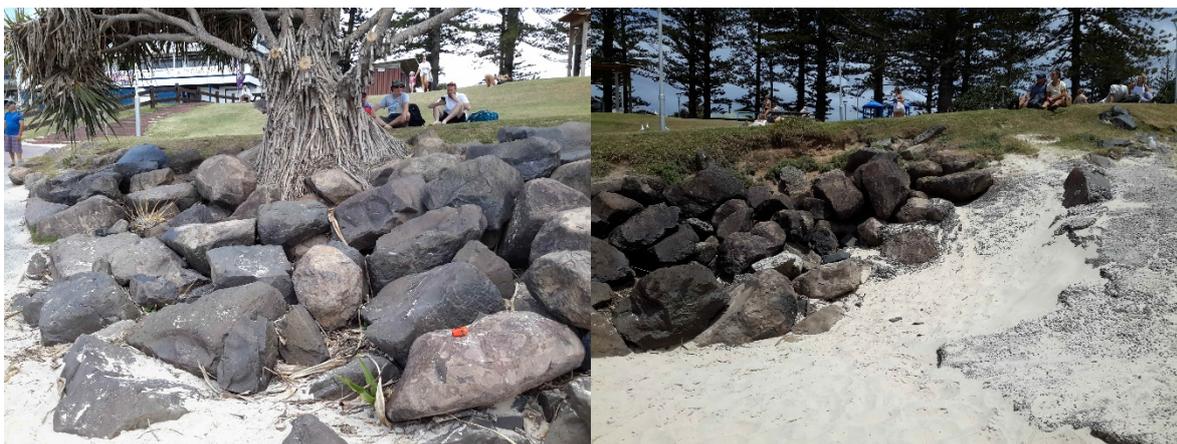
Figure 8: Fieldwork photos of segment 1.3

1.3 Reserve revetment Chainage: 67 to 90m	3	2	3	<p>Poured concrete ramp acting as an informal beach access has caused the rock slope to slide and steepen adjacent to the ramp. Concrete filled voids adjacent to ramp where there is a small section of the upper slope with no armour. The ramp reduced the structure's effectiveness against wave run-up. Photos of this segment are provided in Figure 8.</p> <p>In general, the armour layer is in fair condition but some wave damage (erosion) and overtopping is evident. No filter layer was visible.</p> <p>Based on visual inspection in 2012, Worley Parsons (2013) assigned this segment a 'fair' condition rating and used a detailed risk assessment to assign a design standard of approximately 10-year ARI. The condition rating assigned here is also 'fair'. This segment does not meet contemporary design standards for coastal protection structures.</p>

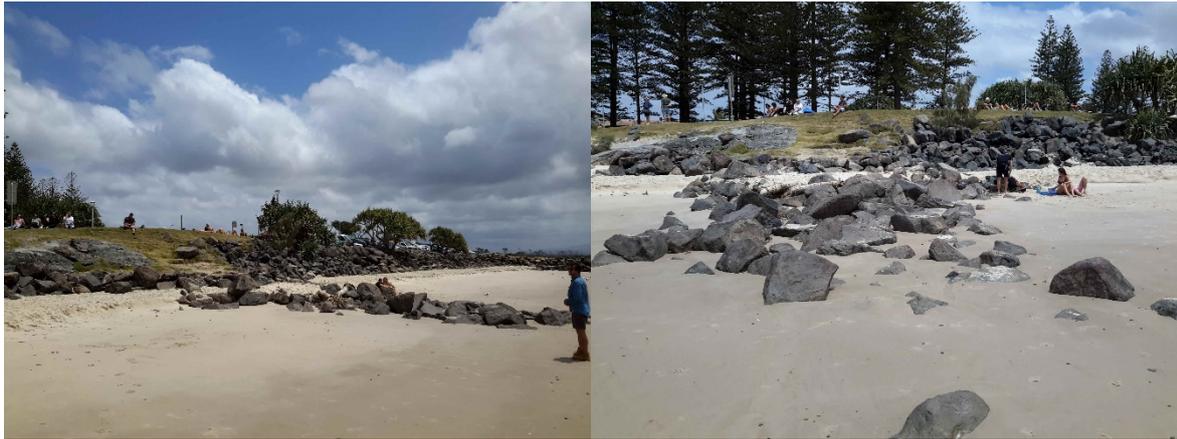
Figure 9: Fieldwork photos of segment 1.4

1.4 1st spur groyne Chainage: 100 to 118m	1	2	2	<p>The 1st spur groyne appears to have been poorly constructed and has been subsequently badly damaged. The crest level of the groyne is only 2.6m AHD and significantly less than that shown on the 1975 design drawings. It appears that settlement, scour and wave damage have dislodged armour and core (noting the 1975 drawings show no existing rock apron under this groyne) and scattered and flattened the structure with almost complete loss of interlocking. Sand infills the low structure and there was very little effect on the beach at the time of the inspection. Photos of this segment are provided in Figure 9.</p> <p>West of the 1st spur groyne there is a short section of revetment built from the same, significantly undersized armour and armour of poor quality with cracking, fracturing, spalling and rounding all observed. The core is exposed in the corner under small pandanus tree.</p> <p>Based on visual inspection in 2012, Worley Parsons (2013) assigned this segment a 'poor' condition rating and used a detailed risk assessment to assign a design standard of less than 1-year ARI. The condition rating assigned here is 'failed'. This segment does not meet contemporary design standards for coastal protection structures.</p>

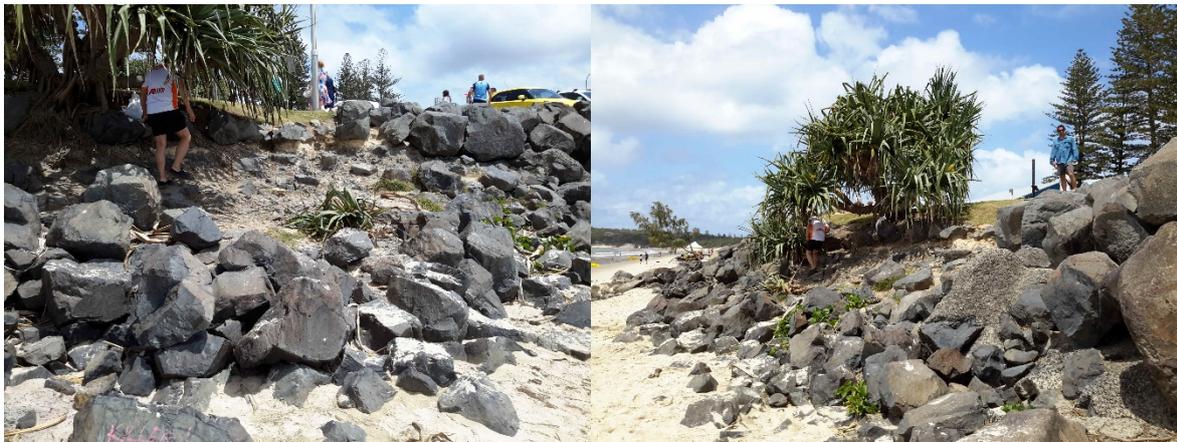
Figure 10: Fieldwork photos of segment 1.5

1.5 Car park revetment east Chainage: 118 to 199m	2	2	3	<p>This segment shows significantly different construction with larger armour rocks (lighter in colour and less angular) overlaying older smaller and darker rocks that have been rounded by wave action, see Figure 5. Informal access at the eastern end of the car park has resulted in loss of armour layer integrity. Photos of this segment are provided in Figure 10.</p> <p>Based on visual inspection in 2012, Worley Parsons (2013) assigned this segment a 'fair' condition rating and used a detailed risk assessment to assign a design standard of approximately 1-year ARI. The condition rating assigned here is 'poor'. This segment does not meet contemporary design standards for coastal protection structures.</p>

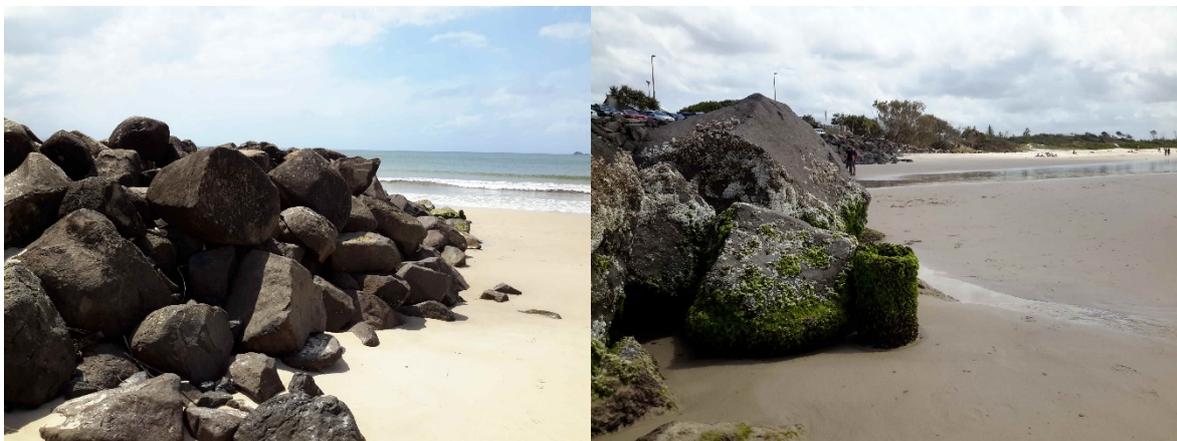
Figure 11: Fieldwork photos of segment 1.6

1.6 Main groyne Chainage:	2	1	3	<p>The main groyne shows a wide grading of rock sizes with a predominant fraction of larger rock. Some steepening of the eastern slope at the shore connection with the adjacent revetment was evident. The western side showed greater damage with some sections of core exposed and evidence of</p>

Segment ID Name	Condition rating (1 = failed, 5 = excellent)			Description and design standard
199 to 215m				<p>some fractured armour rocks. Several drifters were visible several metres away from the groyne on its seaward end. A large section of its western shore connection slumped and with evidence of old concrete stormwater outlet rubble. Photos of this segment are provided in Figure 11.</p> <p>The beach level of the western side of the groyne (downdrift) appeared significantly lower at the time of inspection, exposing greater extents of the toe apron. Two exposed remains of the piling of the old timber jetty were noted at the seaward end of the groyne suggesting that more remains may be buried under the groyne.</p> <p>Based on visual inspection in 2012, Worley Parsons (2013) assigned this segment a 'fair' (eastern side) and 'poor' (western side) condition ratings and used a detailed risk assessment to assign a design standard of approximately 1-year ARI. The condition rating assigned here is 'poor'. This segment does not meet contemporary design standards for coastal protection structures.</p>

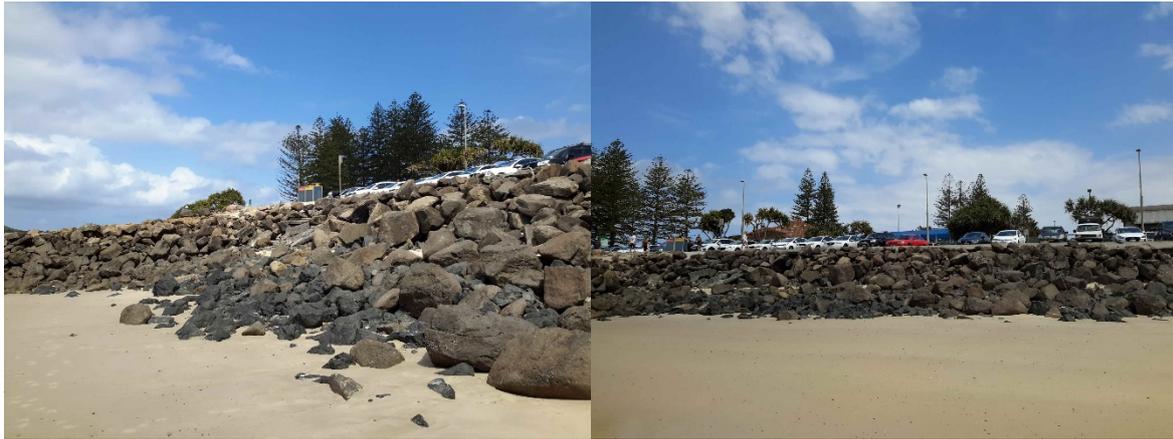
Figure 12: Fieldwork photos of segment 1.7

<p>1.7 Car park revetment west Chainage: 215 to 288m</p>	2	2	3	<p>This segment showed a similar build to the Main Groyne with a wide armour rock grading and a sloping crest level of 4m AHD along the eastern extent sloping to 3m AHD on its western end. In the corner closest to the Main Groyne, the eastern end of this segment had slumped, resulting in a steepened face. Several concrete slabs are mixed in with the rock armour layer in this area. Photos of this segment are provided in Figure 12.</p> <p>The upper face of the revetment has steepened as armour rocks were displaced to the lower faces. The crest of the revetment has been concrete capped with some evidence of degradation and cracking of the concrete layer. Clear evidence of sand infill at approximately mid face was noted. Older, more rounded and darker rock was visible on the lower slope of the revetment extending away from the upper revetment at a milder slope (refer Figure 6).</p> <p>Based on visual inspection in 2012, Worley Parsons (2013) assigned this segment a 'poor' condition rating and used a detailed risk assessment to assign a design standard of approximately 1-year ARI. The condition rating assigned here is 'poor'. This segment does not meet contemporary design standards for coastal protection structures.</p>

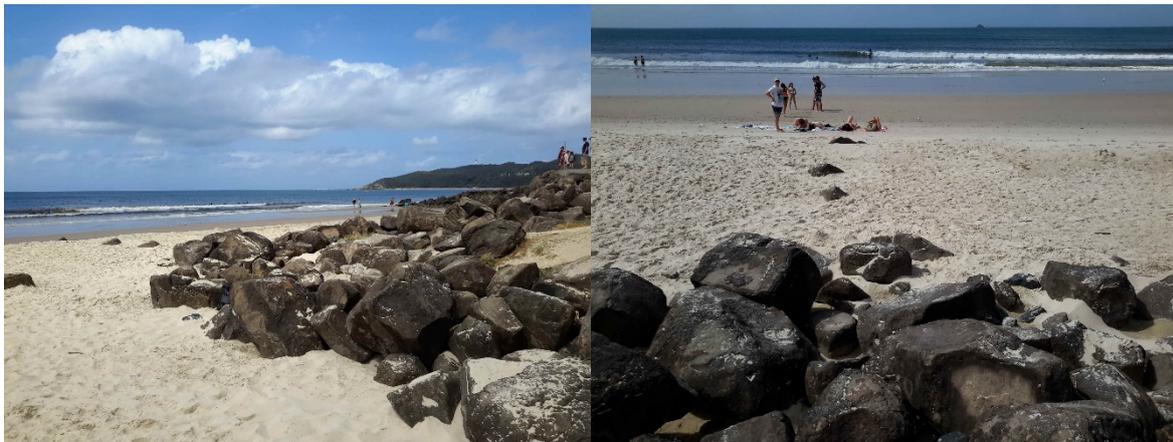
Figure 13: Fieldwork photos of segment 1.8

<p>1.8 3rd Spur Groyne Chainage: 288 to 302m</p>	2	3	1	<p>This 3rd spur groyne appears to be predominately buried while also many of the armour units were displaced by wave action. The armour rocks are significantly undersized and the structure has very low crest elevation of approximately 2m AHD. The eastern connection to the adjacent revetment has steepened due to displaced armour rocks. Photos of this segment are provided in Figure 13.</p> <p>Based on visual inspection in 2012, Worley Parsons (2013) assigned this segment a 'poor' condition rating and used a detailed risk assessment to assign a design standard of approximately 1-year ARI. The condition rating assigned here is 'poor'. This segment does not meet contemporary design standards for coastal protection structures.</p>
<p>1.9 First Sun Holiday Park</p>	3	3	3	<p>This structure comprises toe rock only with several access paths throughout structure and multiple displaced armour rocks. Several drifters were identified 2-3 metres seaward from the toe rock structure. A relatively densely vegetated dune system extends on the shoreward side of this structure. This suggests</p>

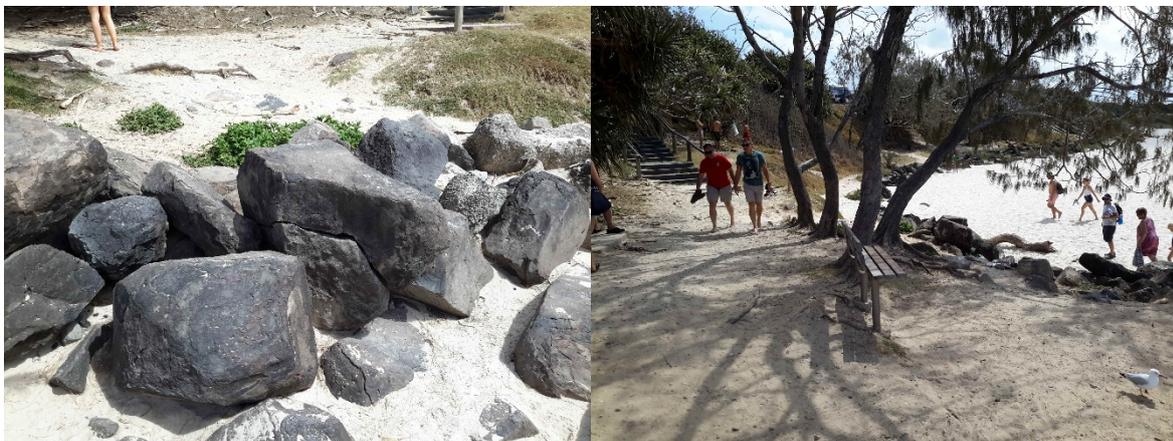
Figure 14: Fieldwork photos of segment

Segment ID Name	Condition rating (1 = failed, 5 = excellent)			Description and design standard
revetment Chainage: 302 to 426m				<p>that it currently provides some protection from wave impacts. Some dune erosion behind one of the access paths through the structure was evident at one of the access paths. Photos of this segment are provided in Figure 14.</p> <p>Based on visual inspection in 2012, Worley Parsons (2013) assigned this segment a 'poor' condition rating and used a detailed risk assessment to assign a design standard of approximately 1-year ARI. The condition rating assigned here is 'poor'. This segment does not meet contemporary design standards for coastal protection structures.</p>
