Main Beach Shoreline Project

Baseline Understanding Report

Findings of a baseline and literature assessment on the coastal protection structure at Main Beach, Byron Bay

Report No: E2020/ 30756

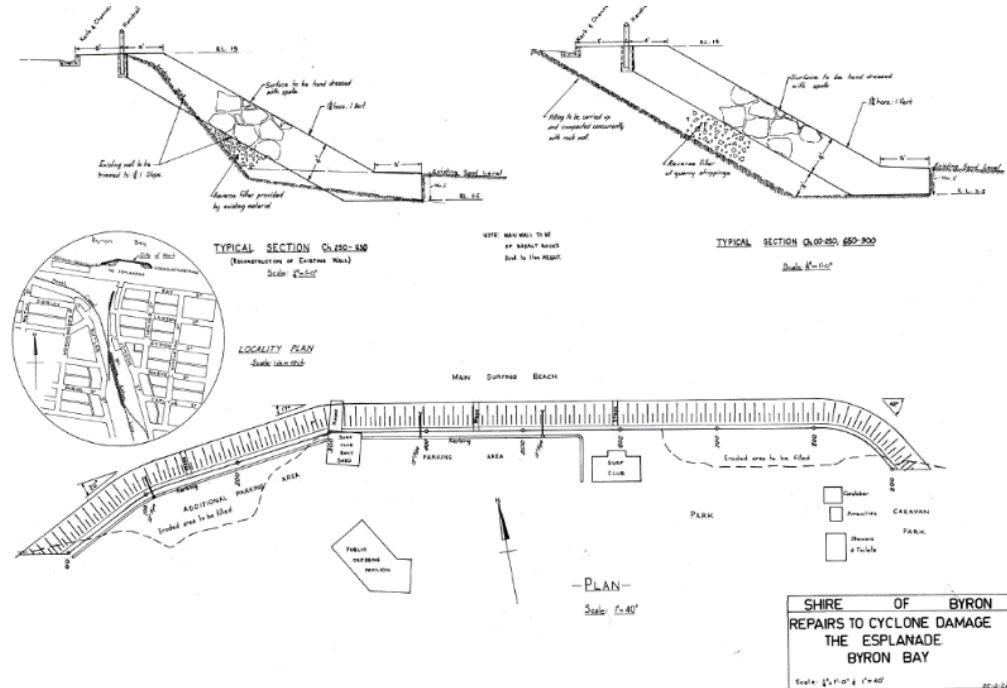
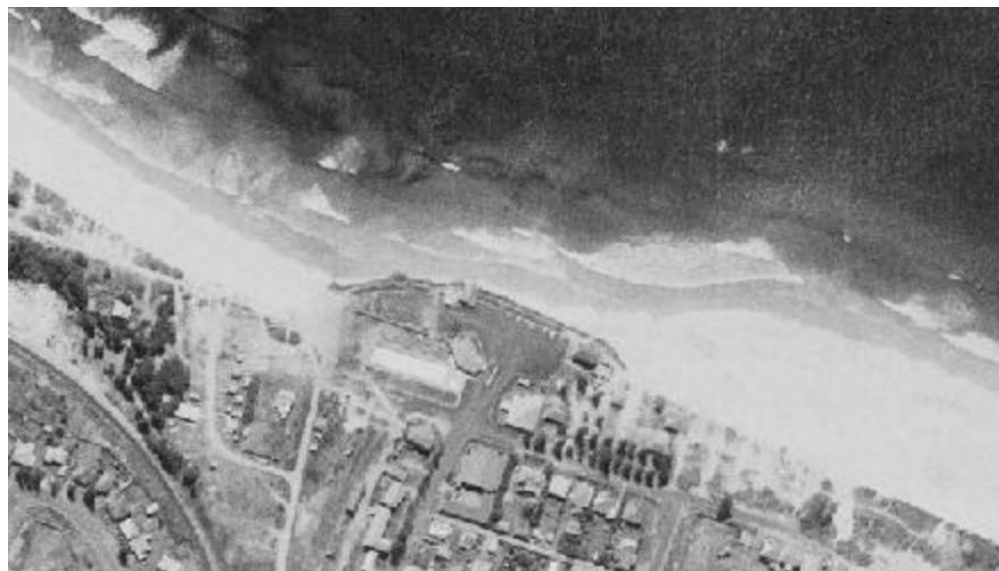
Drawings titled *Repairs to cyclone damage to The Esplanade, Byron Bay*, dated 25th March 1964 show the first engineering designs of what later became known as the JSPW. The 1964 drawings show a 900-feet long (274 metres) rock revetment along the alignment of the previous temporary rock protection works and terrace timber seawall. The drawings show that the rock protection works extend from west of the former surf club boat shed and continuing east past the former Byron Bay SLSC (labelled 'Surf Club') to the site of the present day SLSC at Fletcher Street. However, an aerial photograph captured in 1966 (see Figure 8) suggests that the as-constructed rock protection works terminated just east of the former SLSC, which is approximately 250 feet (76m) shorter than shown on the 1964 design. This shorter extent is also shown as existing works on the 1974 'upgrade' drawings presented in Figure 11.

are to be a repair of the existing wall, reusing the existing rock as the armour underlayer with no thickness nominated on the drawings. The existing wall was to be extended on either end, the typical section for structure chainages 0-250 and 650-900 (top right in Figure 8) showing the eroded areas to be filled and compacted before placing three feet (0.9 metres) of quarry run overlaid by armour rock.

Figure 8: (top) 1964 designs for repairs and extension of the JSPW (WorleyParsons, 2014) and (bottom) 1966 aerial photograph of the constructed rock protection works (source: NSW Government).

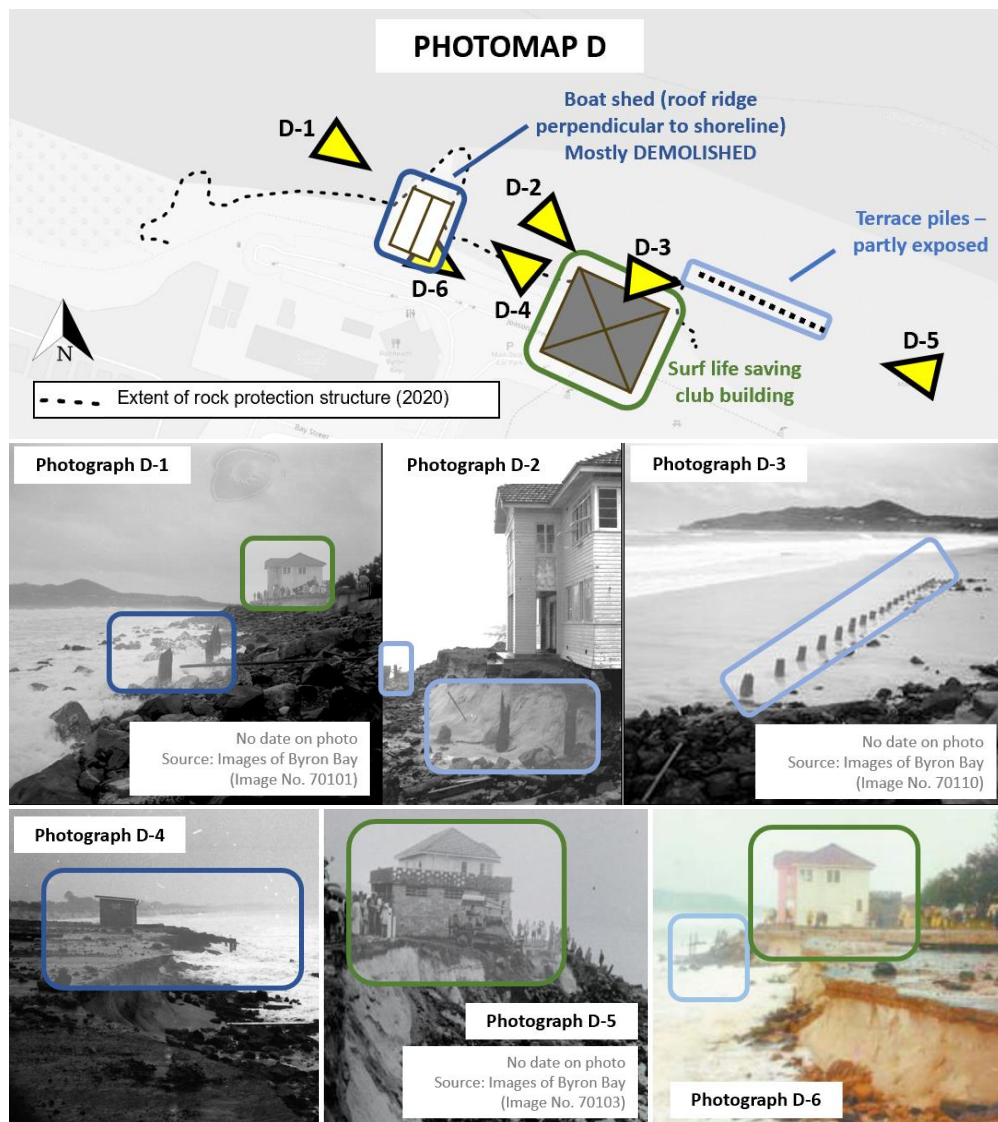
1967-1974 Between 1967 and 1974 seven tropical cyclones impacted NSW (BoM, 2019). These were: Dinah (1967), Barbara (1967), Glenda (1967), Daisy (1972), Wanda (January 1974), Pam (February 1974) and Zoe (March 1974). Large waves and beach erosion claimed houses, roads and public infrastructure. The series of three cyclones in 1974, the most severe being TC Pam in February, caused significant erosion to the dunal system downdrift of the JSPW at Belongil Beach and damage to roads, the JSPW and the surf club.

Figure 10: Photomap D and associated photographs showing erosion and damage to JSPW as a result of tropical cyclones between 1967 and 1974.

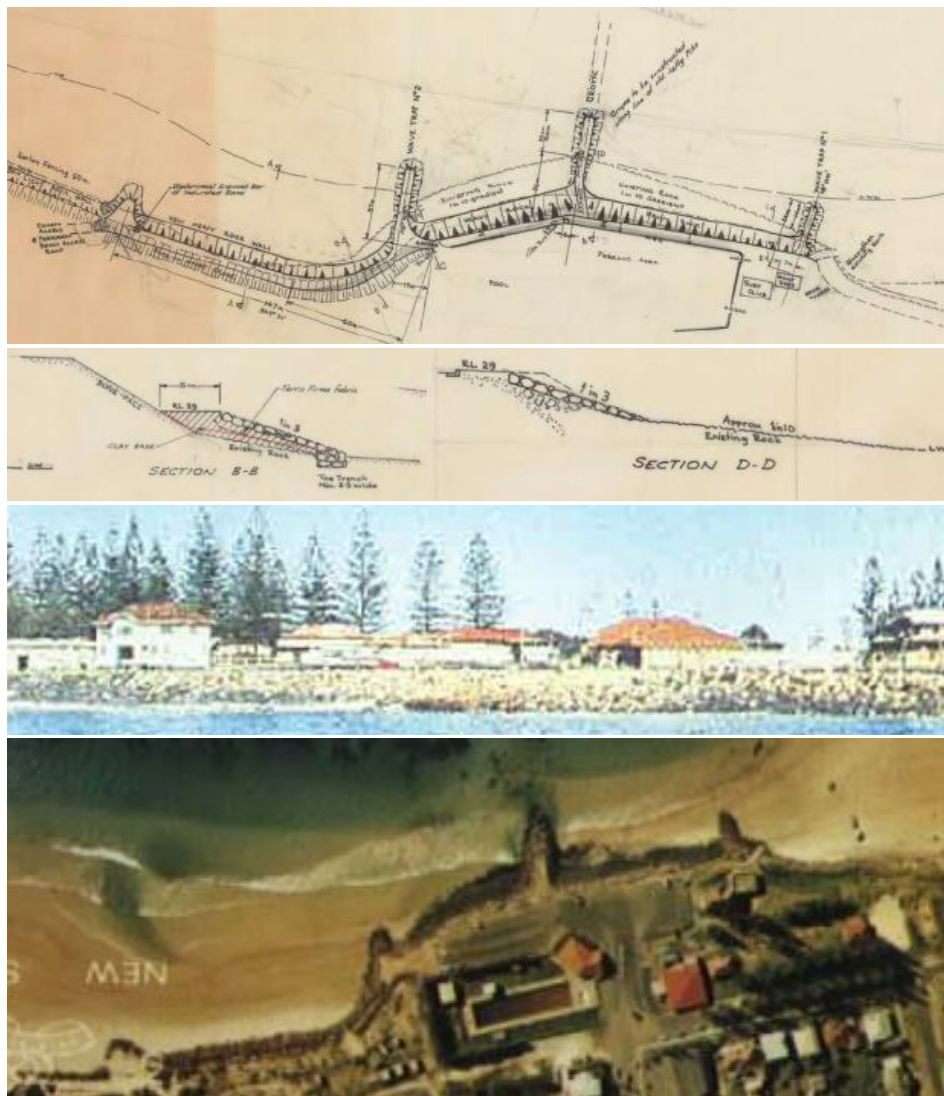
firma" fabric underlay appears on the drawings. Inclusion of this fabric is likely to have been an important element in stopping the loss of finer material from behind the rock revetment, which may have been one cause of the previous failures.

The drawings indicate that the rock previously placed at a 1V:1 $\frac{3}{4}$ H slope had eroded and/or slumped to form an apron at an approximate 1:10 gradient. The new 'heavier' rock was placed onto this apron to restore the upper sections of the revetment (i.e., the remedial rock was founded on the failed existing rock). This rock apron is often buried. However, review of aerial photography when the beach levels in front the JSPW are low indicate this rock apron is still present and should be considered in any future modification design.

Figure 11: 1975 design of the JSPW upgrade and post-construction photographs (source: BSC; PWD, 1978).

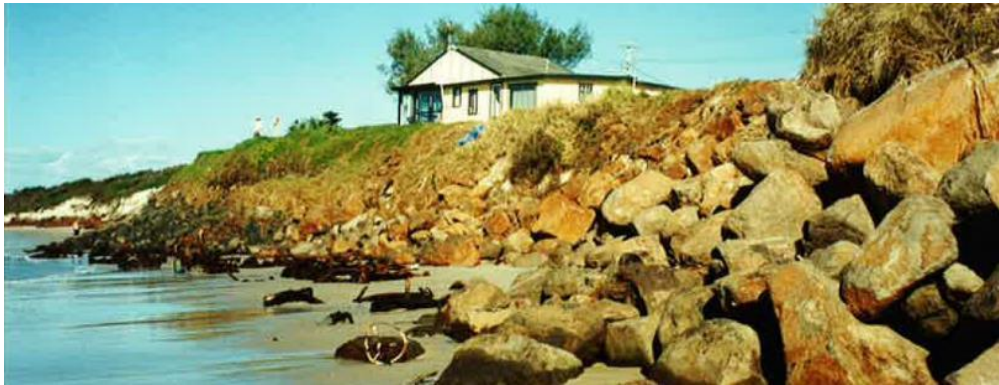
Figure 12: Erosion at Belongil Beach in May 1996 (source: BSC).

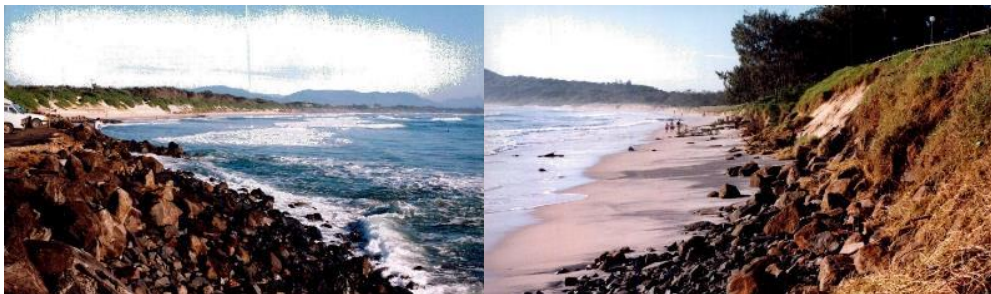
Figure 13: Photographs showing erosion (left) downdrift and (right) updrift of the JSPW in May 1999 (source: Peter Helman).

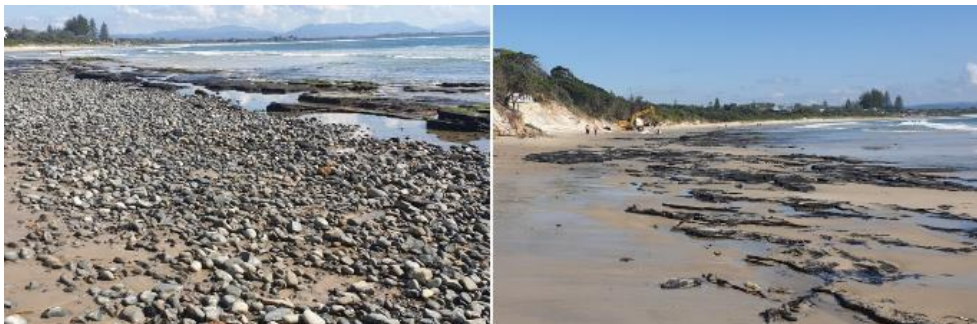
Figure 15: Erosion at Clarkes Beach in July 2019 (source: Bluecoast).

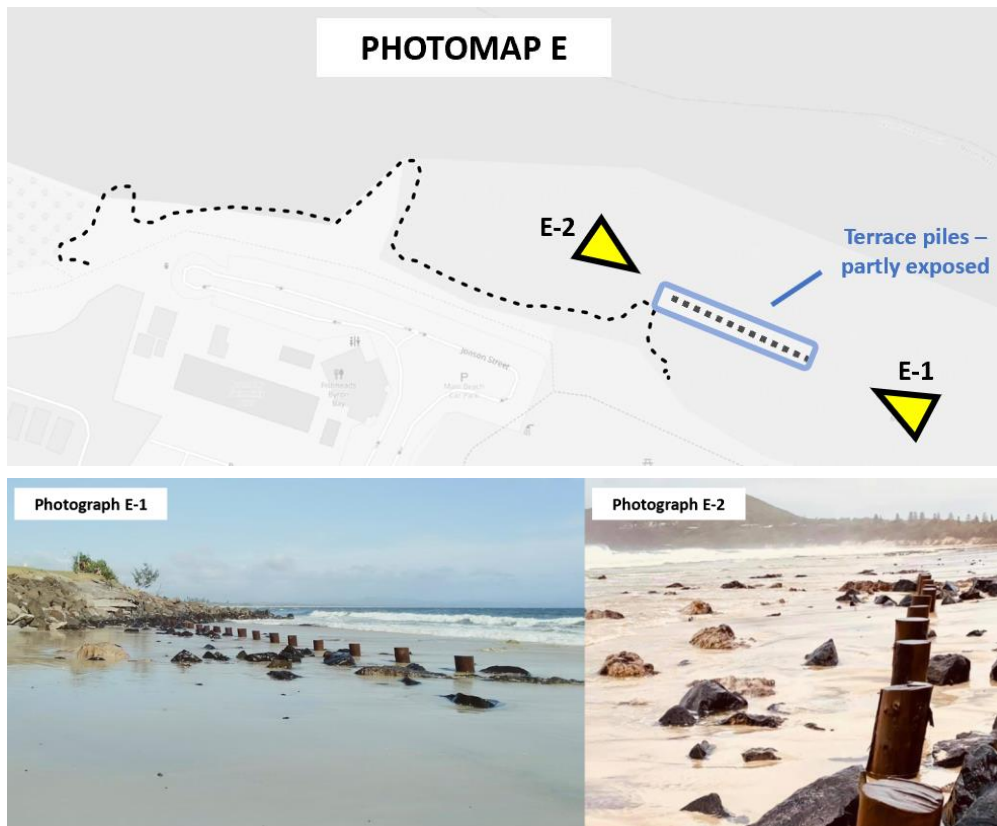
Figure 16: Photomap E – Recent exposure of timber terrace piles following storm event in December 2020.

Note: Timber piles are cut at low beach levels, with the most recent exposure anecdotally understood to be in the 90's.

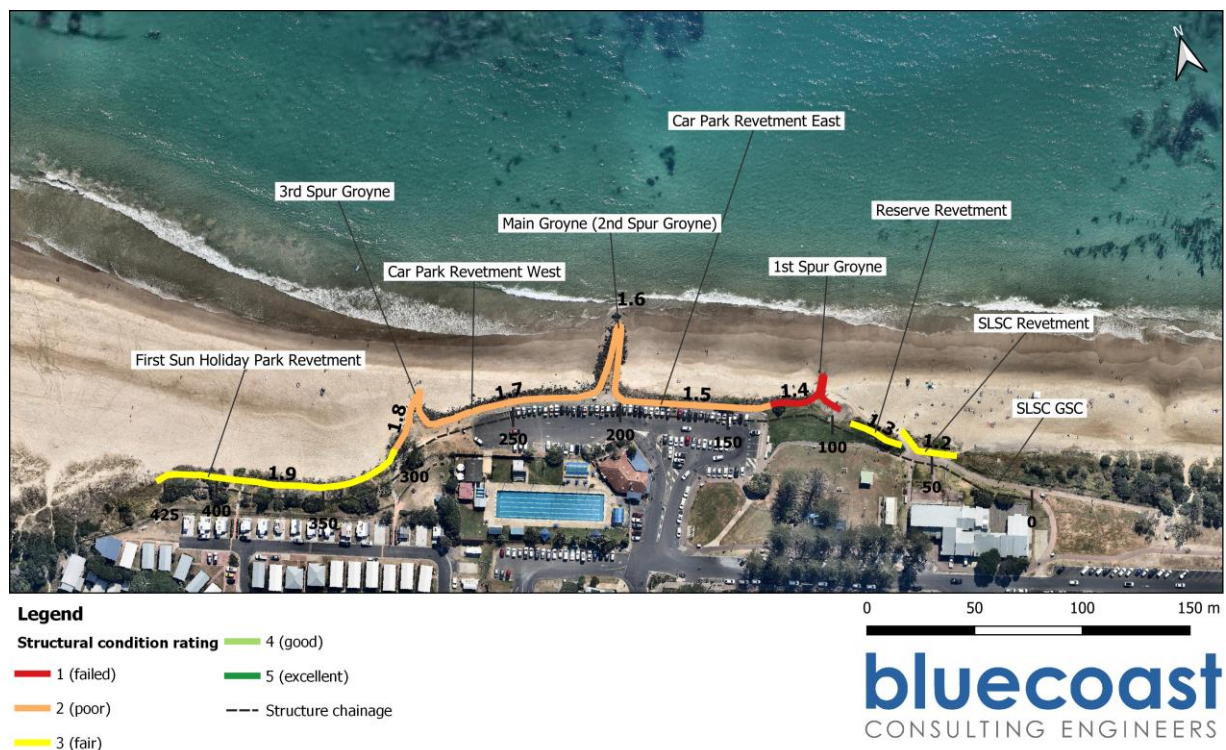
Figure 18: Structural condition rating for JSPW based on visual and drone inspection on 28th October 2019.

- overall, the armour rock quality was fair but there were isolated areas of poor-quality armour rock with significant degradation;
- in addition to the deterioration of the structure, it is evident that the original construction does not meet contemporary standards for rock revetments;
- various formal and informal accessways have been created over the structure, degrading its function (increased wave run-up risk) and compromising the integrity of the armour layer;

- visual inspection of the structure confirms, as suggested by the construction history, that rock has been progressively added to the JSPW. More recent and larger armour rock on the upper slopes was observed to overlay a darker and much smaller rock. Due to the sand level at the time of the inspection, the toe of the structure was not visible. However, it is suspected that the small darker rock originates from the 1960's revetment construction and now forms a mild sloping rock apron.

- the large total quantity of rock that forms these works needs to be considered in the modification designs, particularly any designs involving landward realignment. It is recommended that:
