22 July 2019
Ref No: 3351-1023

Byron Bay Bypass - Stage 1 Pre-clearing Report

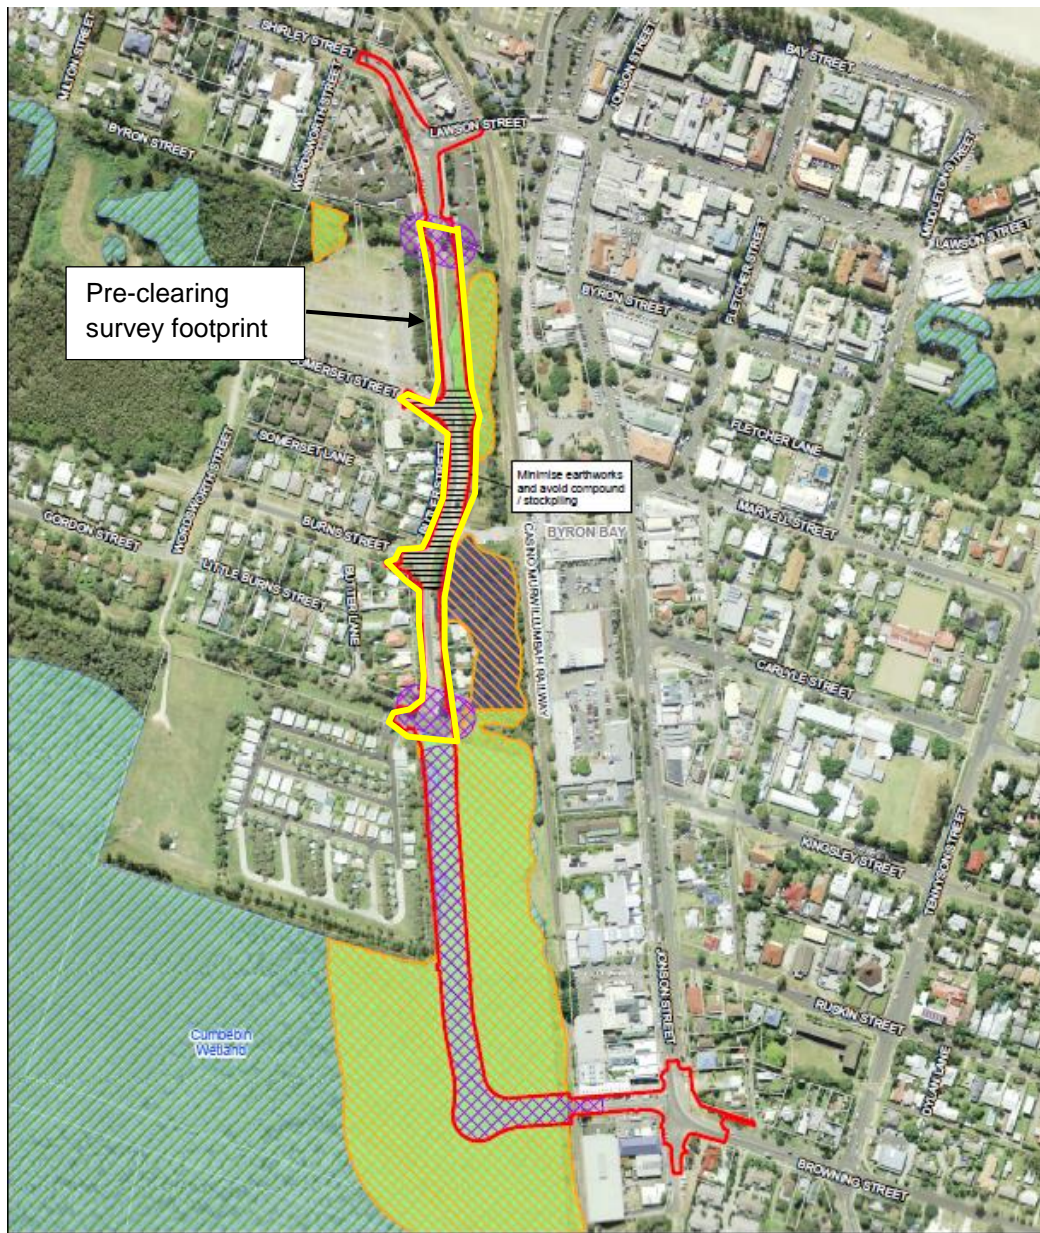
Figure 0.1 Pre-clearing Survey Footprint (yellow outline).

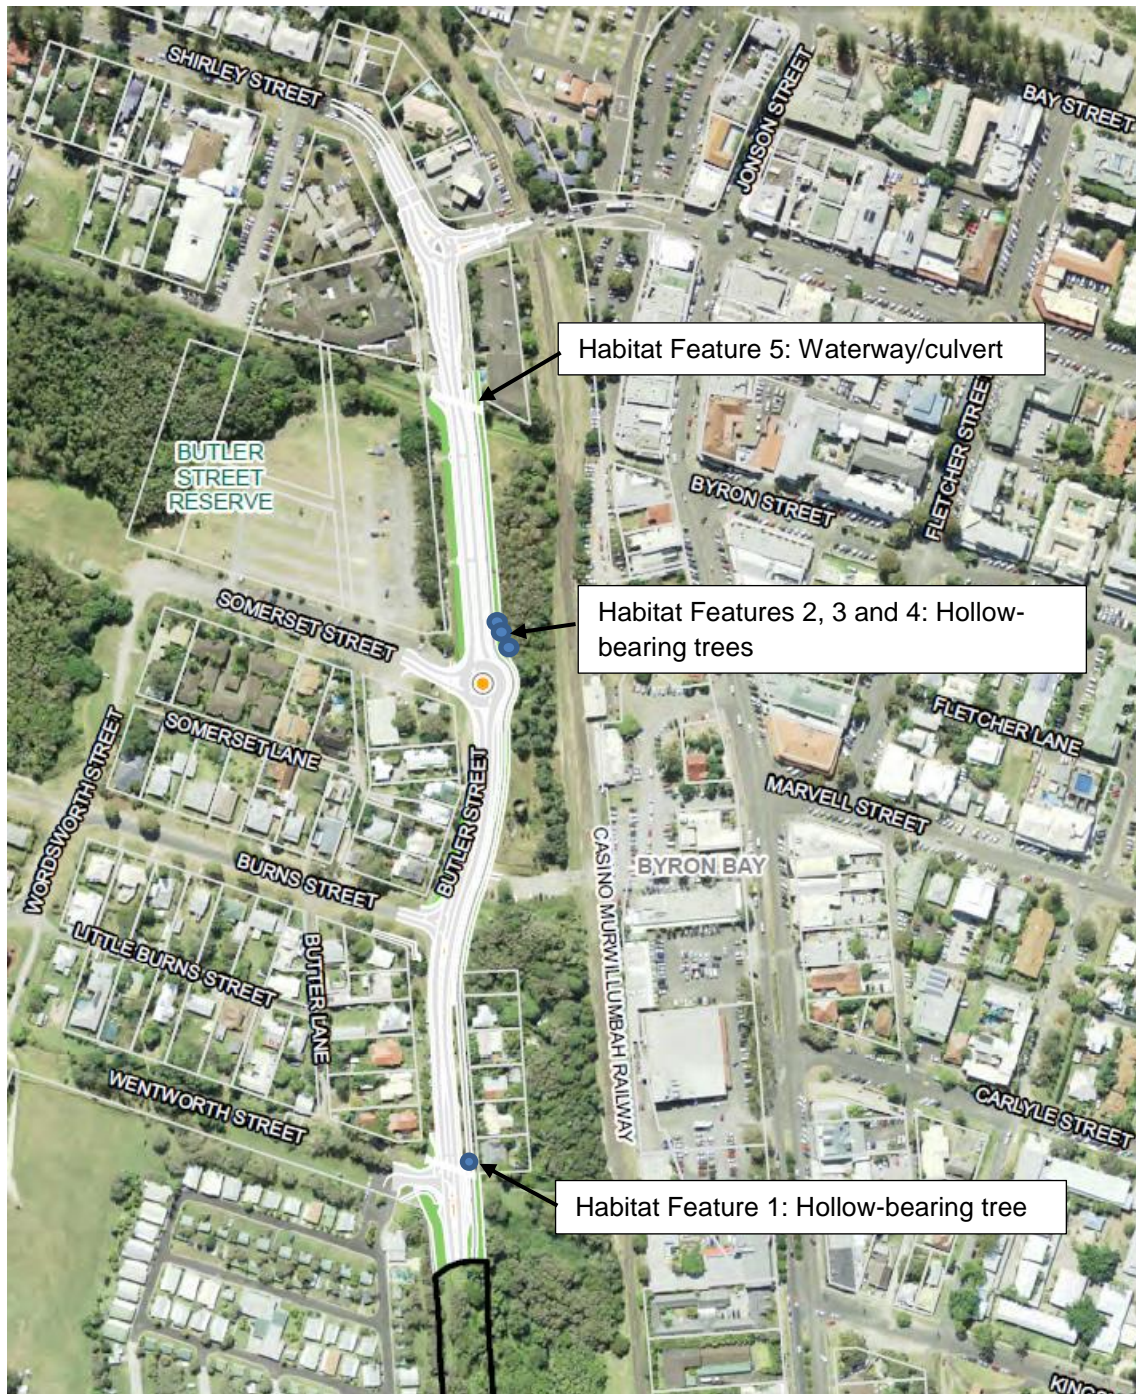
- Four hollow-bearing trees with small hollows. The hollows do not appear to be well formed and are likely to be of limited habitat value.
- One waterway and culvert under Butler Street at approximate chainage 190 (culvert 2-1). The waterway provides aquatic habitat for aquatic species (e.g. turtles, eels, etc) while the culvert cavities provide opportunities for fauna including microbats and Eastern Water Dragons (*Intellagama lesueurii*).

A fauna habitat feature register that includes the location and a description of the subject habitat features is provided in **Table 1**. The locations of these features are displayed in **Figure 2**.

Figure 2 Fauna Habitat Features

- The Environmental Officer would inspect the waterway at approximate chainage 190 prior to installation of bunds or dewatering activities. Appropriate controls would be implemented if aquatic fauna are present at the time of the works. This potentially includes engaging a suitability licenced aquatic ecologist to undertake aquatic fauna salvage and relocation.
- The chainage 190 culvert would be inspected for microbats prior to any works at the culvert.
- A Myrtle Rust management procedure should be established for the project in consultation with Byron Shire Council.

The hollow-bearing trees at the site are of low quality and may be able to be inspected easily with an arborist/inspection camera. Two stage clearing therefore may not be warranted for these trees. It should be noted that two-stage clearing is also not a requirement of the Stage 1 Approvals (GHD 2017 and 2019a).
