Byron Shire ICOLL Water Pollution Source Tracking and Control Programs for Belongil Creek, Tallow Creek and Ti-Tree Lake

Stage 2 Study

Final Report

August 2023

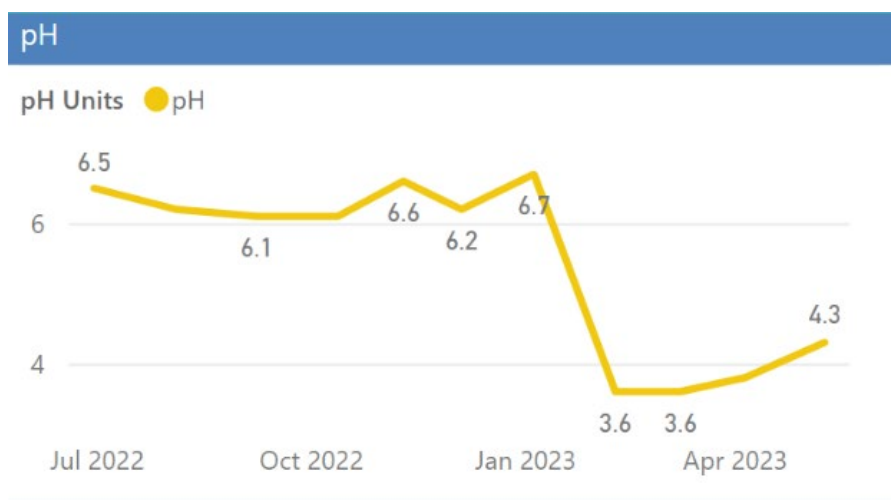
- While not included in the 2016-2022 dataset, of note are recent results published on the BSC Water Quality Public Data Portal (BSC, 2023e), showing a decrease in pH at site BC13 from near neutral pH levels (pH 6.1 – 6.5) to acidic conditions (pH 3.6 – 4.3) from February 2023 – May 2023 (Figure 15). These results were significantly more acidic than all previous values recorded at this site from 2016-2022 (range of pH 5.6 – 7). BSC’s Environmental Health Officer investigated the Harvest construction site (West Byron Subdivision) which is located immediately upstream of BC13 in May 2023 and identified site pH values of pH 3.1 (newly constructed swale), and pH 4.1 within an existing swale on site (pers. comm M. Bingham, 2023). These results highlight the impact of soil excavation activities within ASS areas on downstream water quality. ASS mitigation measures were undertaken at the site following BSC discussions with construction site managers. BSC will continue to monitor the site throughout the construction phase.

Figure 15: Site BC13 pH results for July 2022- May 2023

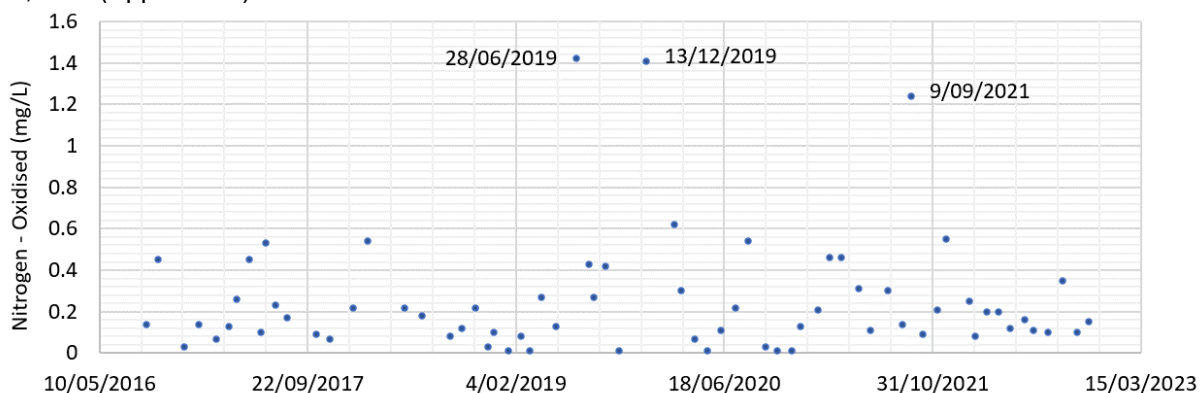
- Oxidised nitrogen (NO_x - bioavailable forms of N) were noticeably higher at site BC15 (Bangalow Road, urban area) than any other site and warrants further investigation of potential sources at this location (e.g. potential sewer leaks/overflows, excessive fertiliser use etc.). Figure 16 shows all NO_x results at BC15 from May 2016 to March 2023 showing consistently elevated levels and three spikes of NO_x occurring in June and December 2019 and again in September 2021. Review of BSC sewer overflow records as part of this project (refer Section 4.2.1, Sewer infrastructure) identified customer reported sewer overflow incidents occurring at properties adjacent to this location in January 2019 (due to pump station 3001 failure from the build-up of oils and grease) and again on 10th February 2020 (due to sewer choke). The consistently high NO_x results indicate an ongoing issue at this site that warrants further investigation. Sites BC07 and BC14 and BC14b also showed elevated median levels of NO_x and occasional spikes over the monitoring period assessed, which may indicate similar issues at these sites and also warrants further investigation. One sewer overflow incident reported to the NSW EPA on 27/1/2021 was described as impacting the Butler Street Drain on the corner of Dryden Street and Shirley Lane with an estimated discharge of effluent to the environment of 10,000L (Appendix 3).

Figure 16: Monthly oxidised nitrogen results at Site BC15 from May 2016 to March 2023

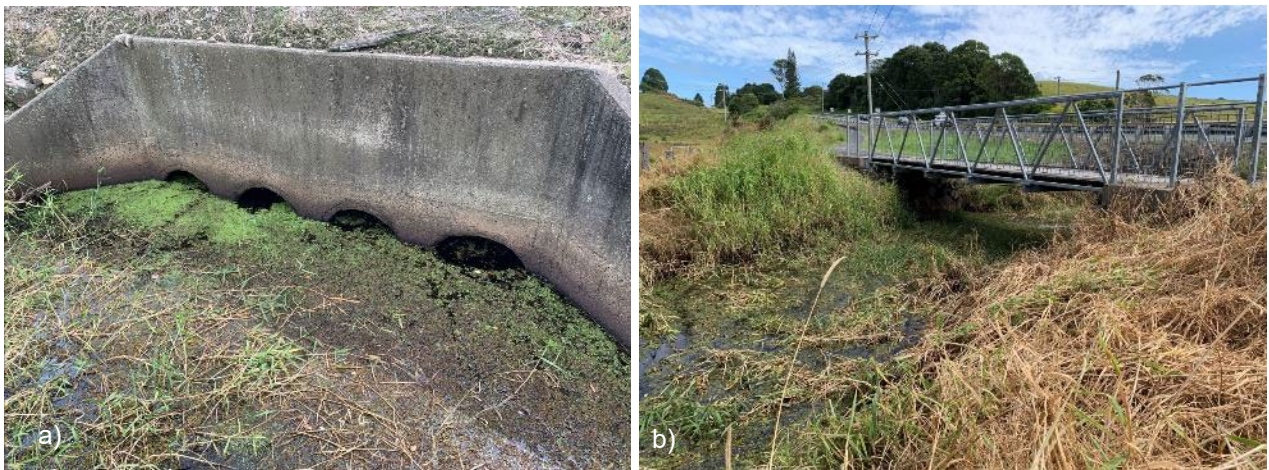
The majority of constructed surface water drains visited in April 2023 were in poor condition. Poor water quality was recorded at many sites including low dissolved oxygen values and high turbidity. Many drains including the Upper Union Drain, Industrial Estate drains and Butler Street Drain were observed to be showing signs of nutrient enrichment (e.g. excess algae and aquatic plant growth, Plate 3, Plate 4, Plate 5, Plate 6). The aquatic weed *Salvinia molesta*, was also observed at several sites within the Upper Union Drain (Plate 3), within BBSTP wetlands and some urban stormwater drains. *Salvinia* is a fast growing and highly adaptable weed that can spread rapidly when conditions are favourable. Still or slow moving, warm fresh water with high nutrient concentrations are ideal conditions for growth. *Salvinia* can form thick mats which prevent light and oxygen from entering a waterway/ waterbody and can shade out other aquatic plants and degrade habitat for aquatic organisms. Decomposing *Salvinia* can reduce water quality by consuming large amounts of dissolved oxygen. Council's preferred management strategy to control *Salvinia* is biological control using the *Salvinia* weevil (*Cyrtobagous salviniae*).

Plate 3: a) Culvert south of Ewingsdale Road within the Upper Union Drain (Moran's Hill) b) Footbridge over Union Drain downstream/ south of culvert.

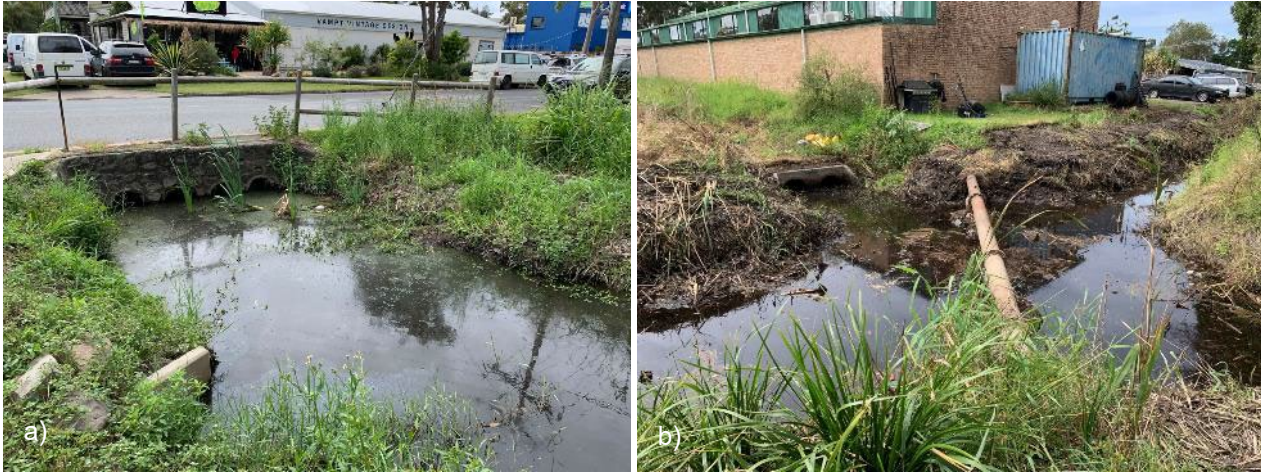
Plate 4: a) Industrial Estate Drain at Banksia Drive b) Confluence along Industrial Estate Drain.

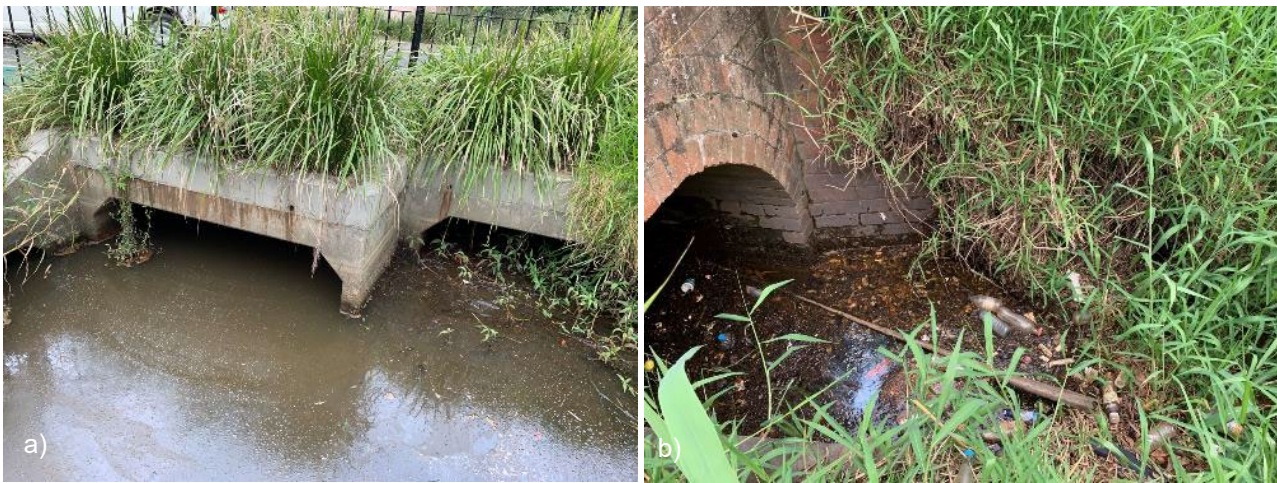
Plate 5: a) Butler Street Drain downstream of bypass culvert b) Butler Street Drain upstream of bypass.

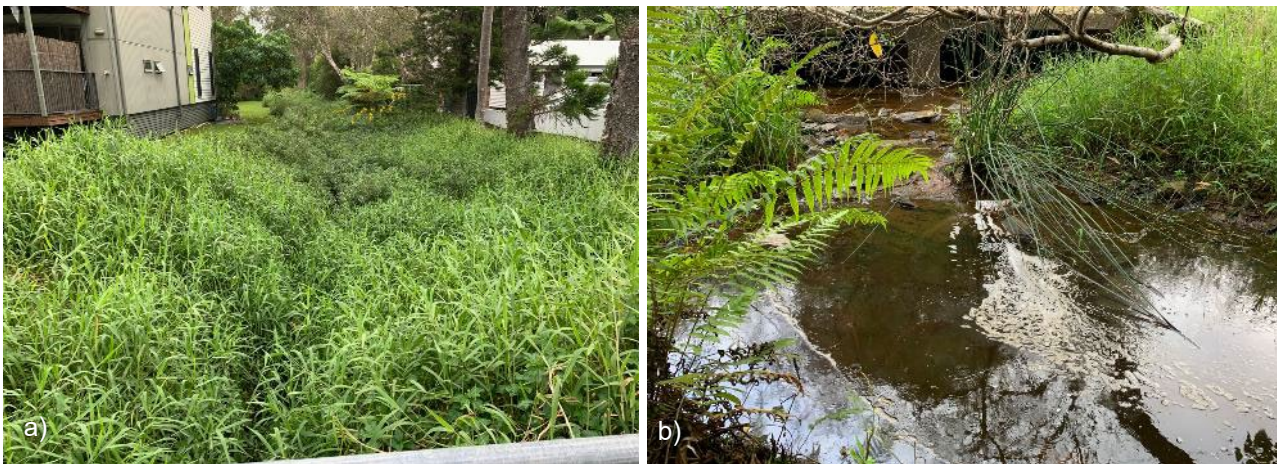
Plate 6: a) Water quality sample site BC15 downstream of Bangalow Road b) Water quality sample site BC17 downstream of Old Bangalow Road.

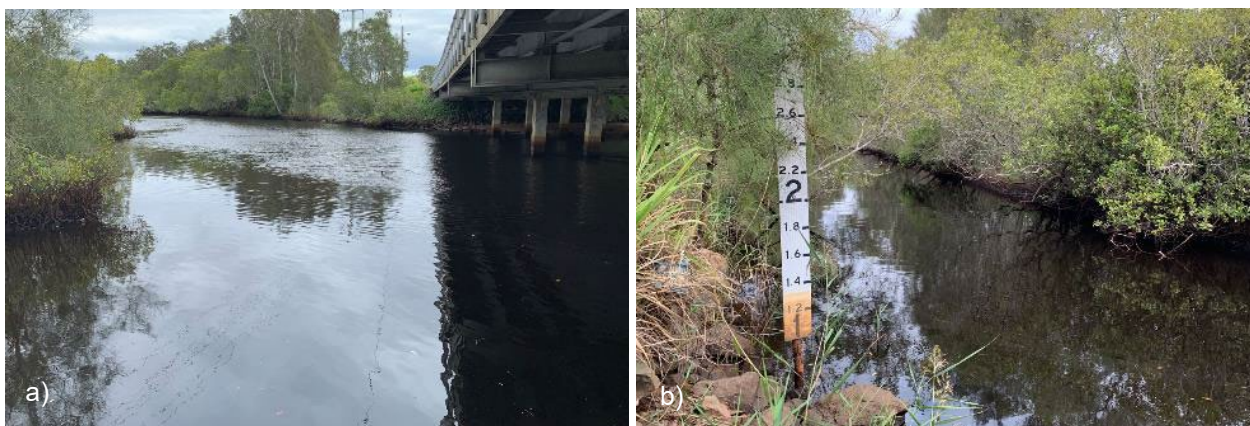
Plate 8: a) Belongil Creek at Ewingsdale Bridge b) Confluence of Butler Street Drain with Belongil Creek at Ewingsdale Bridge, note orange iron-staining at base of flood level marker.

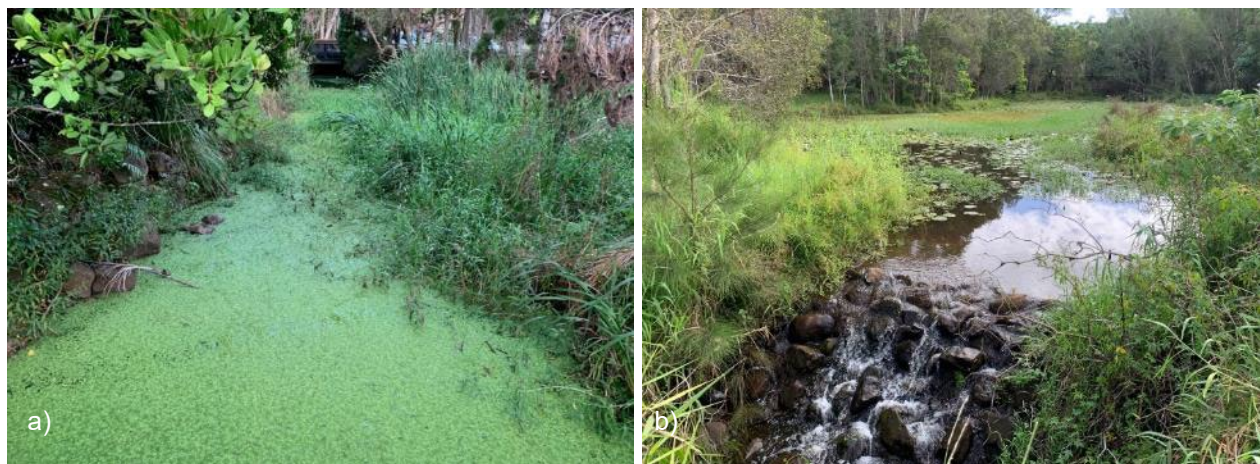
Plate 12: a) Water quality sampling site TC19 at Crystalbrook Resort downstream of Broken Head Rd. culvert, choked with Salvinia b) Shallow pond opposite Suffolk Park Service Station upstream of Broken Head Rd. culvert.

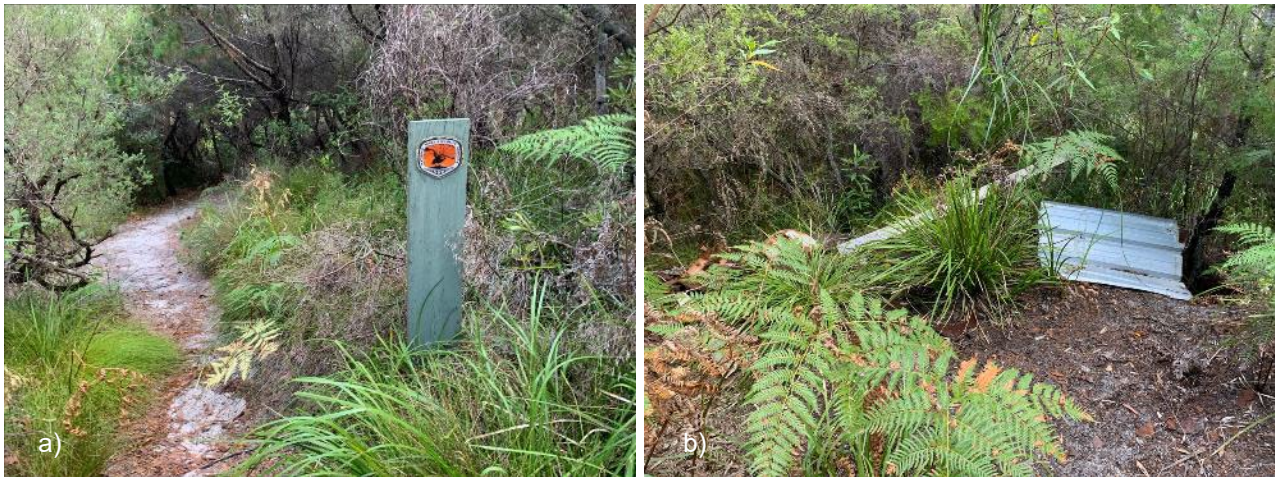
Plate 20: a) Walking track from Suffolk Park through Ti-Tree Lake Aboriginal Area b) Roofing, wood and other waste dumped along the track in the Ti-Tree Lake Aboriginal Area close to Macgregor Street in Suffolk Park.
