# Compliance Noise Monitoring

Byron Resource Recovery Centre  
The Manse Road  
Myocum

Prepared for: Byron Shire Council  
Project: 14/2017  
Version 1.0  
Date: 15 September 2017  
Tim Fitzroy & Associates  
ABN: 94120188829  
ACN: 120188829

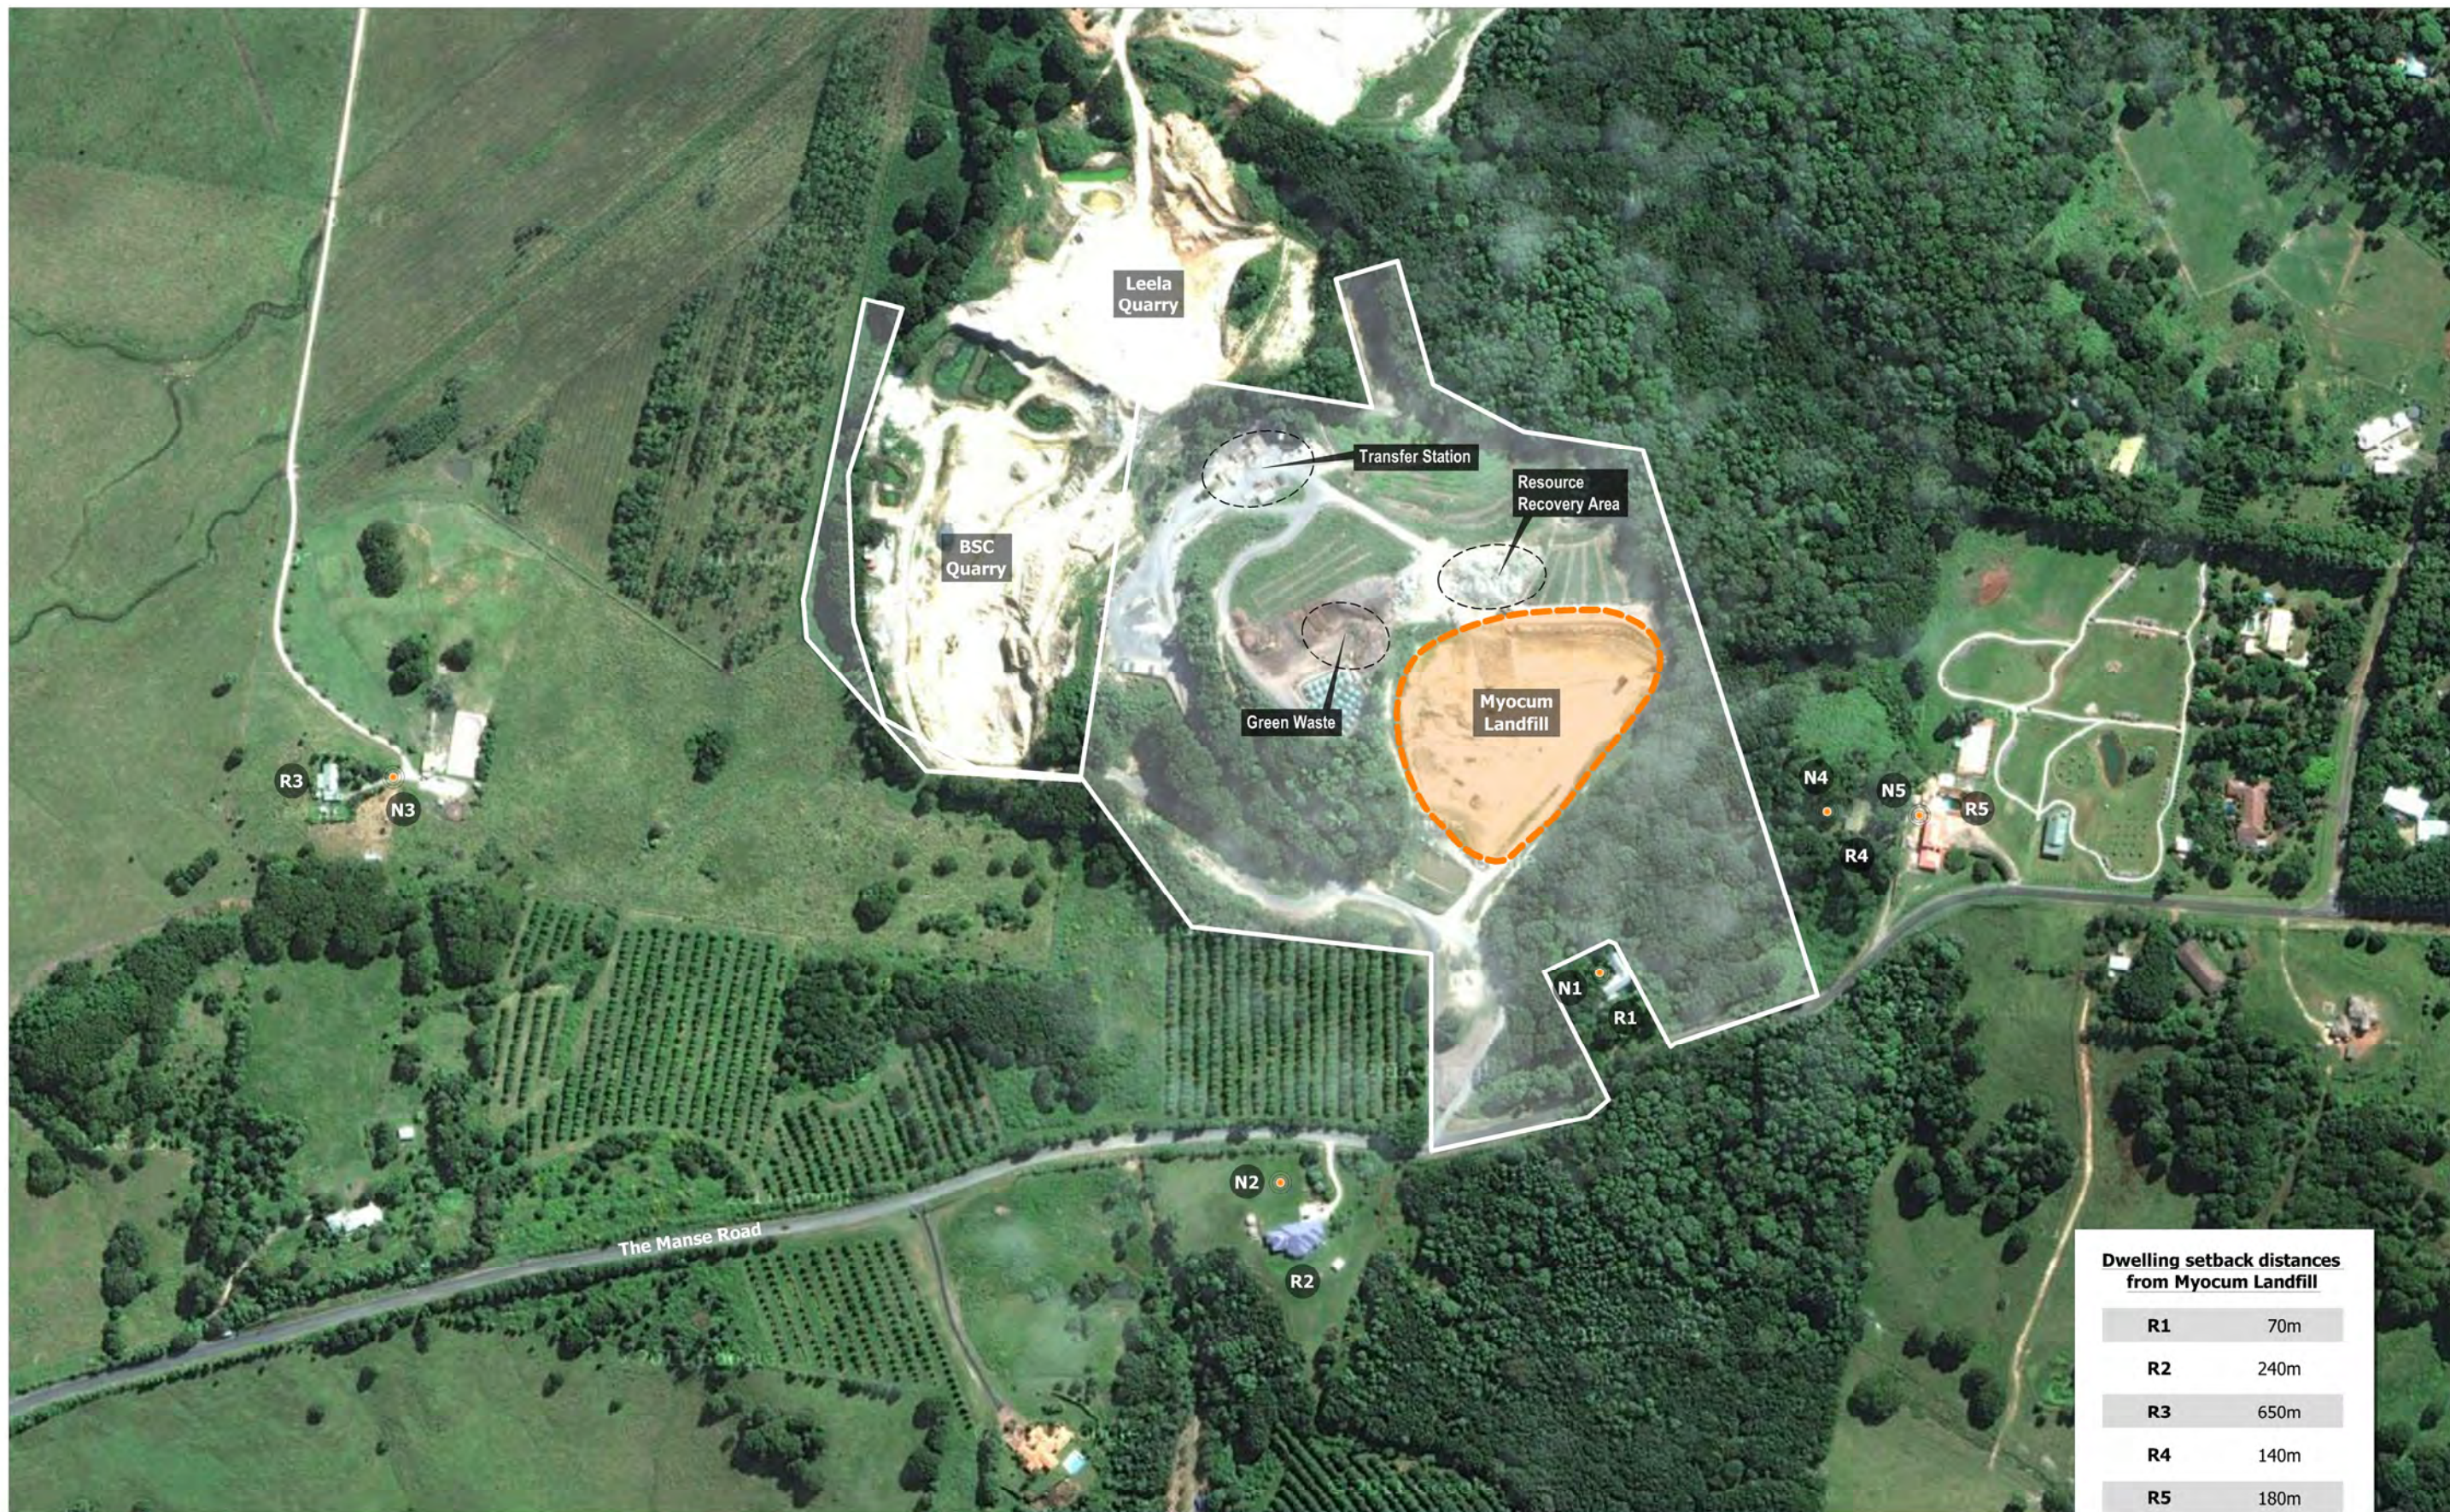
**Illustration 2.1:**  
**Noise Monitoring Locations and Dwelling Setbacks**

A number of residences are within close proximity of the BRCC. Residences R1 to R5 (inclusive) are identified in **Illustration 2.1**. Residences R1, R3 and R4 are owned by BSC, while the other residences are privately owned. Residences R1 and R5 are two storey dwelling houses while the other dwellings are single storey.

A BSC operated quarry is located to the immediate west of the BRCC, while Leela Quarry (privately operated) is located to the north (see **Illustration 2.1**). Vegetation provides a visual screen from the BRCC to residences R1, R2, R3 and R5.

**Dwelling setback distances from Myocum Landfill**

R1	70m
R2	240m
R3	650m
R4	140m
R5	180m

Condition No. L6.2 states that noise compliance is to occur within 30m of each nominated residence. Noise Monitoring locations are depicted in **Illustration 2.1**.

**Illustration 2.1** shows the location of the noise monitoring locations and set back distances from residences R1 to R5 inclusive to the BRCC.

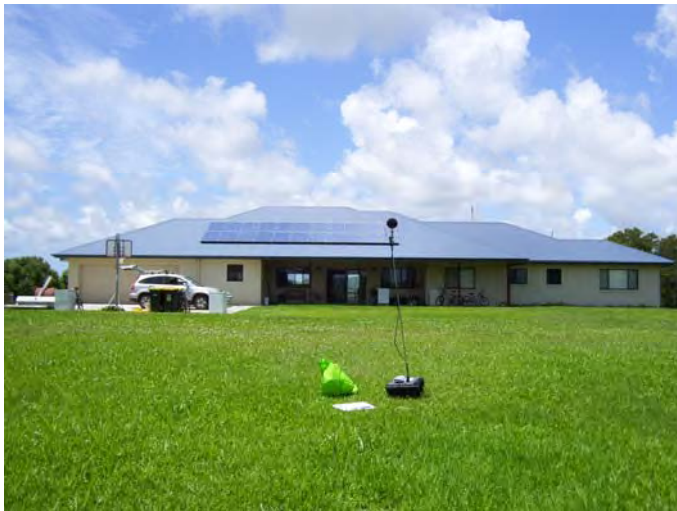
**Photo D**      **Noise Monitoring Location (N2)**

At location N2, the measured LAeq was 54dB (A). N2 was affected by traffic noise primarily associated with the Byron Resource Recovery Centre, wind impacts around 18km/hr and bird calls. Noise from the Byron Resource Recovery operation was not audible and estimated <35 db (A). This is below the noise limit of 43 dB (A).
