Compliance Noise Monitoring

Byron Resource Recovery Centre
The Manse Road
Myocum

Prepared for: Byron Shire Council
Project: 14/2017
Version 2.0
Date: 6 March 2016
Tim Fitzroy & Associates
ABN: 94120188829
ACN: 120188829

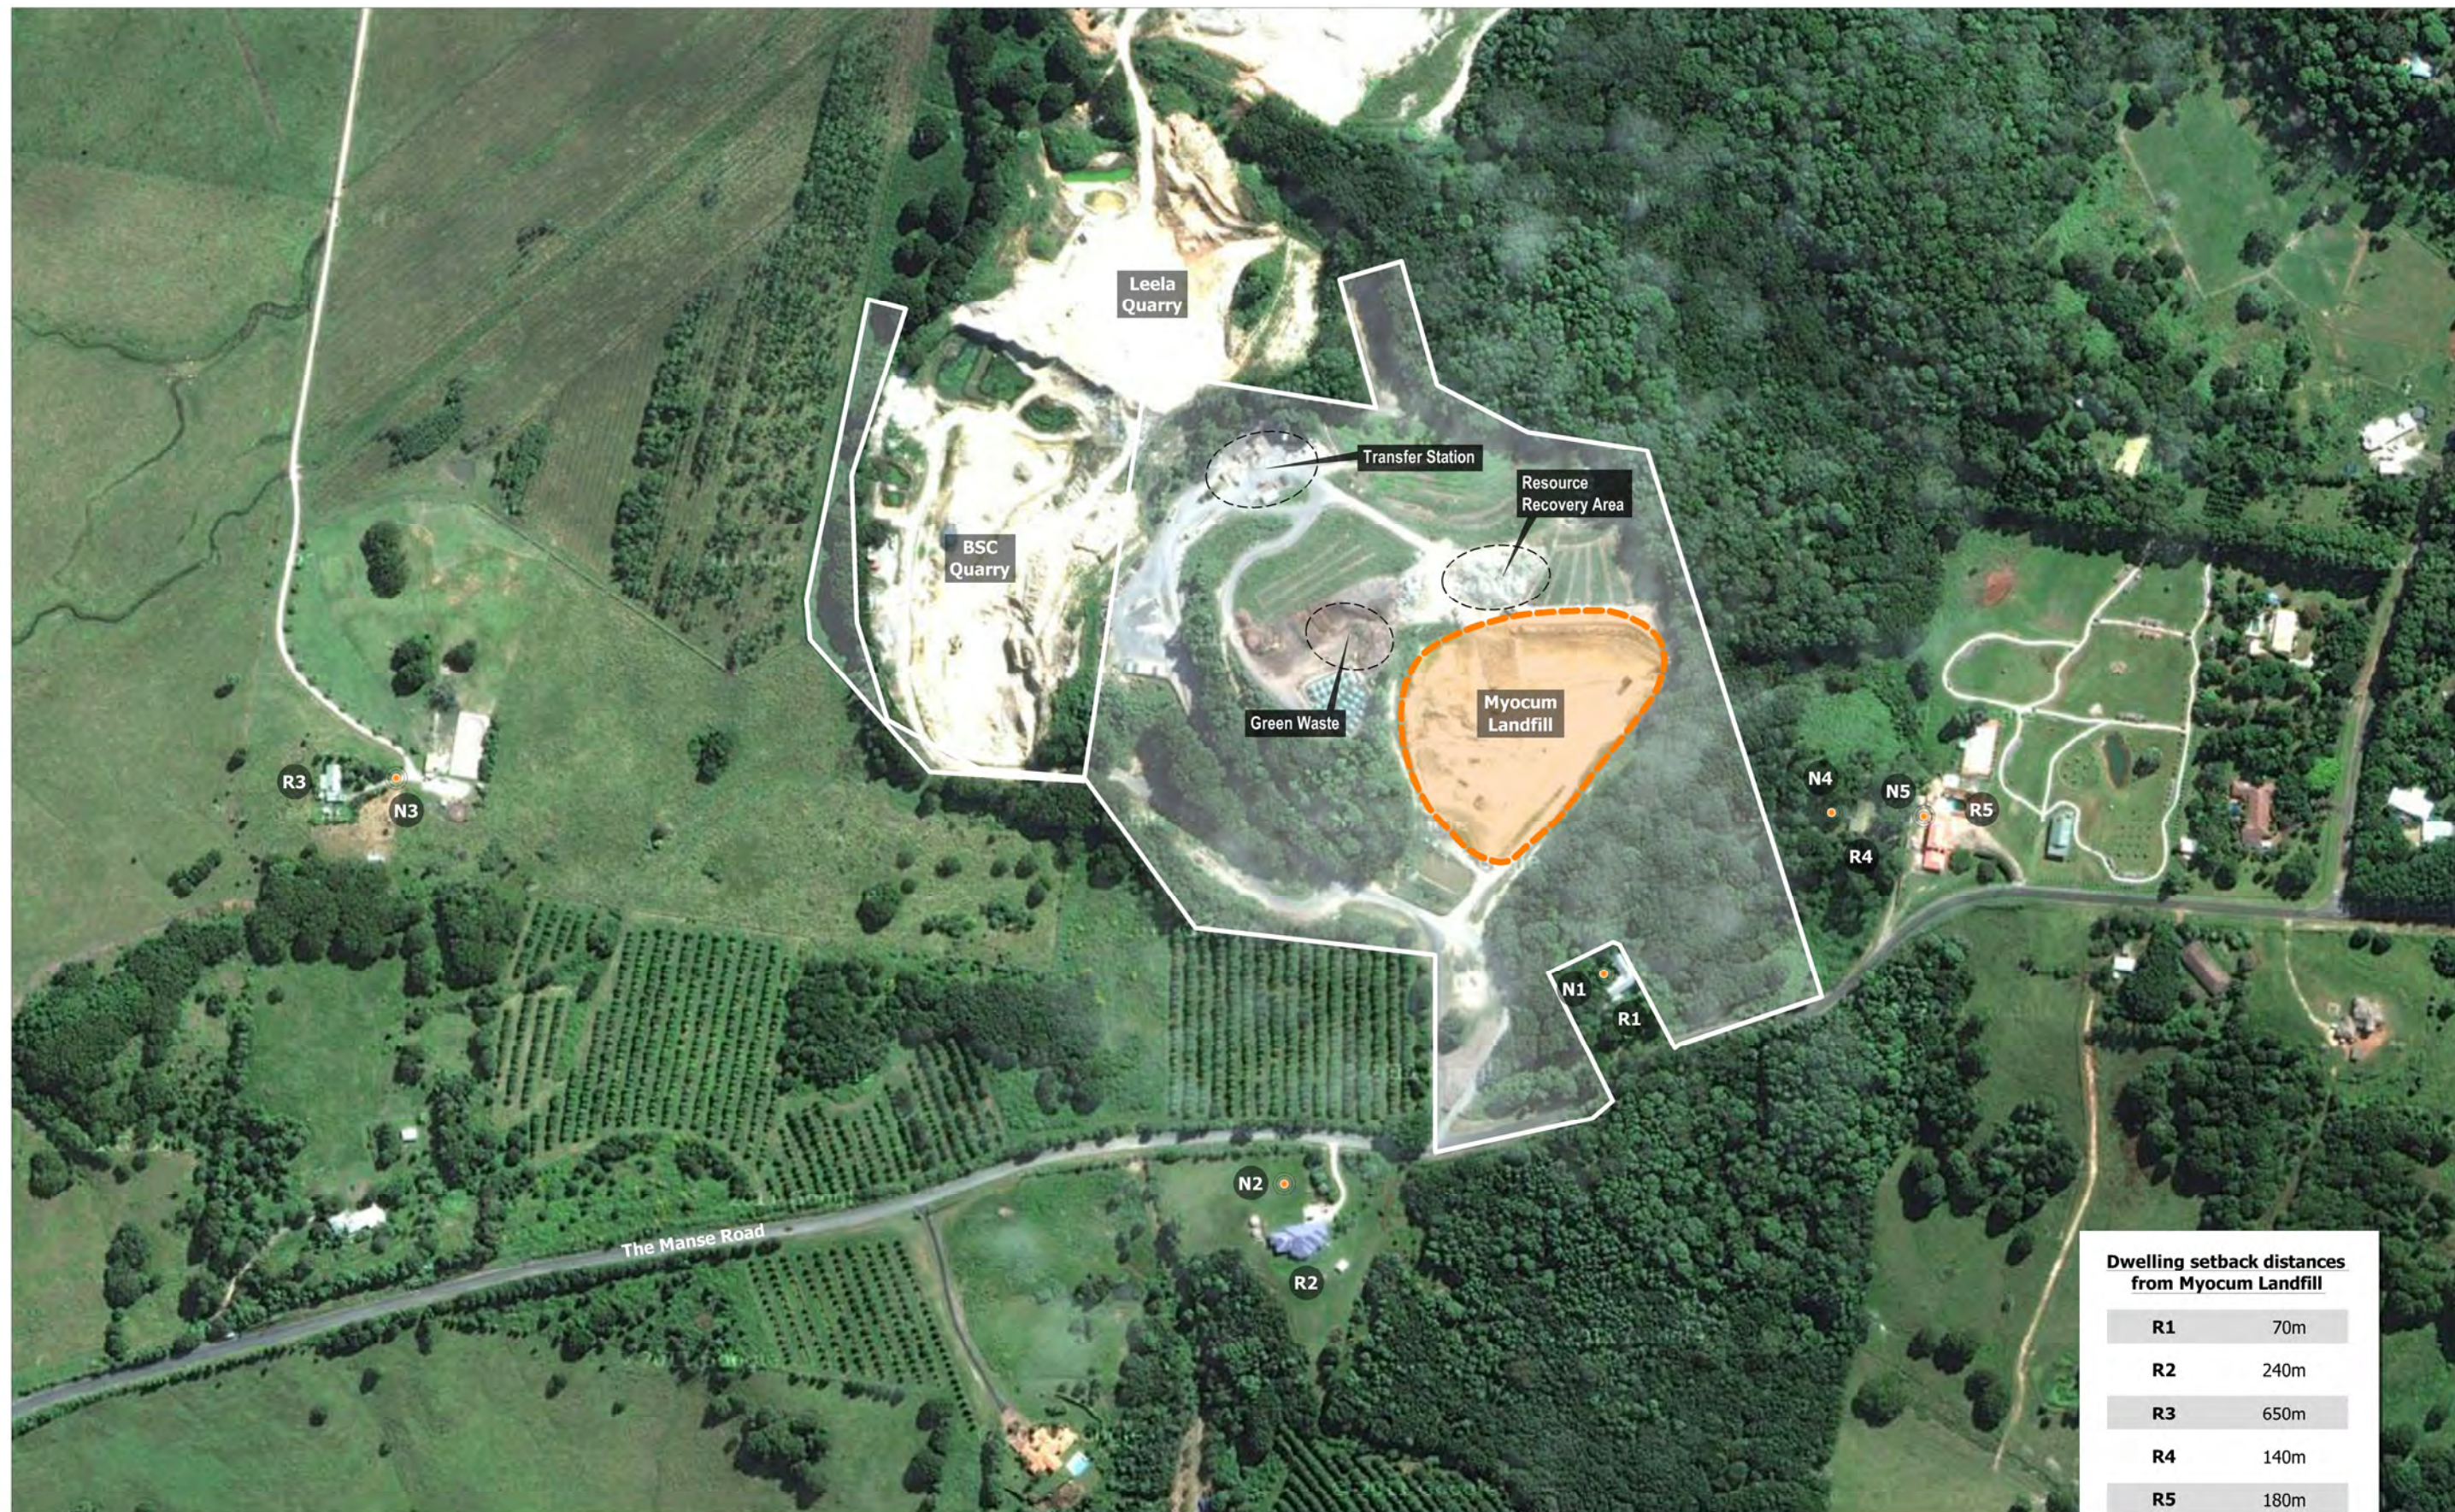
Illustration 2.1:
Noise Monitoring Locations and Dwelling Setbacks

Dwelling setback distances from Myocum Landfill

R1	70m
R2	240m
R3	650m
R4	140m
R5	180m

Note: Distances are approximate only.

A number of residences are within close proximity of the BRCC. Residences R1 to R5 (inclusive) are identified in **Illustration 2.1**. Residences R1, R3 and R4 are owned by BSC, while the other residences are privately owned. Residences R1 and R5 are two storey dwelling houses while the other dwellings are single storey.

Condition No. L6.2 states that noise compliance is to occur within 30m of each nominated residence. Noise Monitoring locations are depicted in **Illustration 2.1**.

Illustration 2.1 shows the location of the noise monitoring locations and set back distances from residences R1 to R5 inclusive to the BRCC.

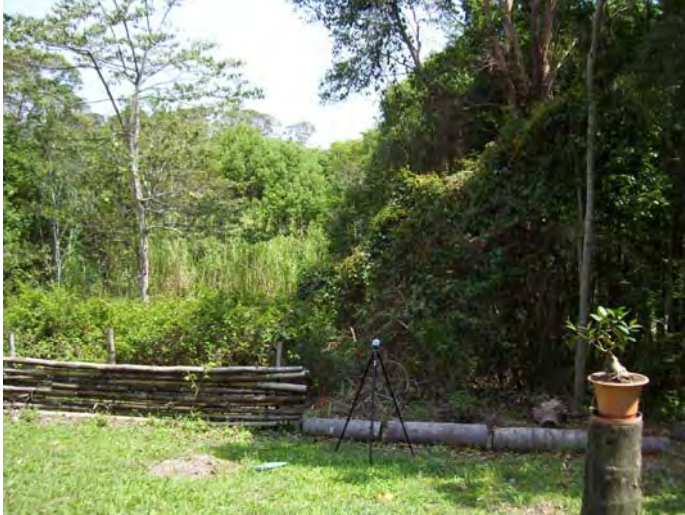
Photo C Noise Monitoring Location (N1)

At location N1, the measured LAeq was 52 dB (A). The dominant noise was the excavator operation in the Resource Recovery Area and the sound of vehicles entering and leaving the BRRC. Secondary noises included crow calls.

The measured LAeq of 52 dB (A) is 9 dB (A) above the noise limit of 43 dB (A). The estimated contribution from Resource Recovery Operations was 48 dB (A). The residence, R1 is owned by BSC, the operator of the Byron Resource Recovery Centre.

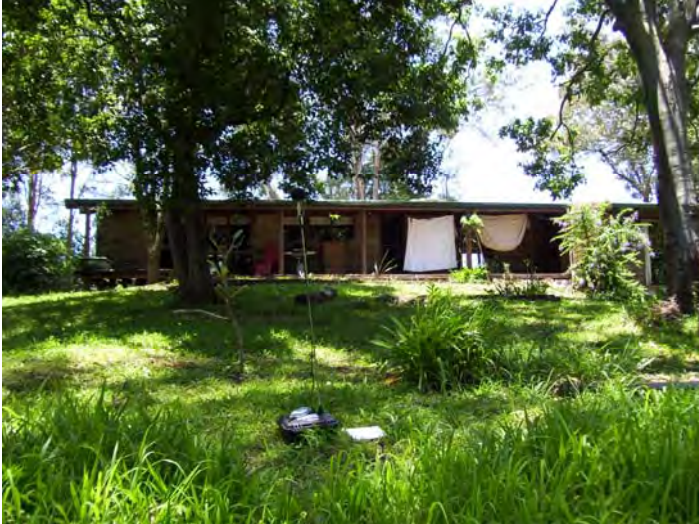
Photo F Noise Monitoring Location (N4)

At location N4, the measured LAeq was 59dB (A) with the dominant noise being the excavator operation and crow calls. Noise estimated from Resource Recovery operations account for 47 dB (A). This is 4 dB (A) above the noise limit of 43dB (A). The residence, R4 is owned by BSC, the operator of Byron Resource Recovery Centre.
