Compliance Noise Monitoring

Byron Resource Recovery Centre
The Manse Road
Myocum

Prepared for: Byron Shire Council
Project: 06/2016
Version: Draft 1.0
Date: 6 September 2016
Tim Fitzroy & Associates
ABN: 94120188829
ACN: 120188829

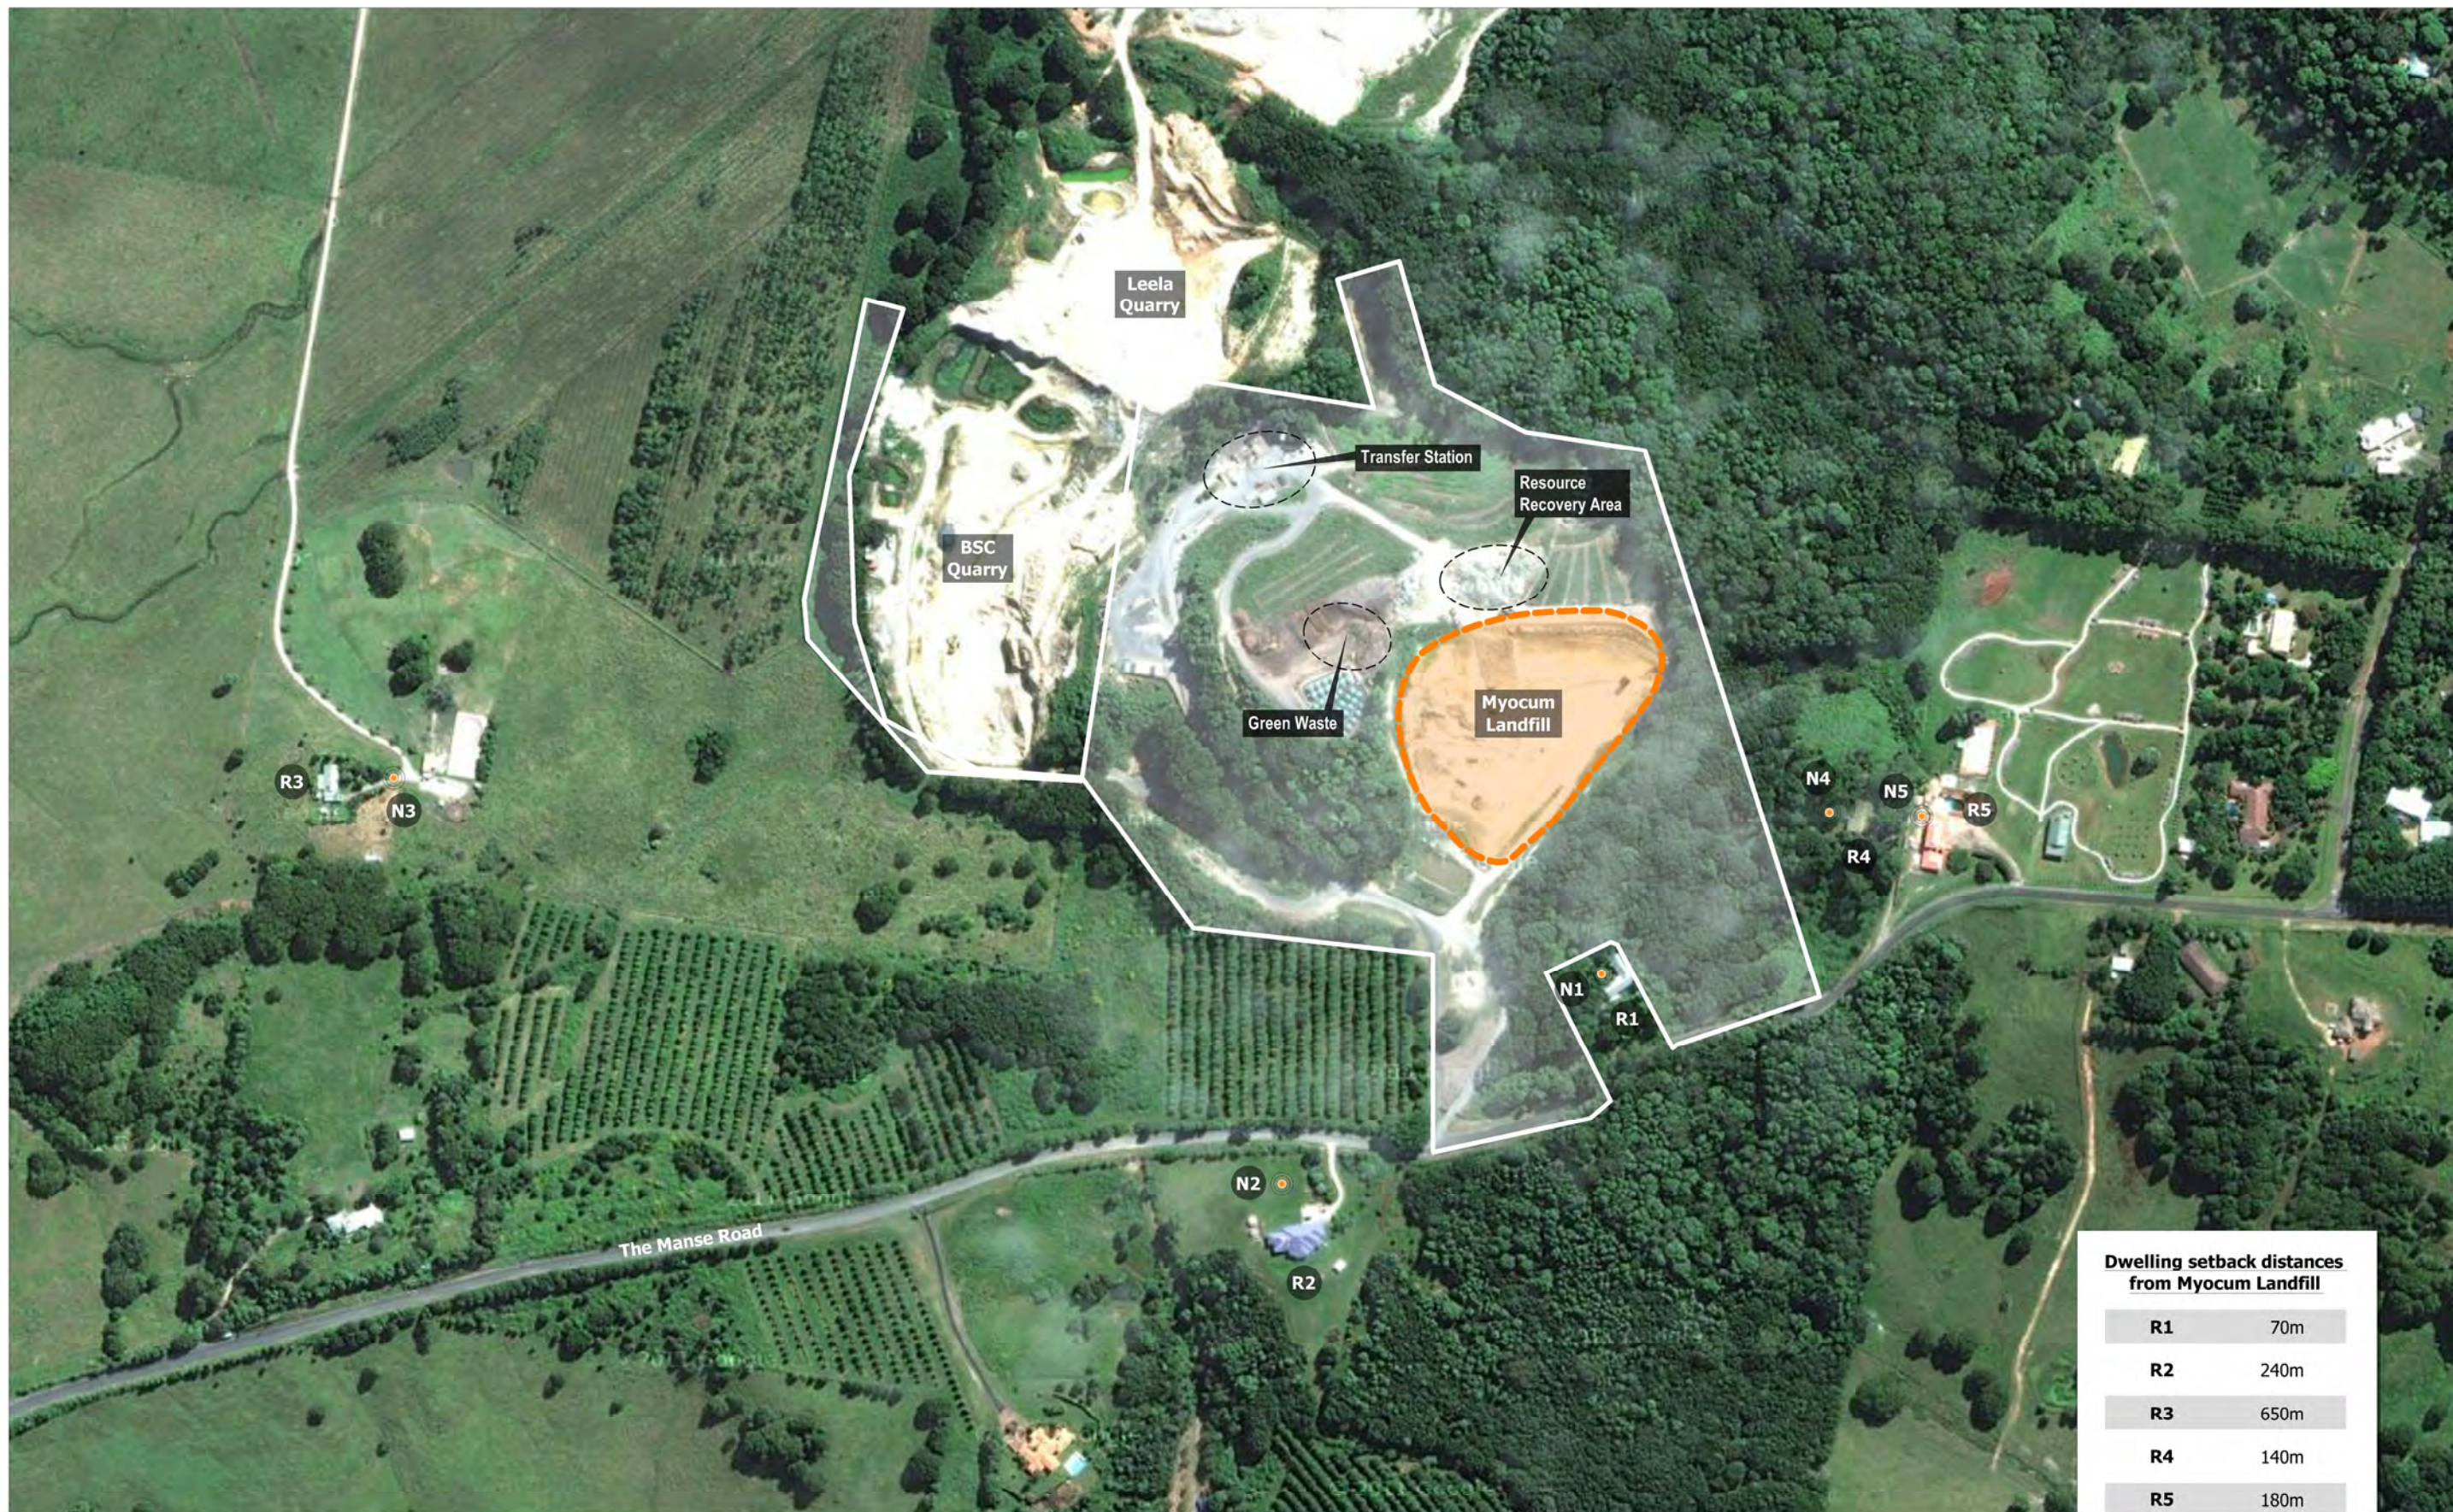
Illustration 2.1:
Noise Monitoring Locations and Dwelling Setbacks

Dwelling setback distances from Myocum Landfill

R1	70m
R2	240m
R3	650m
R4	140m
R5	180m

Note: Distances are approximate only.

A number of residences are within close proximity of the BRCC. Residences R1 to R5 (inclusive) are identified in **Illustration 2.1**. Residences R1, R3 and R4 are owned by BSC, while the other residences are privately owned. Residences R1 and R5 are two storey dwelling houses while the other dwellings are single storey.

Condition No. L6.2 states that noise compliance is to occur within 30m of each nominated residence. Noise Monitoring locations are depicted in **Illustration 2.1**.

Illustration 2.1 shows the location of the noise monitoring locations and set back distances from residences R1 to R5 inclusive to the BRCC.

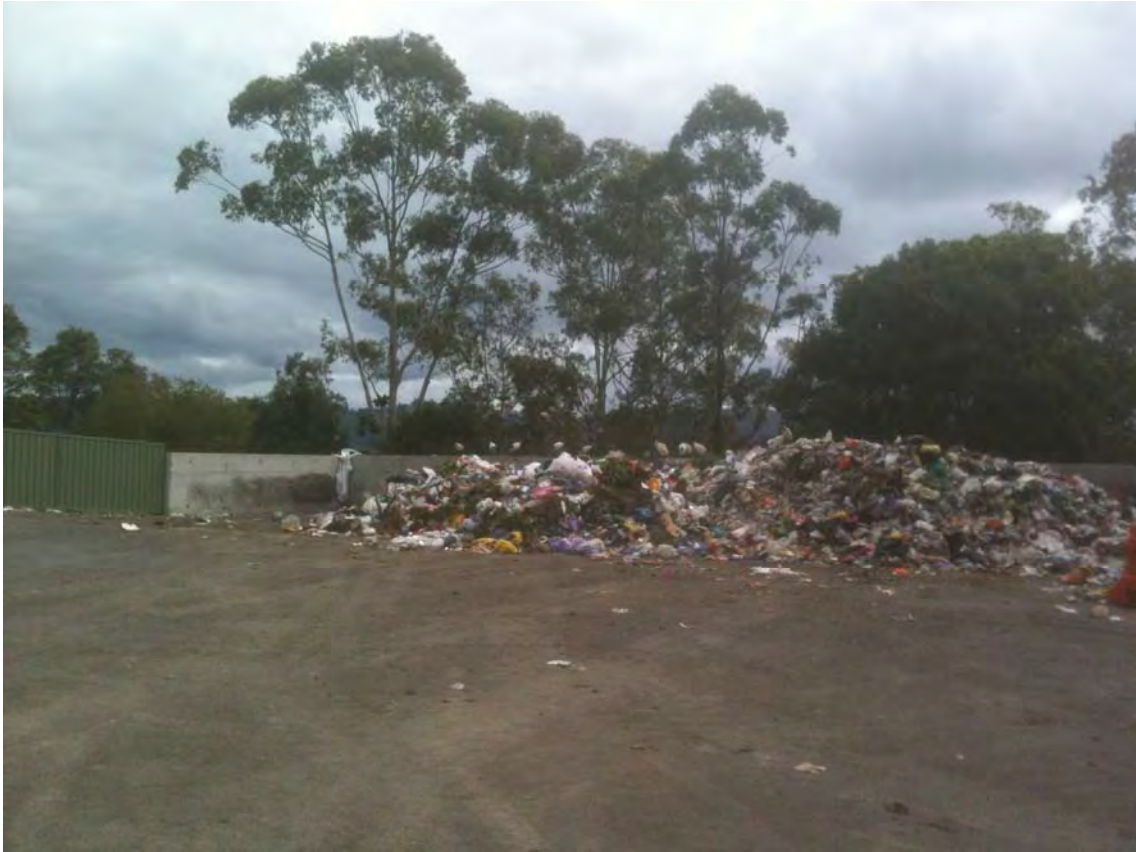
Photo A **Transfer Station**

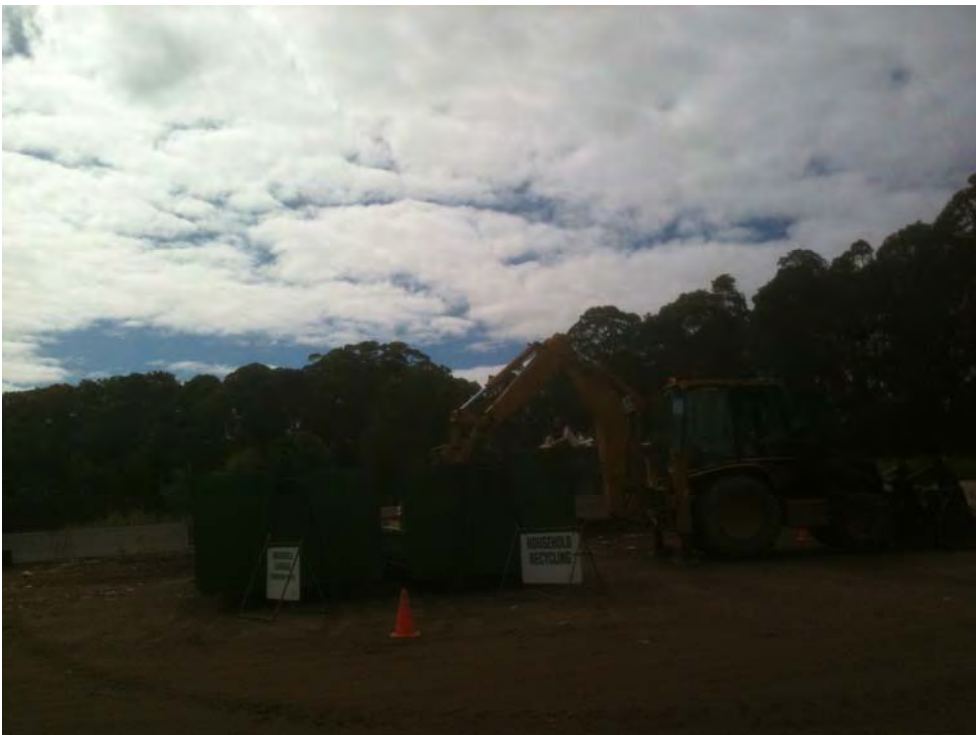
Photo B **Resource Recovery Area**

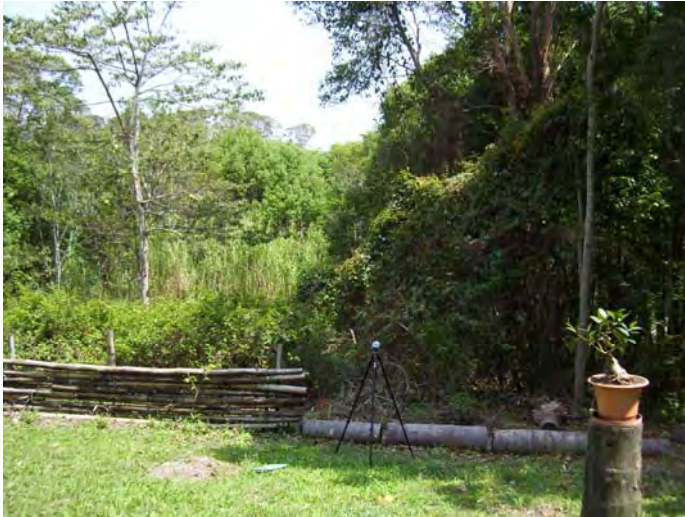
At location N1, the measured LAeq fro 1 hour was 46.5 dB (A). The dominate noise was the loader and excavator operation in the Resource Recovery Area. Secondary noises included the loader and crow calls.

The measured LAeq of 46.5 dB (A) is 3.5 dB (A) above the noise limit of 43 dB (A). The estimated contribution from Resource Recovery Operations was 45 dB (A). The residence, R1 is owned by BSC, the operator of the Byron Resource Recovery Centre.

Photo C **Noise Monitoring Location (N1)**

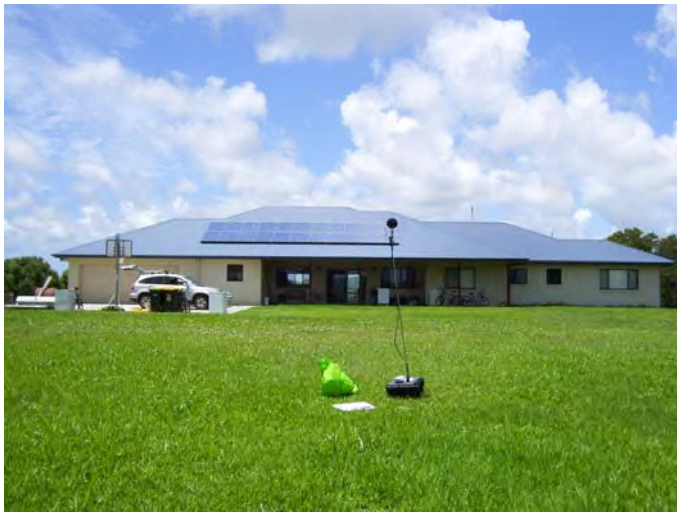
At location N2, the measured LAeq was 54.1 dB (A). N2 was affected by crushing operations at the Leela Quarry and traffic noise primarily associated with the Byron Resource Recovery Centre and bird calls. Noise contribution from the Byron Resource Recovery operation was estimated to be 40 dB (A). This is 3 dB (A) below the noise limit of 43 dB (A).

Photo D **Noise Monitoring Location (N2)**

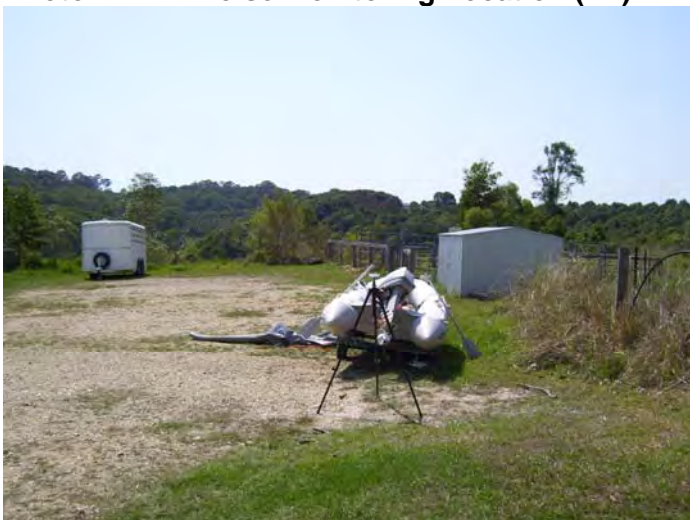
At location N3, the measured LAeq was 48.6dB (A). During the monitoring period the loader operation in transfer station was not audible. The primary noise source was from excavator and crusher operations at the adjoining Leela Quarry. The estimated contribution from Resource Recovery Operations was less than 30 dB (A). This is 9dB (A) below the noise limit of 39dB (A). The residence, R3 is owned by BSC, the operator of the Byron Resource Recovery Centre. Measurement was suspended after a minimum 15 minute period due to the inaudibility of BRRC operations at the N3.

Photo E **Noise Monitoring Location (N3)**

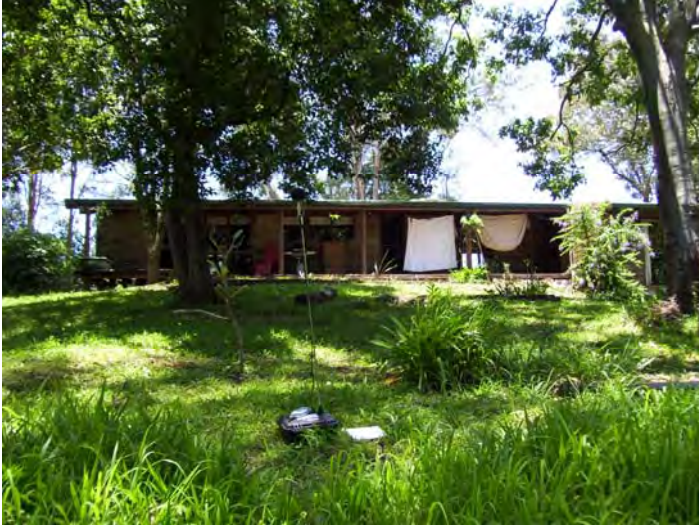
At location N4, the measured LAeq was 52.7dB (A) with the dominant noise being the excavator and loader operations BRRC coupled with crow calls and breeze in adjacent trees. Noise estimated from Resource Recovery operations account for 47 dB (A). This is 4 dB (A) above the noise limit of 43dB (A). The residence, R4 is owned by BSC, the operator of Byron Resource Recovery Centre.

Photo F Noise Monitoring Location (N4)

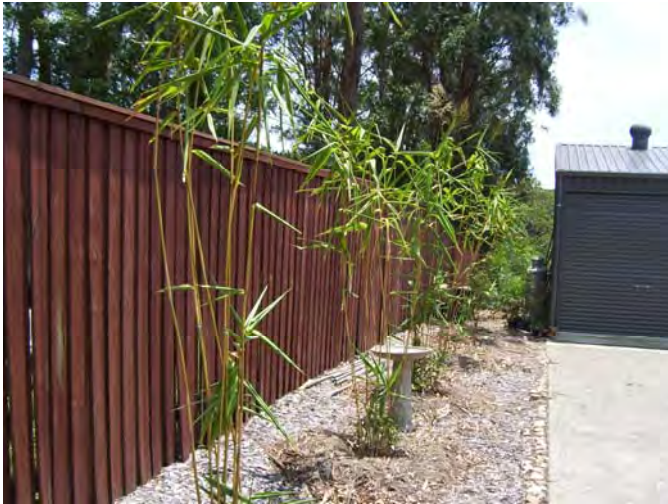
At location N5, the measured LAeq was 52.1 (A). The Resource Recovery Facility operations were not audible, with the exception of the reverse beeper on the excavator operating at the Resource Recovery Area. In the absence of environmental noises and vehicular traffic along the Manse Road the Resource Recovery Facility operations noise level was 39dB (A) and therefore in compliance with the noise limit.

Photo G Noise Monitoring Location (N5)
