Byron Shire Council

Buildings Asset Management Plan

October 2019

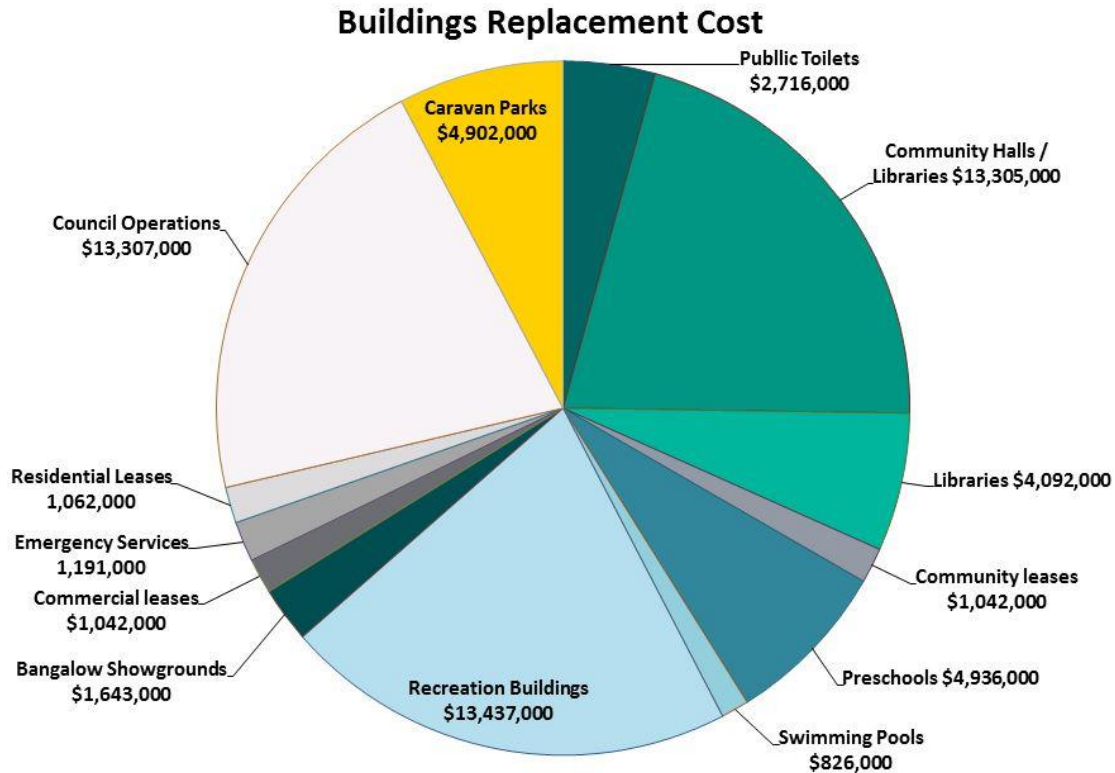
Figure 3 Overall breakdown of depreciated replacement cost for Building Assets

The replacement value of Council's building asset portfolio is **\$74.3 million** with a written down cost of **\$62.7 million**. The annual depreciation is **\$993,863** as at 30 June 2018. The break-up of Council's Building asset portfolio by replacement value is illustrated in the following diagram.

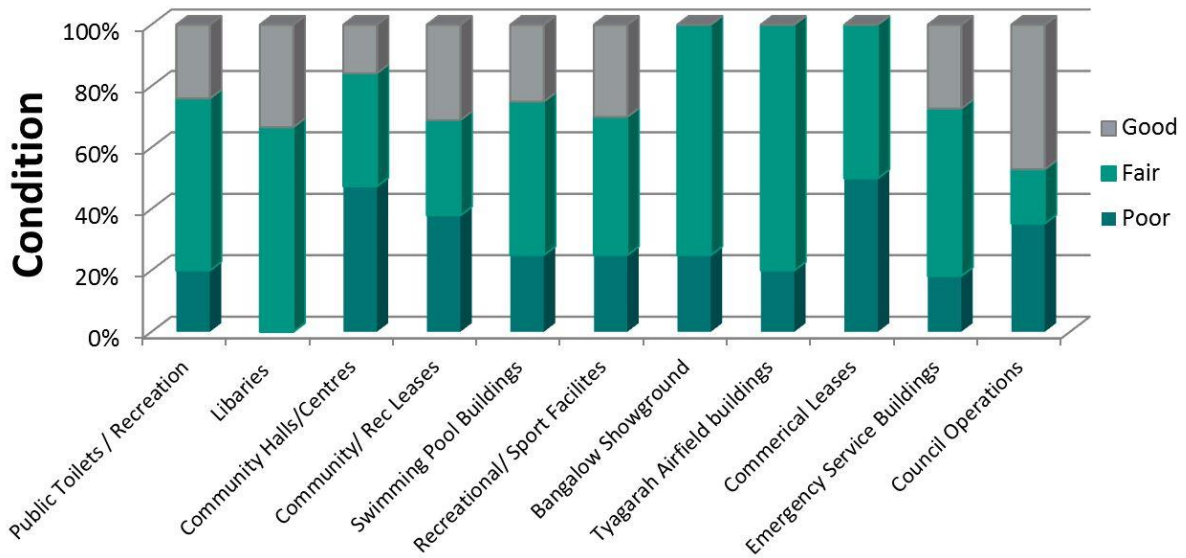
Figure 4 Building Assets by condition

A simplified model derived from Table 3 Condition Grading Model is set out in Figure 4 below. Condition Excellent (1) and Good (2) have been combined into GOOD, and Poor (4) and Very Poor (5) into POOR.

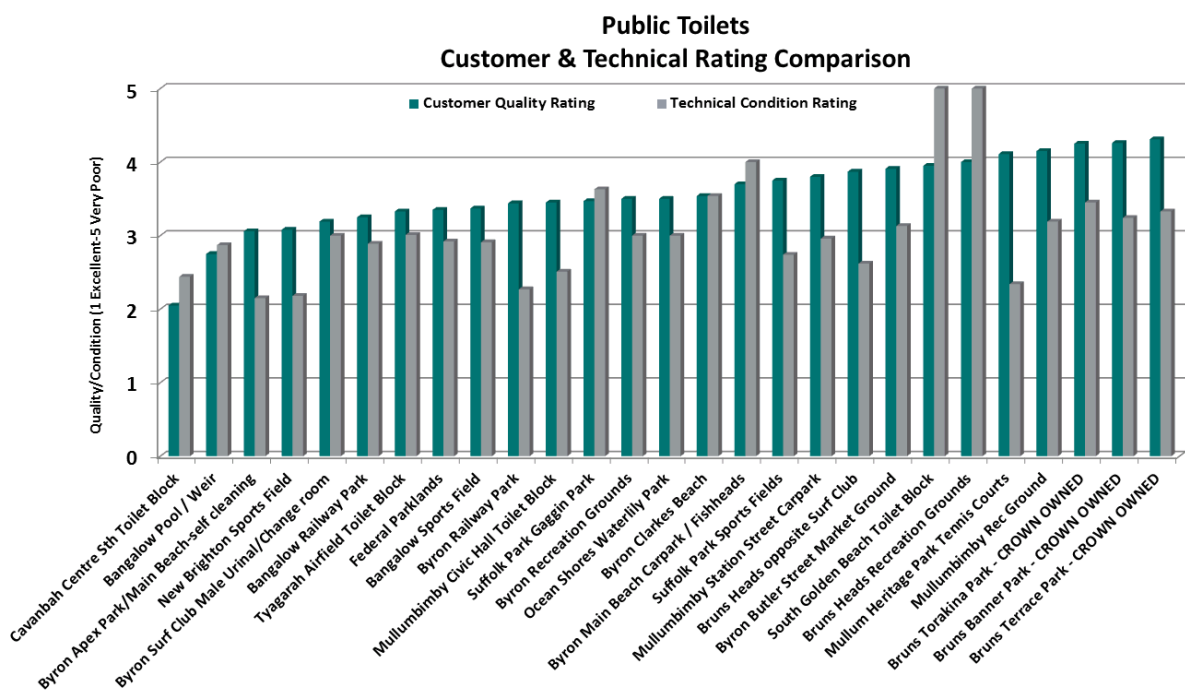
Figure 6 Customer & Technical Rating Comparison

The public toilet average ratings were compared. The average customer quality was rated at **3.6** and technical condition at **3.0**, refer to Figure 6 **Error! Reference source not found..** This indicates that the community expects a higher level of service than Council provides. This is also relevant in terms of the survey feedback in which respondents listed many requirements including: no graffiti, baby change tables, paper towels, hand dryers, soap, single sex toilets as opposed to multi-use cubicles, and no stainless steel toilets without seats that are unpleasant in winter. The responses indicate the community prioritises renewed modern and clean toilets above more toilets.

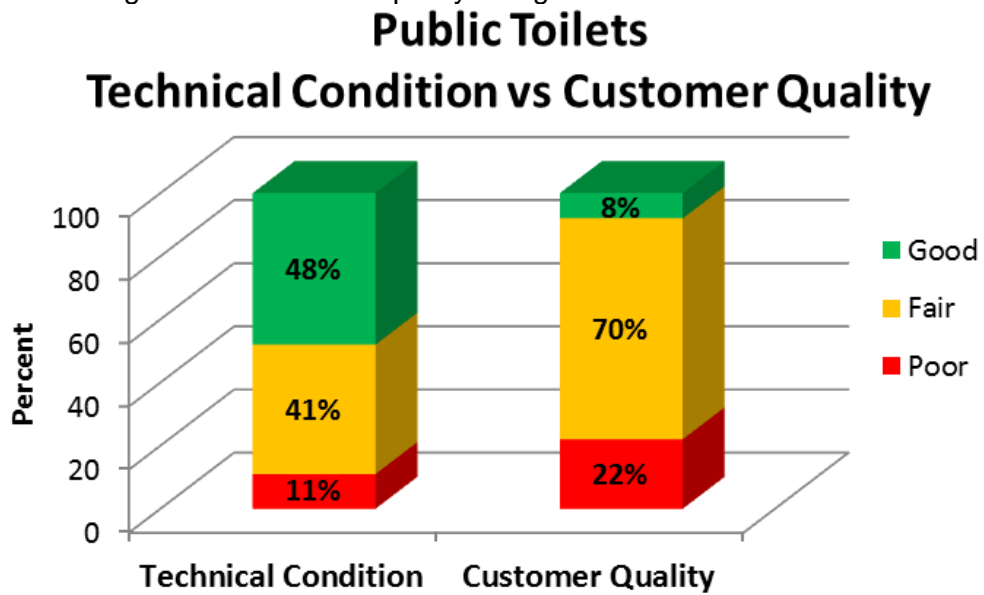
Figure 7 Public Toilet Technical Condition vs Customer Quality

The overall public toilet category has been ranked by condition and customer quality into Good, Fair and Poor (Figure 7). Whilst results are similar, Figure 7 shows a mismatch between the Technical Levels of Service rating and the customer quality rating.

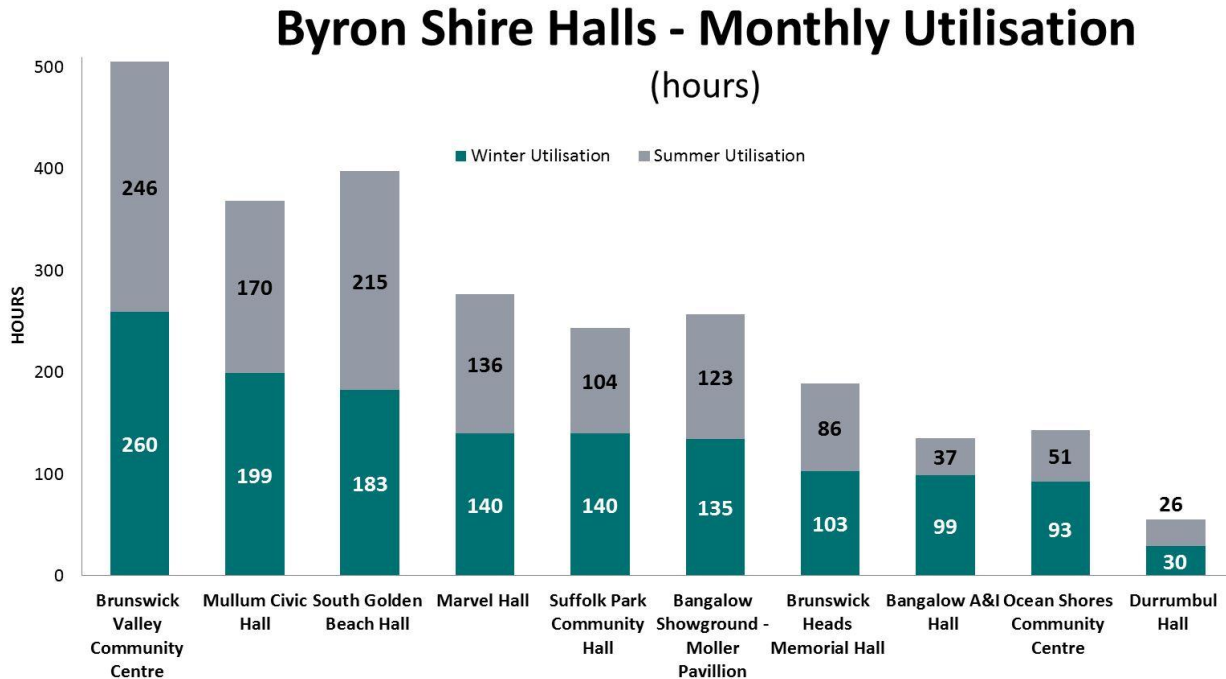
Figure 9 Community Hall Monthly Utilisation
(E2019/28051)

Use of the community halls and centres has been analysed over both summer and winter months using sample data from the online calendar booking system. Figure 9 below clearly indicates that the Brunswick Valley Community centre is being fully utilised with an average of 253 hours per month with the Durrumbul Hall at the lowest with just 56 hours per month. When it comes to measuring Customer Levels of Service, use of facilities is one of the key criteria. This is a point in time snapshot and can be remeasured to assist with Future Demand planning.

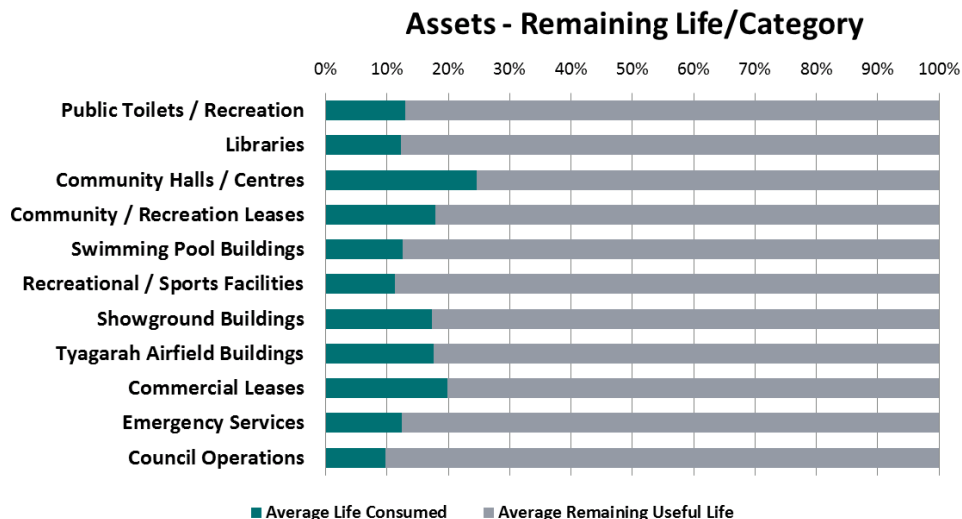
Figure 13 Useful life consumption from financial register

Figure 13 represents the remaining life by asset category in the financial asset register. The building assets have an average life of 12 years. On a network basis Council’s assets have 85% of their useful life remaining. However in comparing useful life data with overall condition and Predictor © useful life data, it is apparent that the data is not similar (Refer to Figure 20 in the Financial Summary). The useful life used in modelling goes to a sub-component level and provides greater detail. It indicates that the assets appear to be deteriorating at a greater rate.

The conclusion is that the remaining life data from the 2016 building valuations is not consistent with the recent condition inspections and identifies an area for improvement in future financial asset revaluations (Refer to Improvement Plan). This data is to be used for financial management and not to be taken out of context from this document.

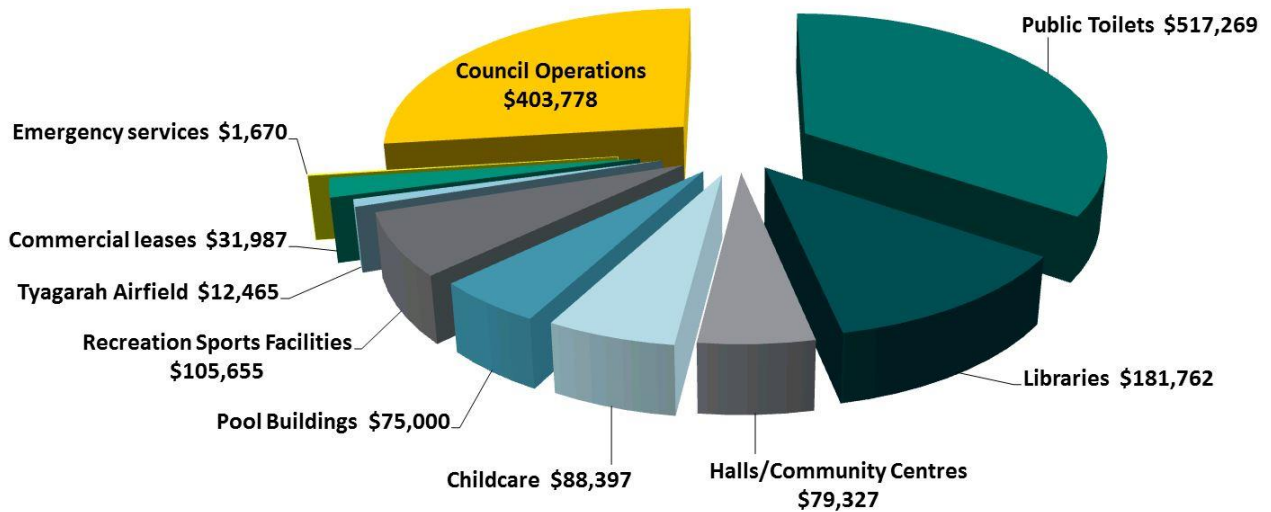
Figure 15 Buildings Operations & Maintenance Actuals 2017/18

Figure 15 details the actual expenditures of building operations and maintenance. Notably public toilets account for nearly half the expenditure due to the high operational cleaning costs as perviously detailed in Table 11.

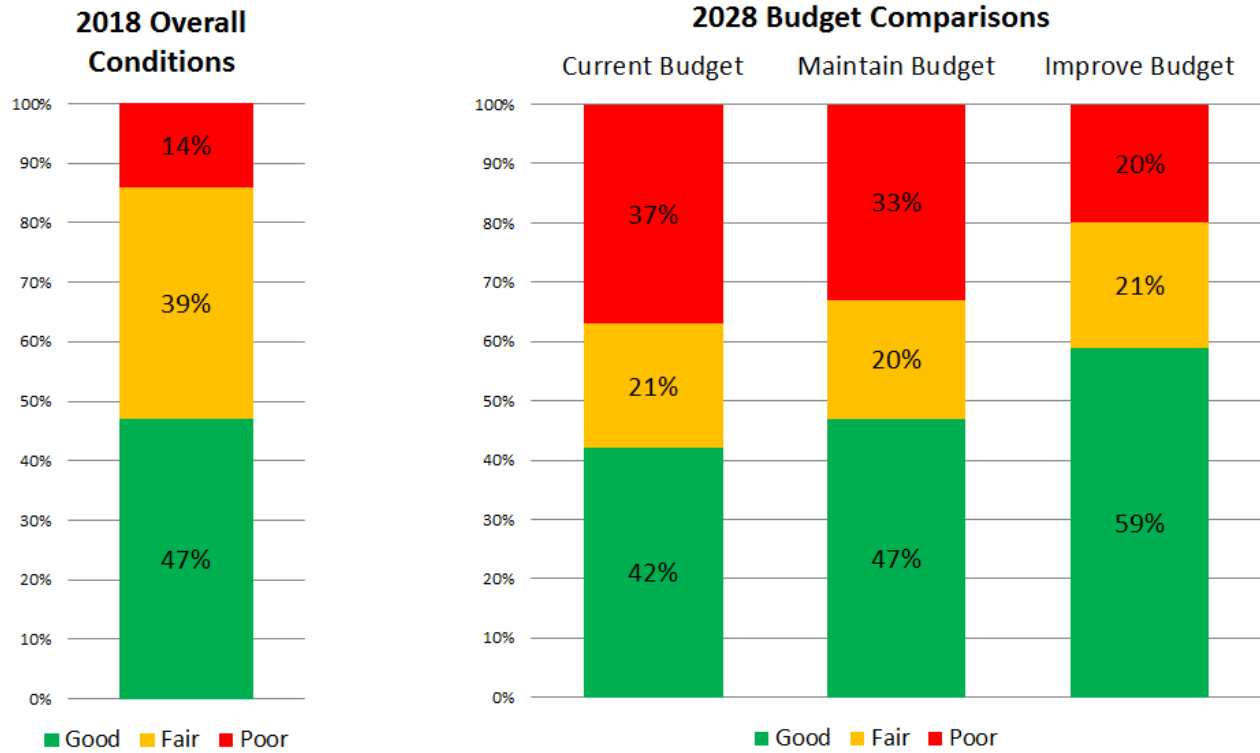
Below are the 10 year budget comparisons of the overall condition using the modelling scenarios above. By investing (the 'improve' budget), 17 % of the Poor assets move into the Good condition over 10 years and the whole asset portfolio looks much more healthy. The 'improve' budget scenario also saves \$5,260,000 in maintenance costs over 10 years. Figure 17 Modelling Scenario 10 Year Condition Comparisons depicts the condition changes with budget scenarios. The output of the Current Budget scenario has produced 10 year capital works.

Using the “hold / maintain” Scenario 2 less money is spent in total.

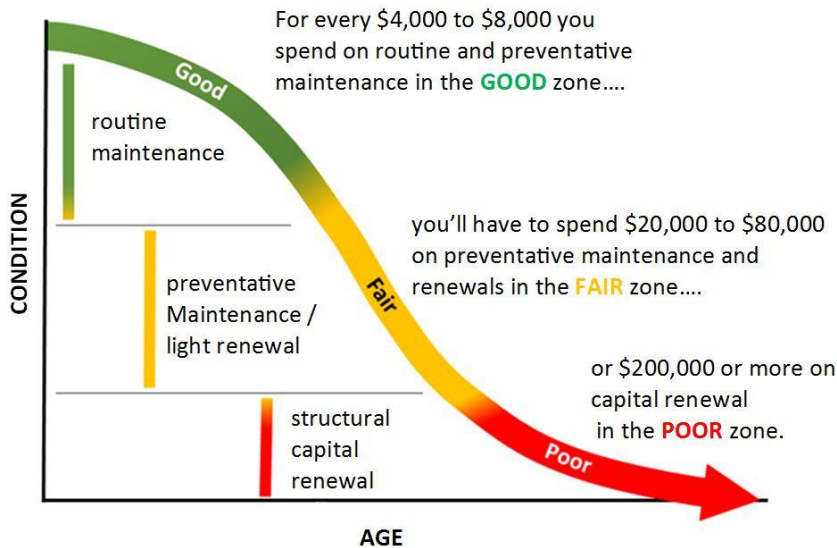
Figure 18 Building Deterioration and Maintenance Curve

Deferring renewal works occurs when renewal requirements exceed the available budget. Deferring renewal projects impacts on the level of service an asset is able to provide. In the short term the impact may be acceptable, however continued deferral can lead to an increase in backlog and therefore risk (Figure 18).

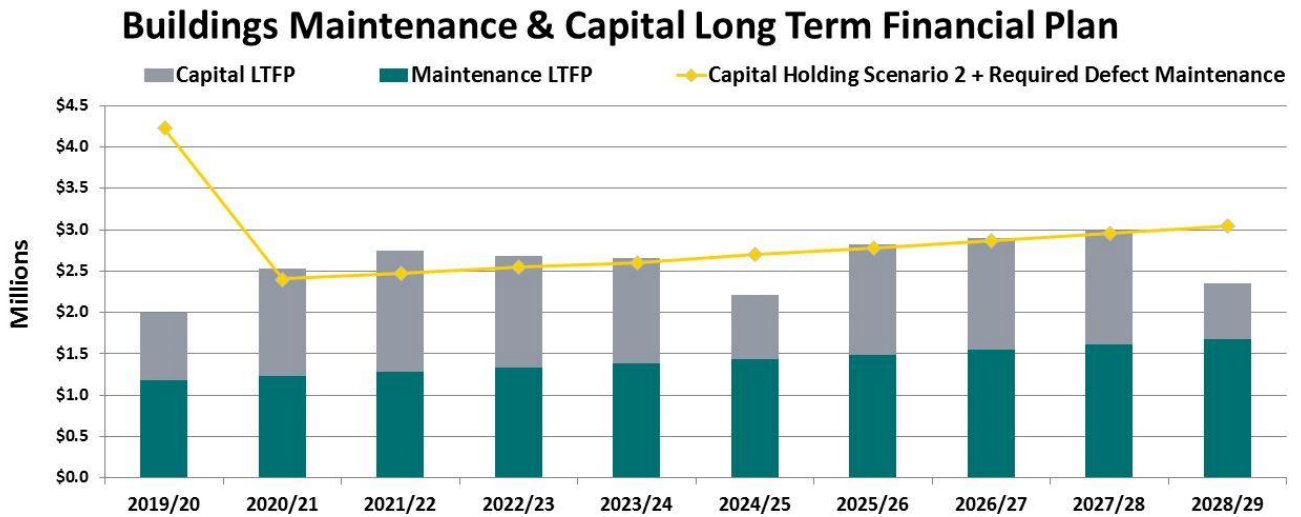
Figure 19 Maintenance & Capital Long Term Financial Plan (LTFP)

This graph compares Scenario 1 the budgeted LTFP with Scenario 2 the Holding budget.

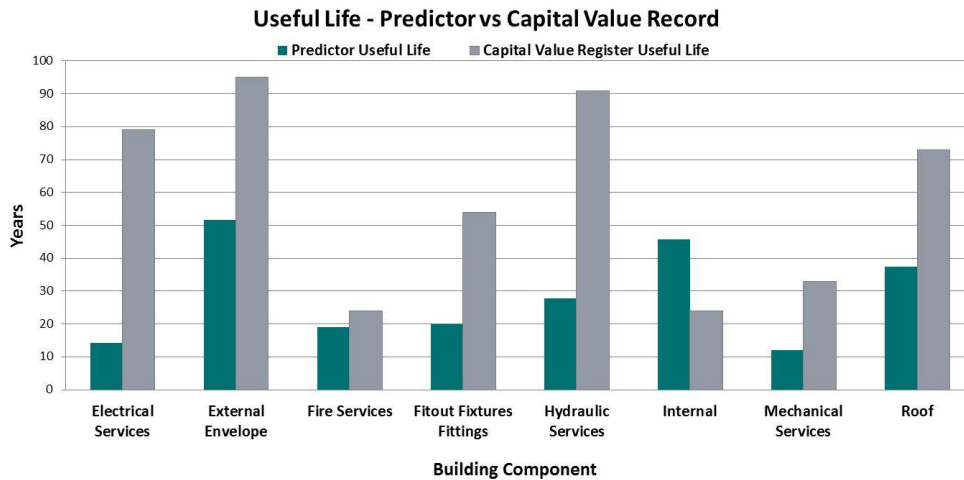
Figure 20 Useful Lives vs Capital Value Record

The next section will discuss the financial performance ratios. It is worth noting that the useful lives figure derived from the Capital Value Register (CVR) and the useful lives figure derived from modelling vary greatly (Figure 20). The average useful life in modelling is **28 years** compared with **59 years** in CVR.

Average Useful life is lower than industry standard due to deferred renewals and reduced preventative maintenance.
