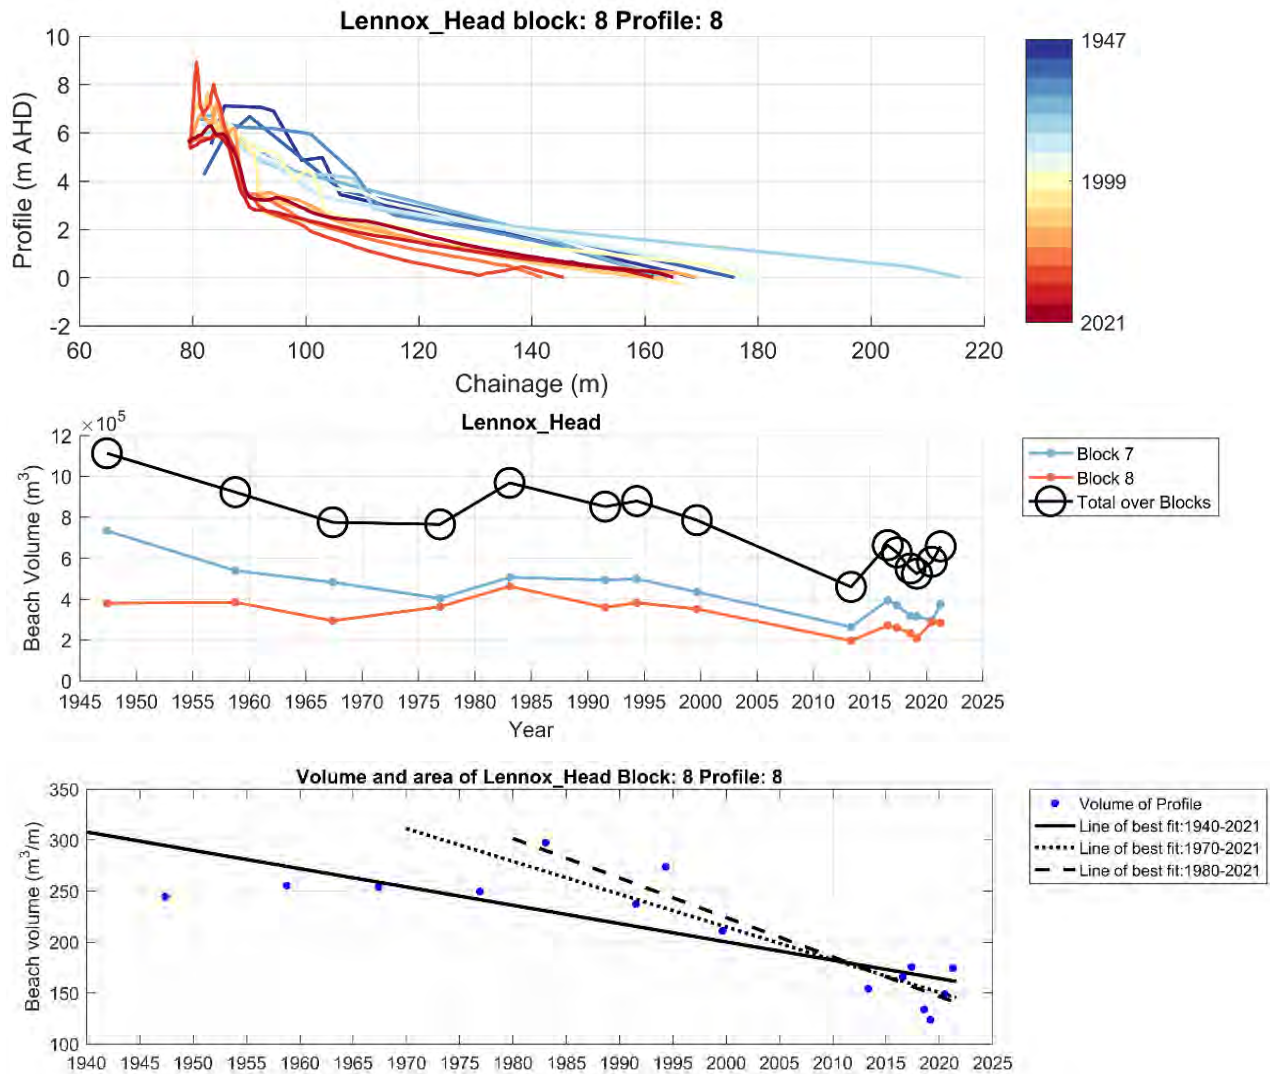
Figure 117: Timeseries of (top) beach profiles, (centre) calculated subaerial beach volume and (bottom) regression analysis.

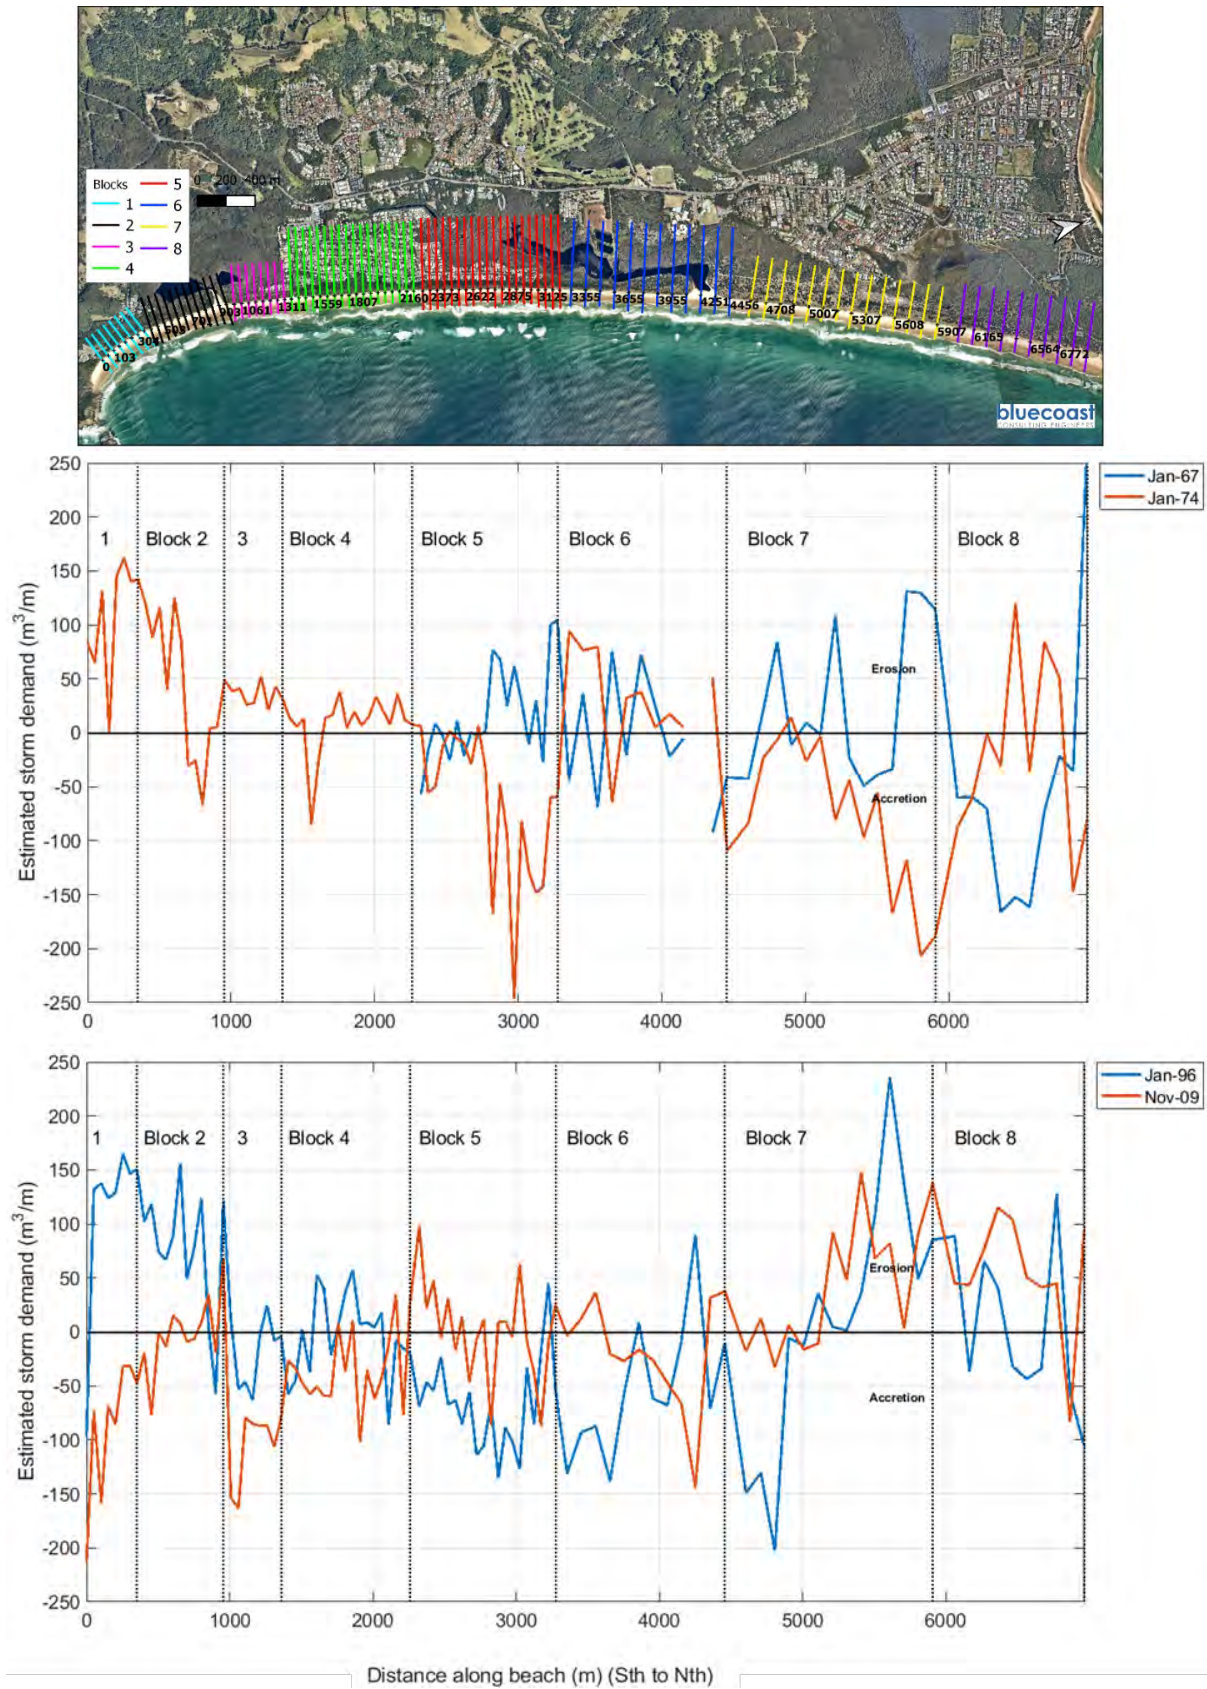
Figure 121: Tallow Beach - alongshore storm demand estimates derived from NSW Beach Profile Database for storms in 1967, 1974, 1996 and 2009.

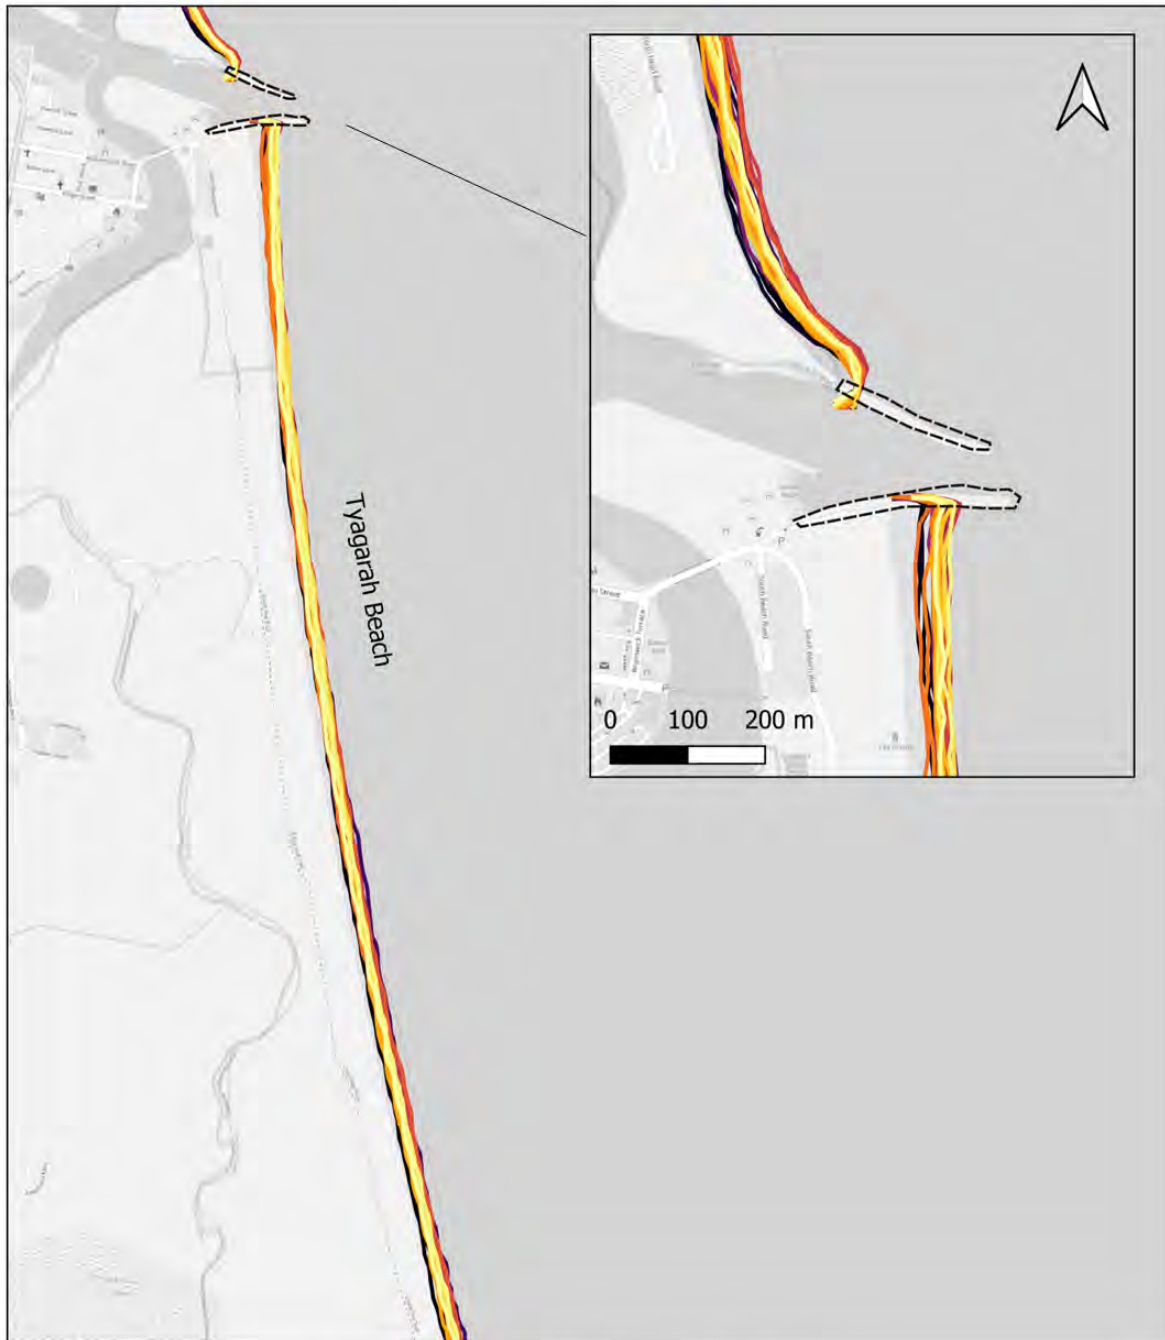
Figure 124: Mean annual shorelines between Tyagarah Beach to Brunswick Heads from 1988 to 2020.

Digital Earth Australia's (DEA) mean annual shorelines from for the period 1988 to 2020 were analysed. Results showing the historic shoreline behaviour within the Cape Byron to Wooyung beach compartment are presented in Figure 122 to Figure 125.

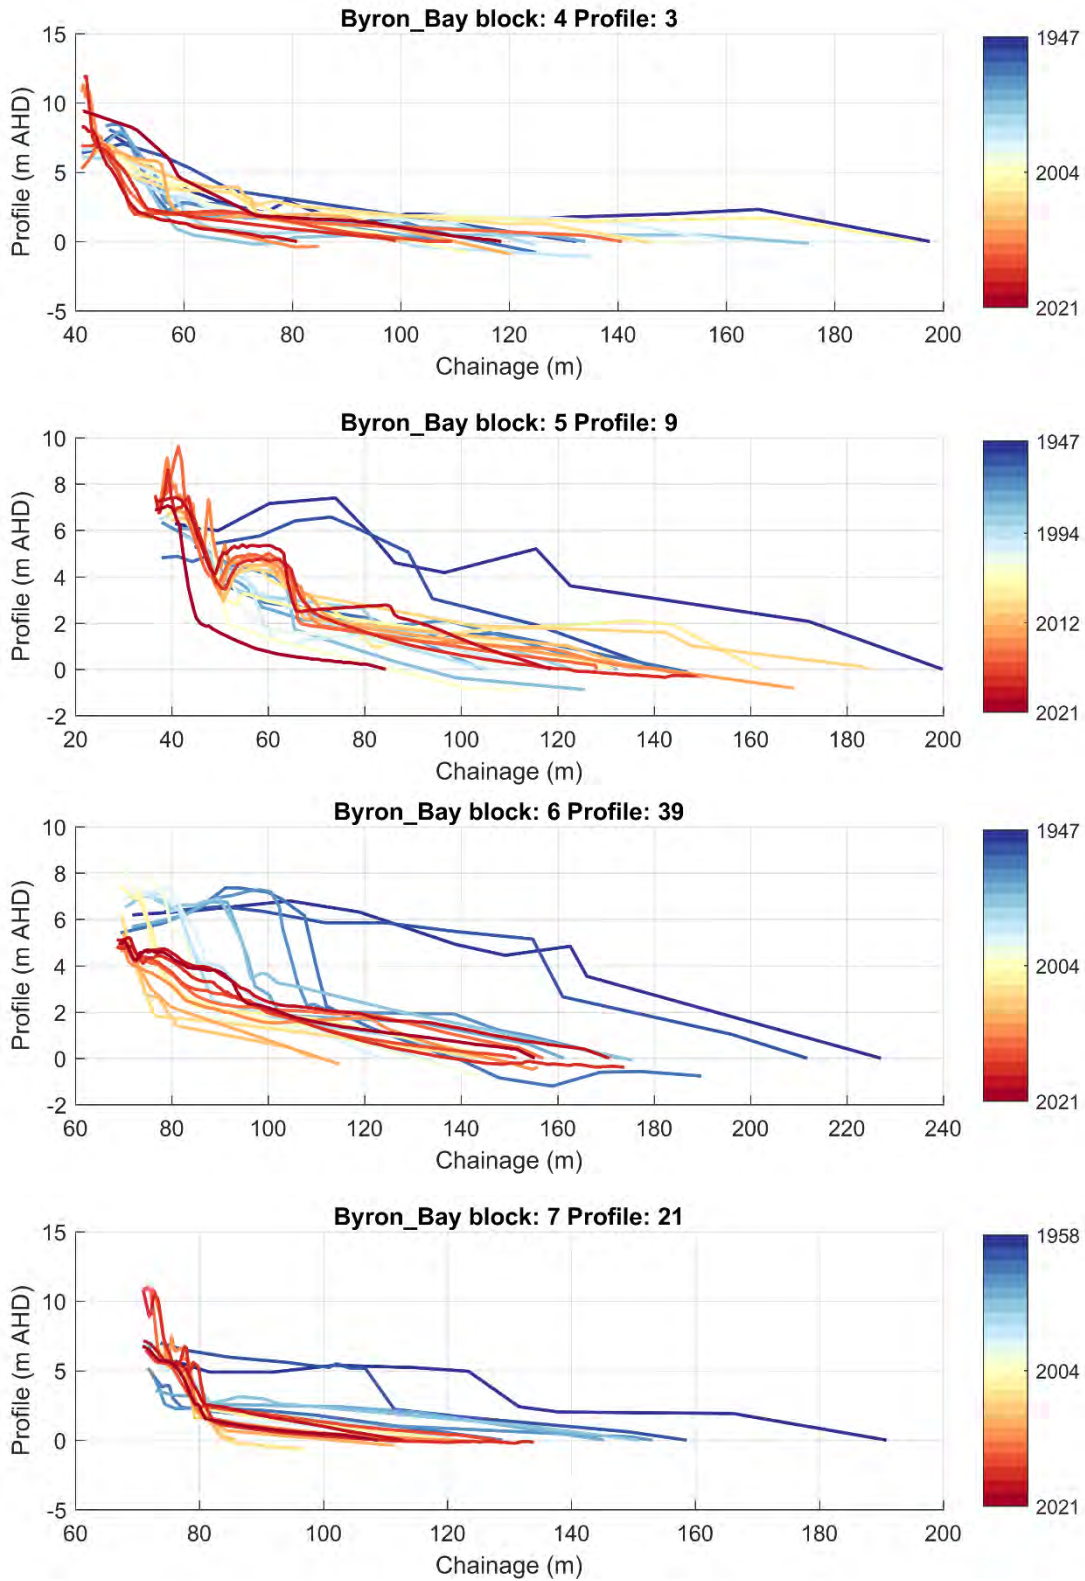
Figure 127: Selected subaerial beach profile plots between Clarkes Beach (Block 4) and Belongil Beach (Block 7).

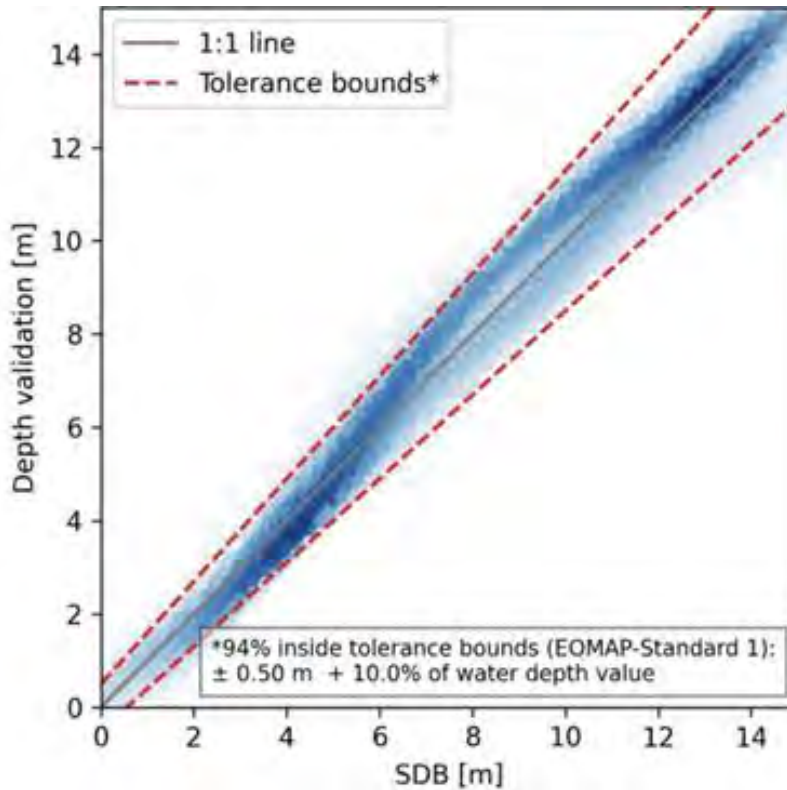
Figure 1: Comparison of 2018 SDB with 2018 Coastal LiDAR survey.

- The 2018 NSW Coastal LiDAR was supplied to EOMAP for calibration and validation purposes. Within the Byron region the coastal LiDAR was captured on four separate dates between 16 July 2018 and 23 August 2018. The coastal LiDAR covers the full coastal profile down to depths of around 20 to 30m (i.e., it includes the subaerial and subaqueous components).
- EOMAP then used the LiDAR survey to produce more accurate depths for the 2018 SDB. EOMAP's comparison showed a good overall agreement of SDB and LiDAR survey data, with 94% of the SDB data being within EOMAP's Standard 1 of $\pm 0.5\text{m} + 10\%$ of survey data depths (refer to Figure 1). The original 2018 SDB dataset covered a 16km² area, which was later reduced to a 12km² area of interest (AOI). EOMAP's data delivery report on the validated 2018 SDB is provided as Attachment 2.

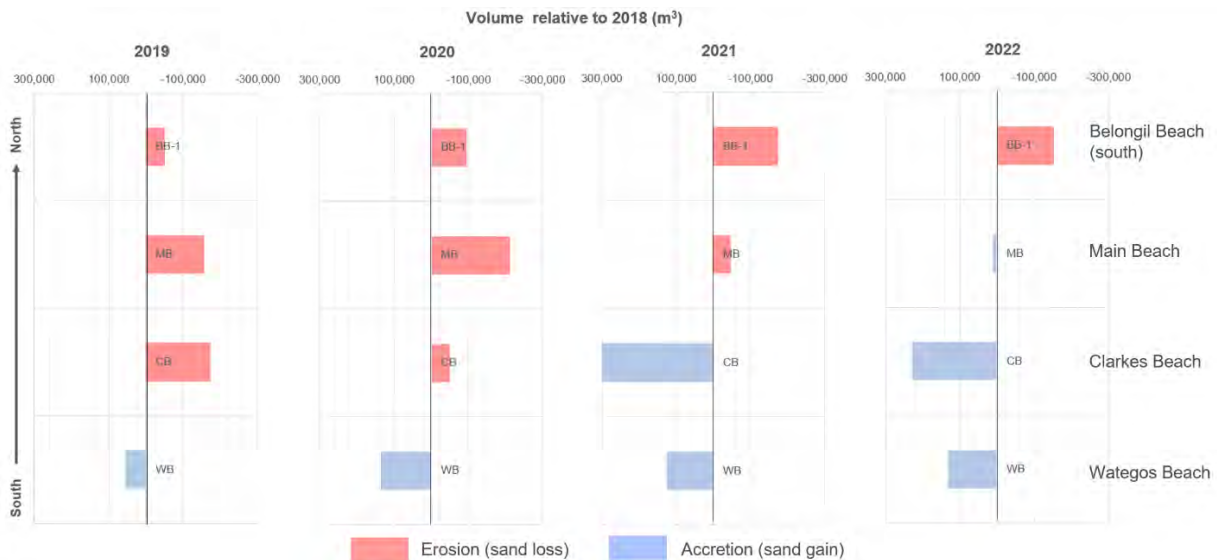
Figure 6: Volume changes between 2019 and 2022 for each alongshore zone from Wategos Beach to Belongil Beach (south).

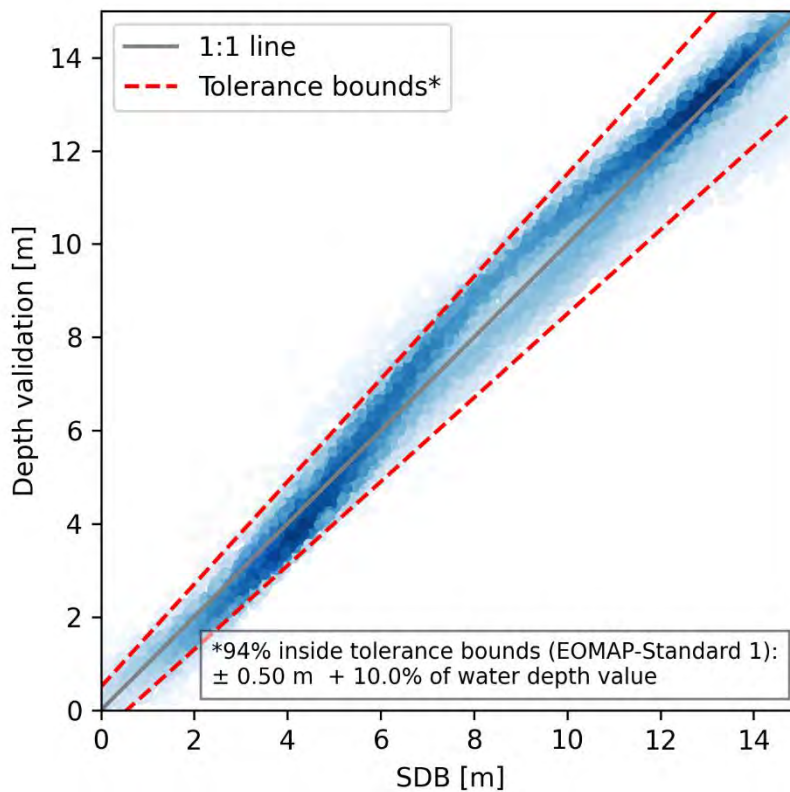
Figure 5: Comparison of SDB vs. client-provided Lidar data

The results of the SDB processing have been compared against on-site Lidar data provided by the client (Figure 5). The comparison shows a good overall agreement of SDB and survey data, with 94% of the SDB data being within EOMAP’s Standard 1 of $\pm 0.5\text{m} + 10\%$ of survey data depths. The survey data helped to increase the accuracy of the SDB data especially in the deeper waters along the shore south of Cape Byron, which is often impacted by strong waves. This can lead to resuspension of sediments and slightly increased turbidity even under the best conditions. Water depths shallower than 5m are less impacted, as the light reflection from the seafloor is higher and SDB retrieval therefore less prone to residual turbidity. It is expected that the survey data will also help to stabilise results in deeper waters for potentially upcoming further timestamps, as the seabed dynamics are highest in the shallow water above 5m (moving sand banks) and more stable in deeper waters.

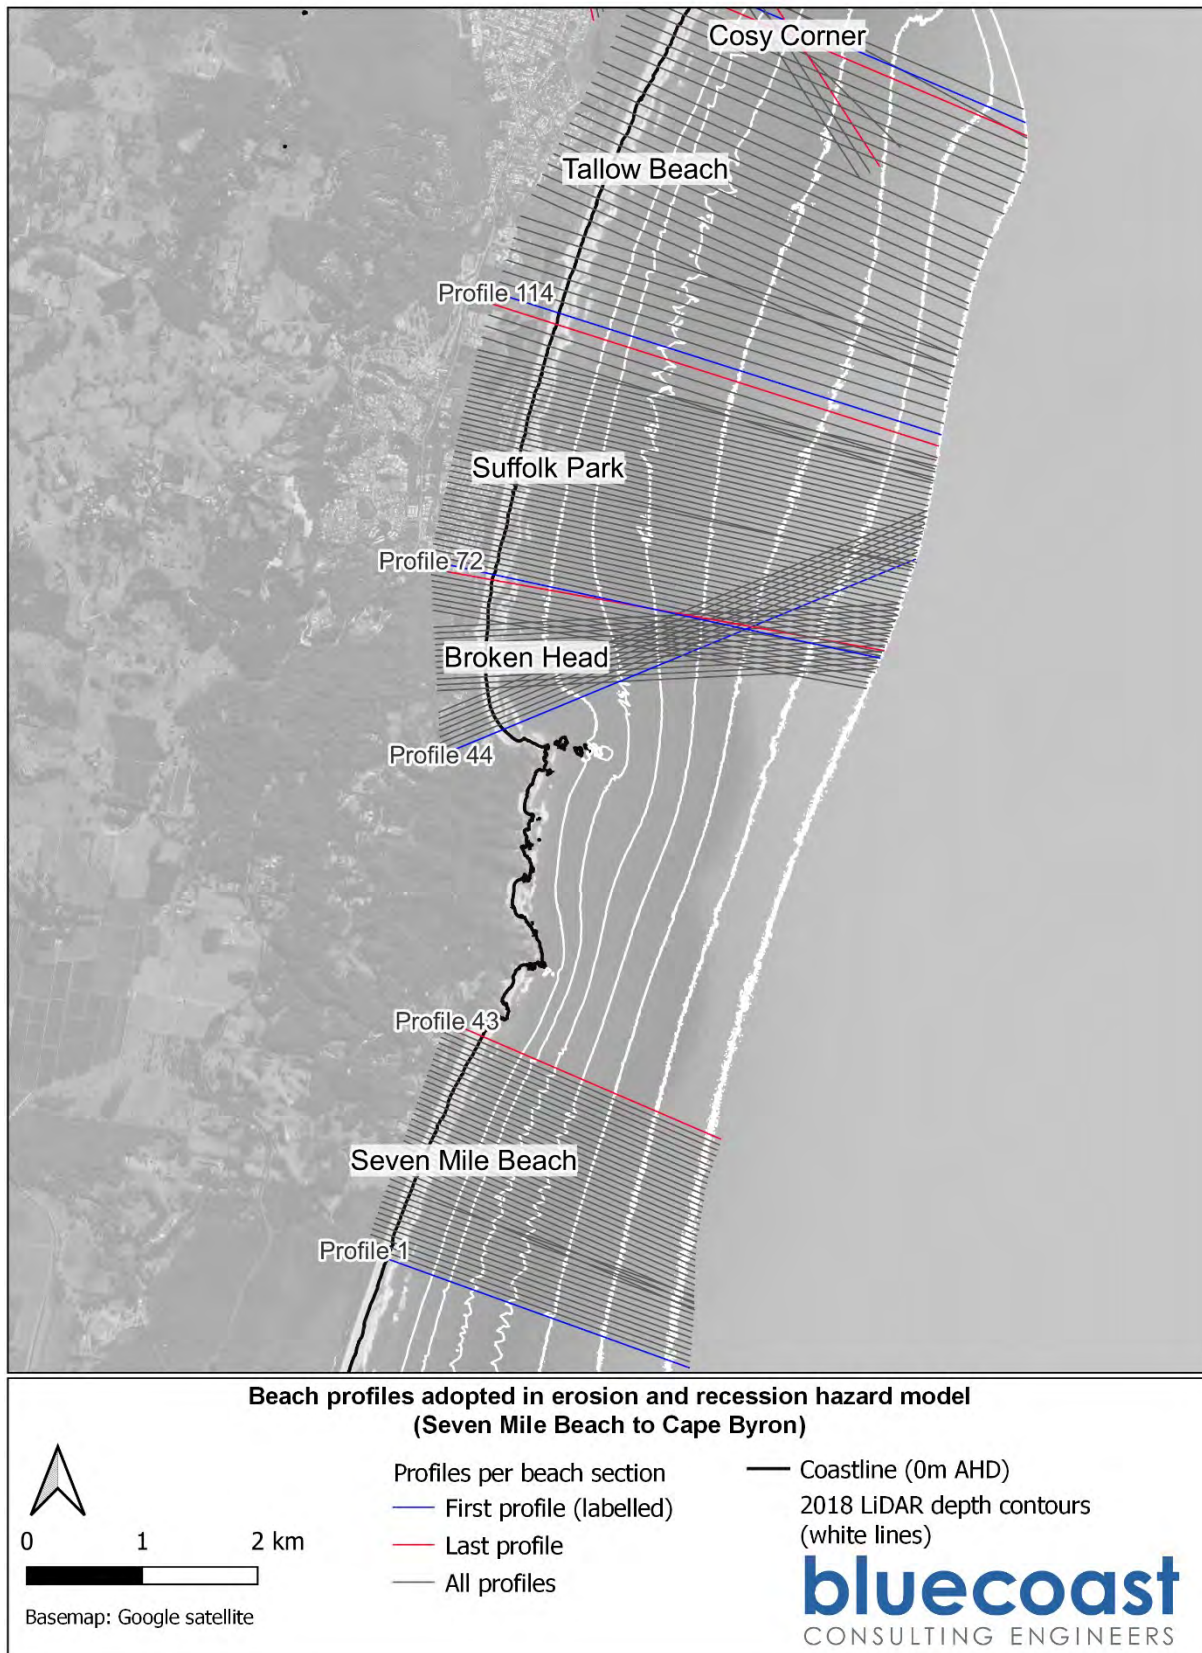
Figure 134: Hazard model profiles for Seven Mile Beach to Cape Byron.

Figure 134 to Figure 137 map the cross-shore (shore-normal) beach profile lines used in the probabilistic erosion and recession hazard model for the Byron Shire.

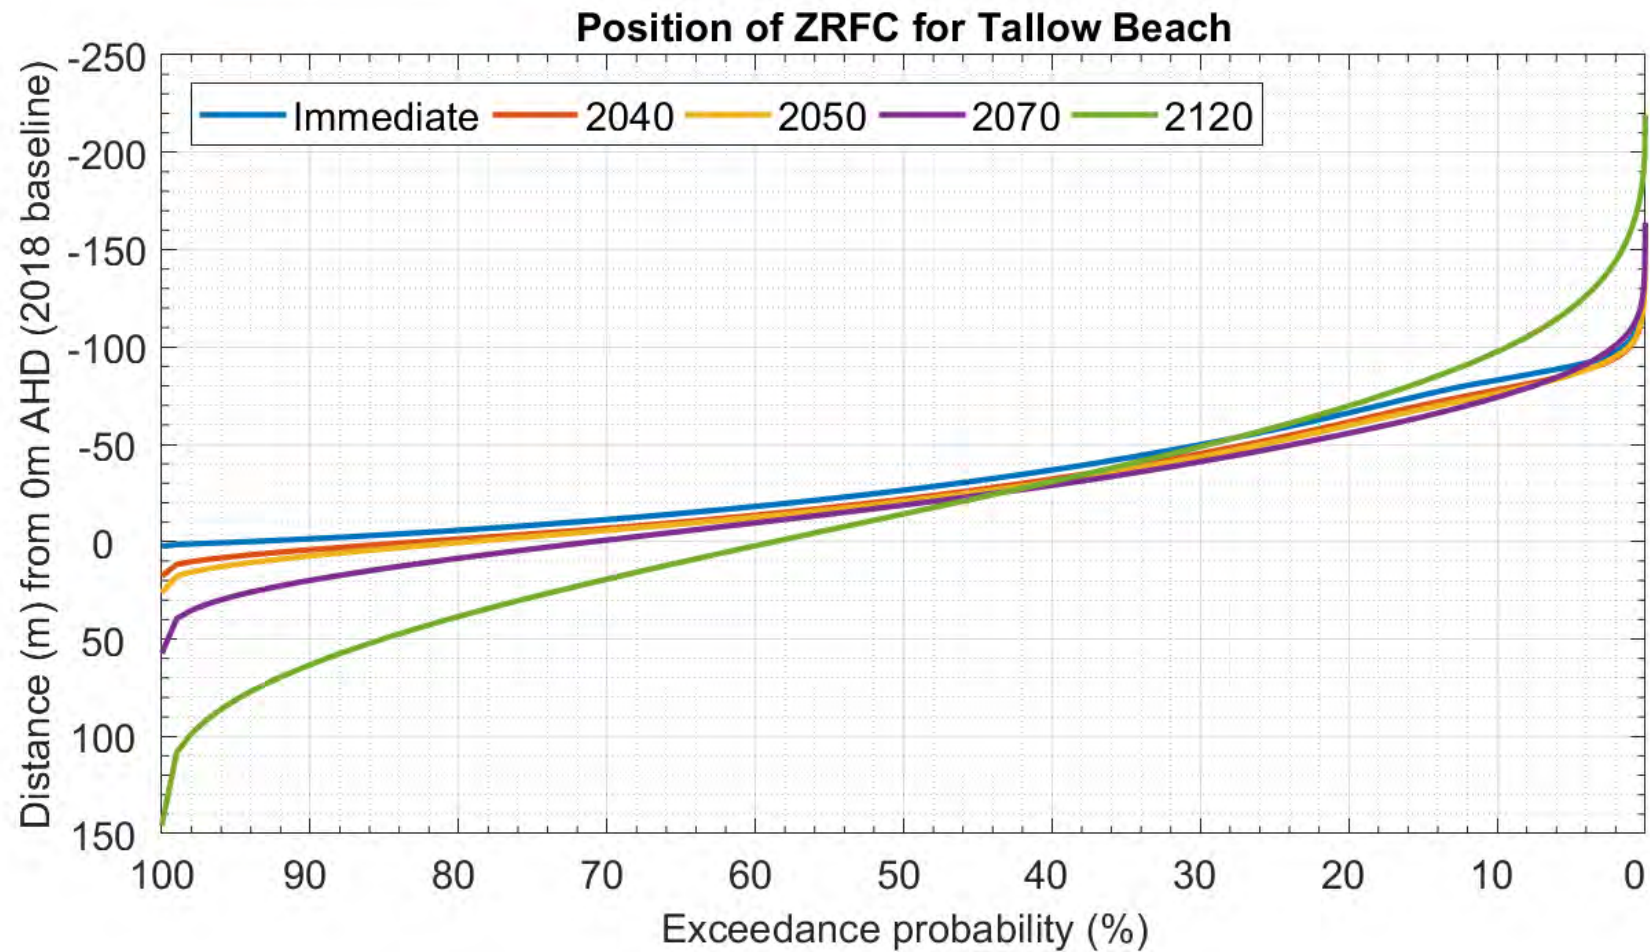
Figure 141: ZRFC probability exceedance curves for Tallow Beach (profile 128).

The probability of exceedance curves of the landward position of the ZRFC for each beach section across the five planning timeframes (immediate, 2040, 2050, 2070 and 2120) are presented below. The distance (m) from 0m AHD (2018 baseline) is used to define the landward position of the ZRFC and was calculated for each profile. Figure 138 to Figure 155 show representative results for each of the 18 beach sections (refer to limitations discussed in Section 5.4). By exception, the Wategos Beach results (Figure 143) shows the ZSA landward position (instead of ZRFC) due to the steep bedrock topography as discussed in Section 5.4.

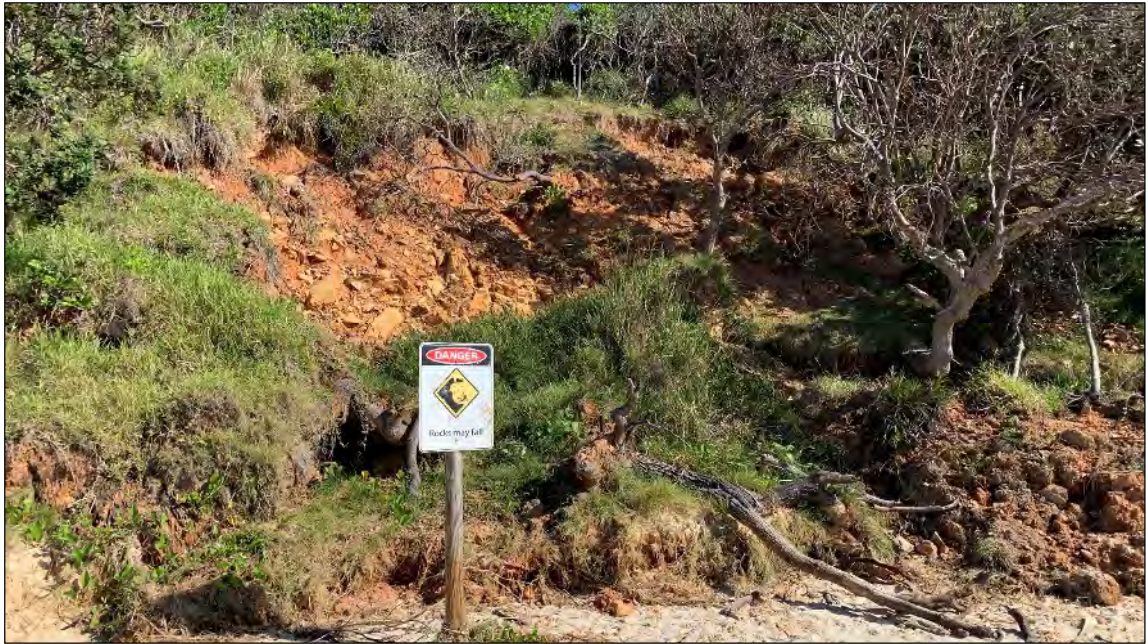
Figure 7: Looking southwest towards foreshore showing slumped area showing potential rock fall signage.

Figures 7 and 8 indicate the slumping observed during the inspection.

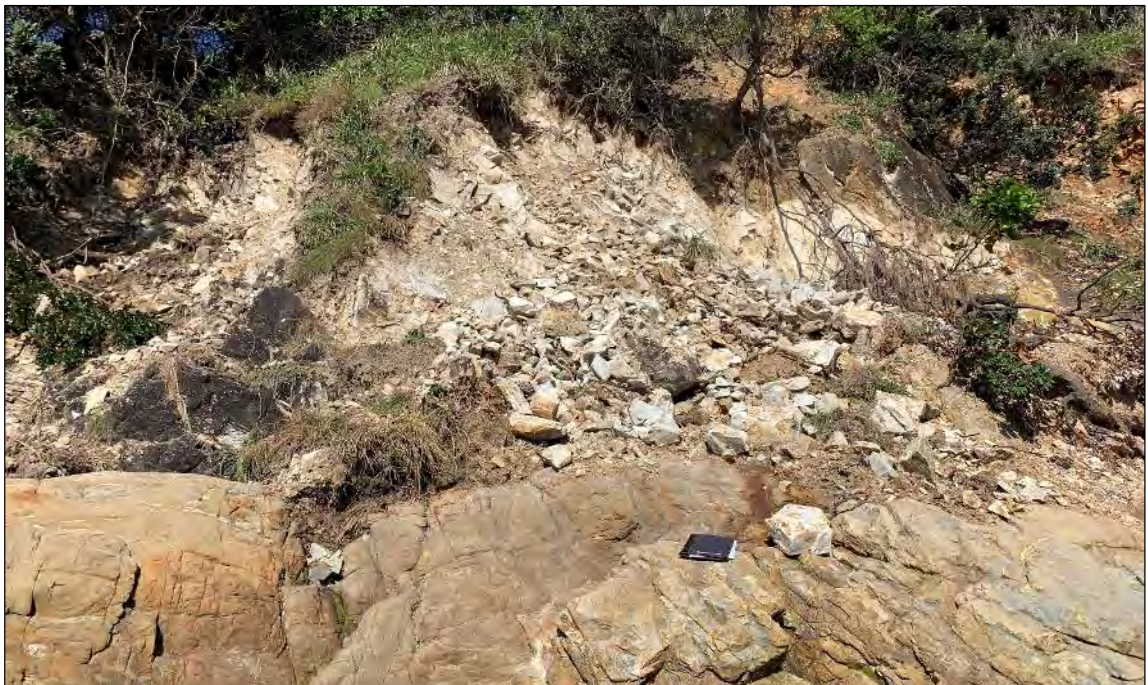
Figure 9: Looking south east towards a recent wedge-failure.

- Joints and foliation were predominantly closed;
- Jointing appeared discontinuous (<1 m long); and
- Predominantly the rock mass appeared intact. However, some wedge block failure was observed. This movement was localised and in an area that would require climbing over rocks in order to access (see Figure 9).
