## Maps

**Seven Mile Beach (south) erosion and recession hazard (Immediate, ZRFC)**

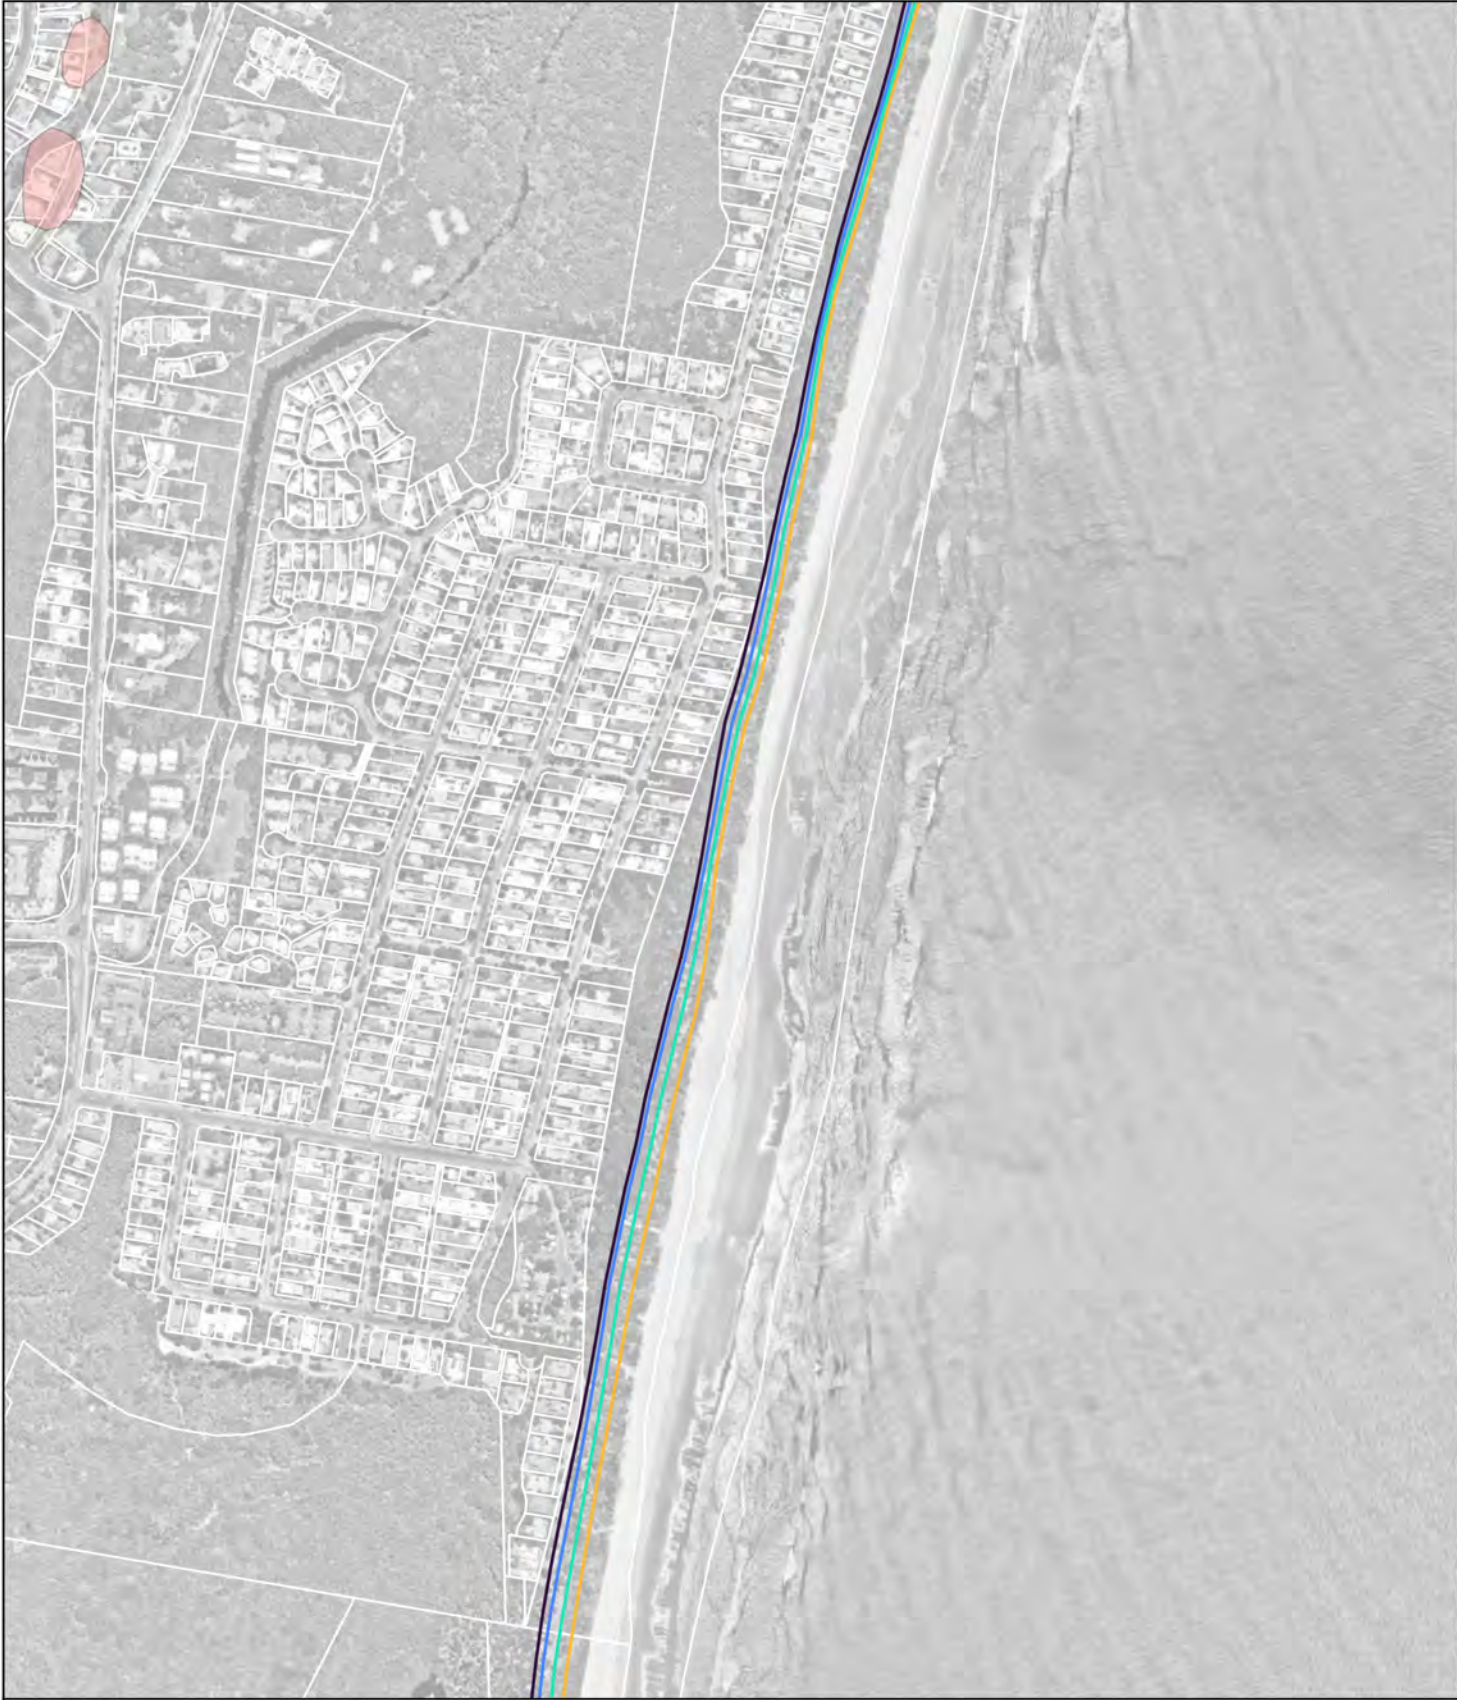
### Broken Head erosion and recession hazard (Immediate, ZRFC)

Alongshore region affected by entrance instability hazard (\*)

The erosion and recession hazard extends to bedrock. Location and level of bedrock subject to confirmation through geotechnical assessment.

- Exceedance probability (%)
  - 1
  - 2
  - 5
  - 10
- Seawall/ revetment
  - Rock structure (non erodible)
  - - Rock structure (low design standard)
  - Geobag (low design standard)
- //// Outcrop/ reef
- Sandstone unit^
- Cadastre (white lines)

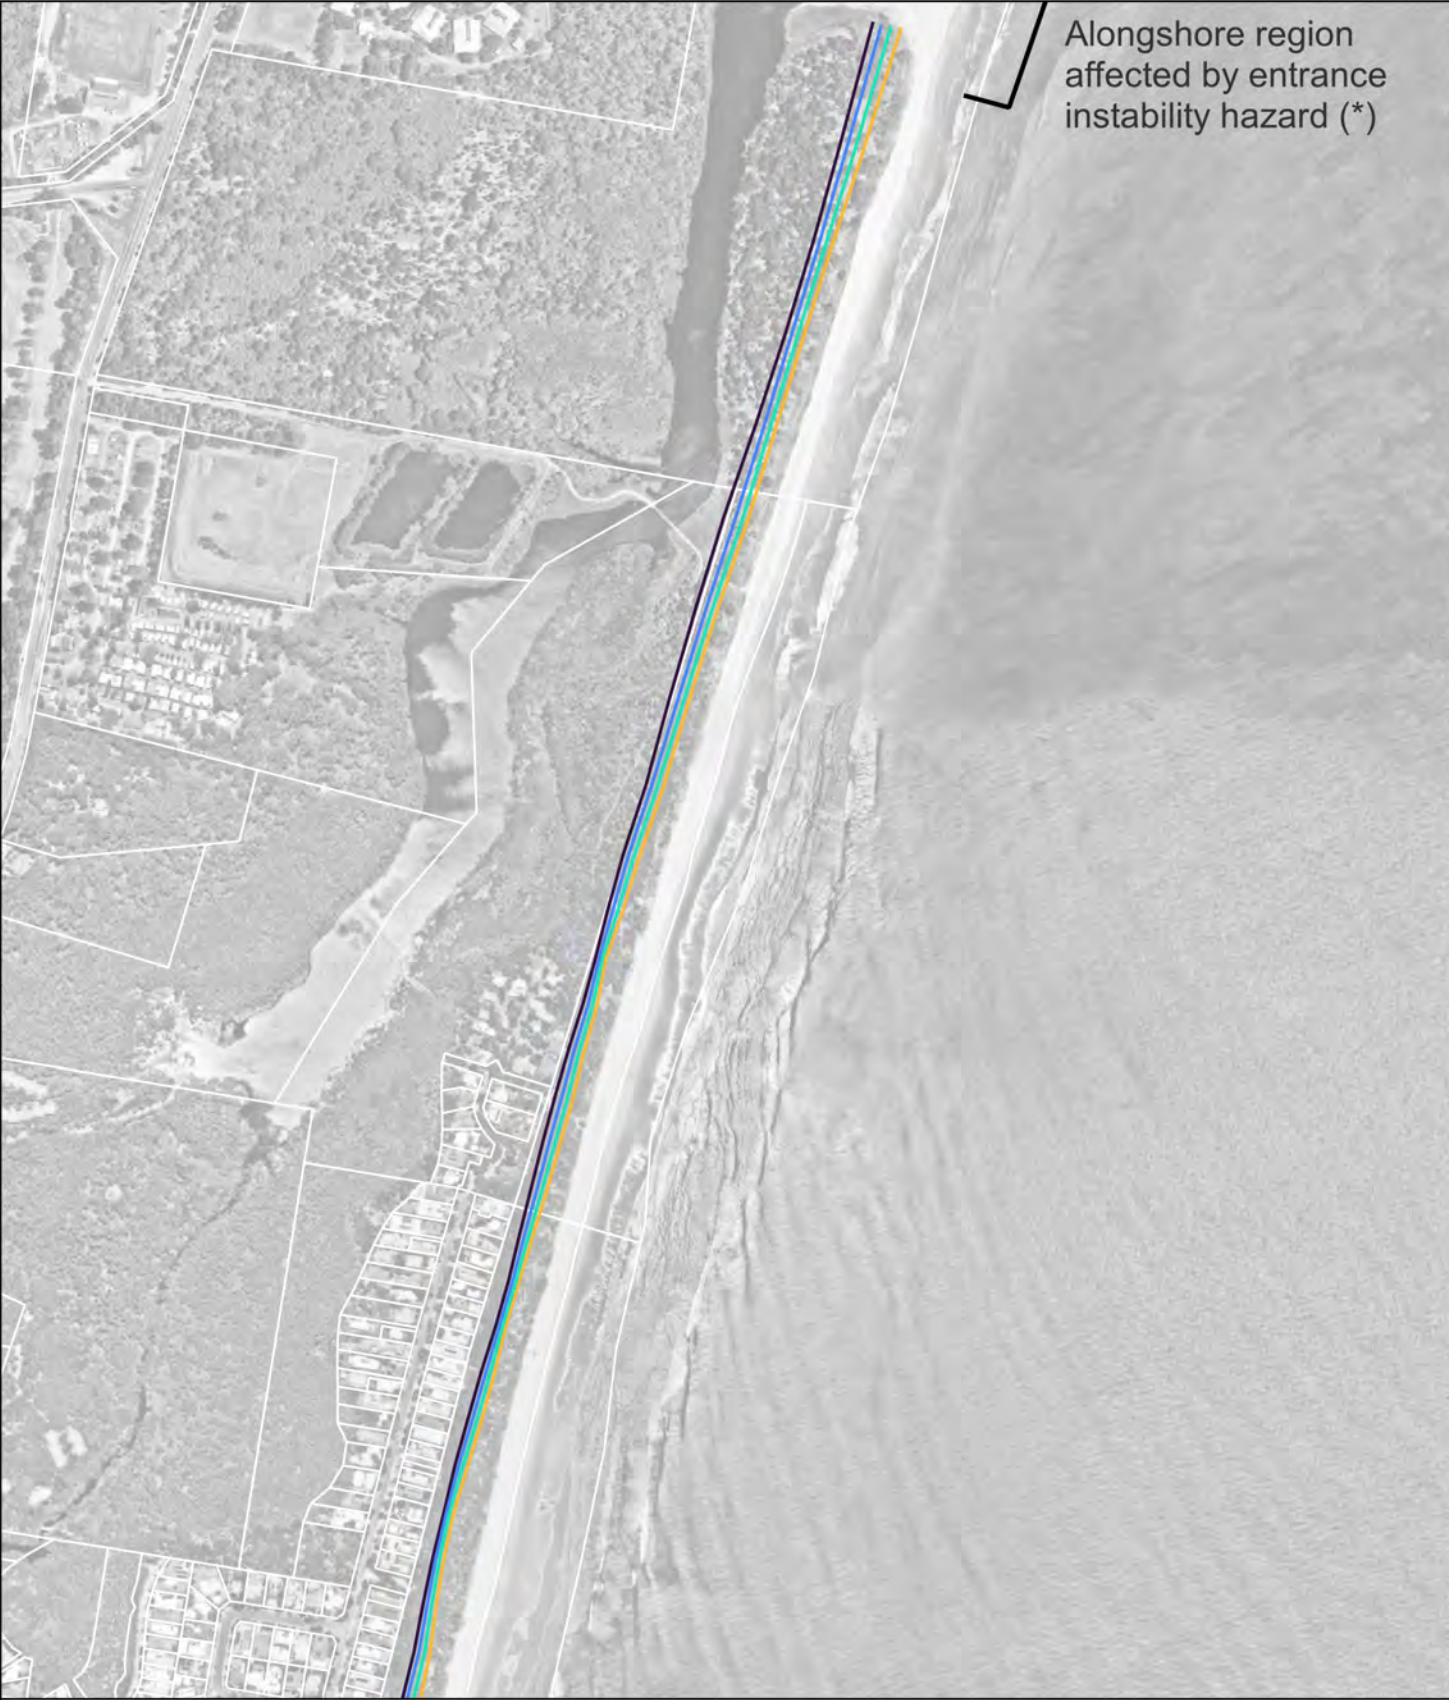
### Suffolk Park to Tallow Beach erosion and recession hazard (Immediate, ZRFC)

Alongshore region affected by entrance instability hazard (\*)

\*Refer to Section 8.2 in main report for further detail

- Exceedance probability (%)
  - 1 (black line)
  - 2 (blue line)
  - 5 (green line)
  - 10 (yellow line)
- Seawall/ revetment
  - Rock structure (non erodible) (solid black line)
  - Rock structure (low design standard) (dashed black line)
  - Geobag (low design standard) (dotted black line)
- Outcrop/ reef (pink hatched area)
- Sandstone unit^ (pink solid area)
- Cadastrate (white lines)

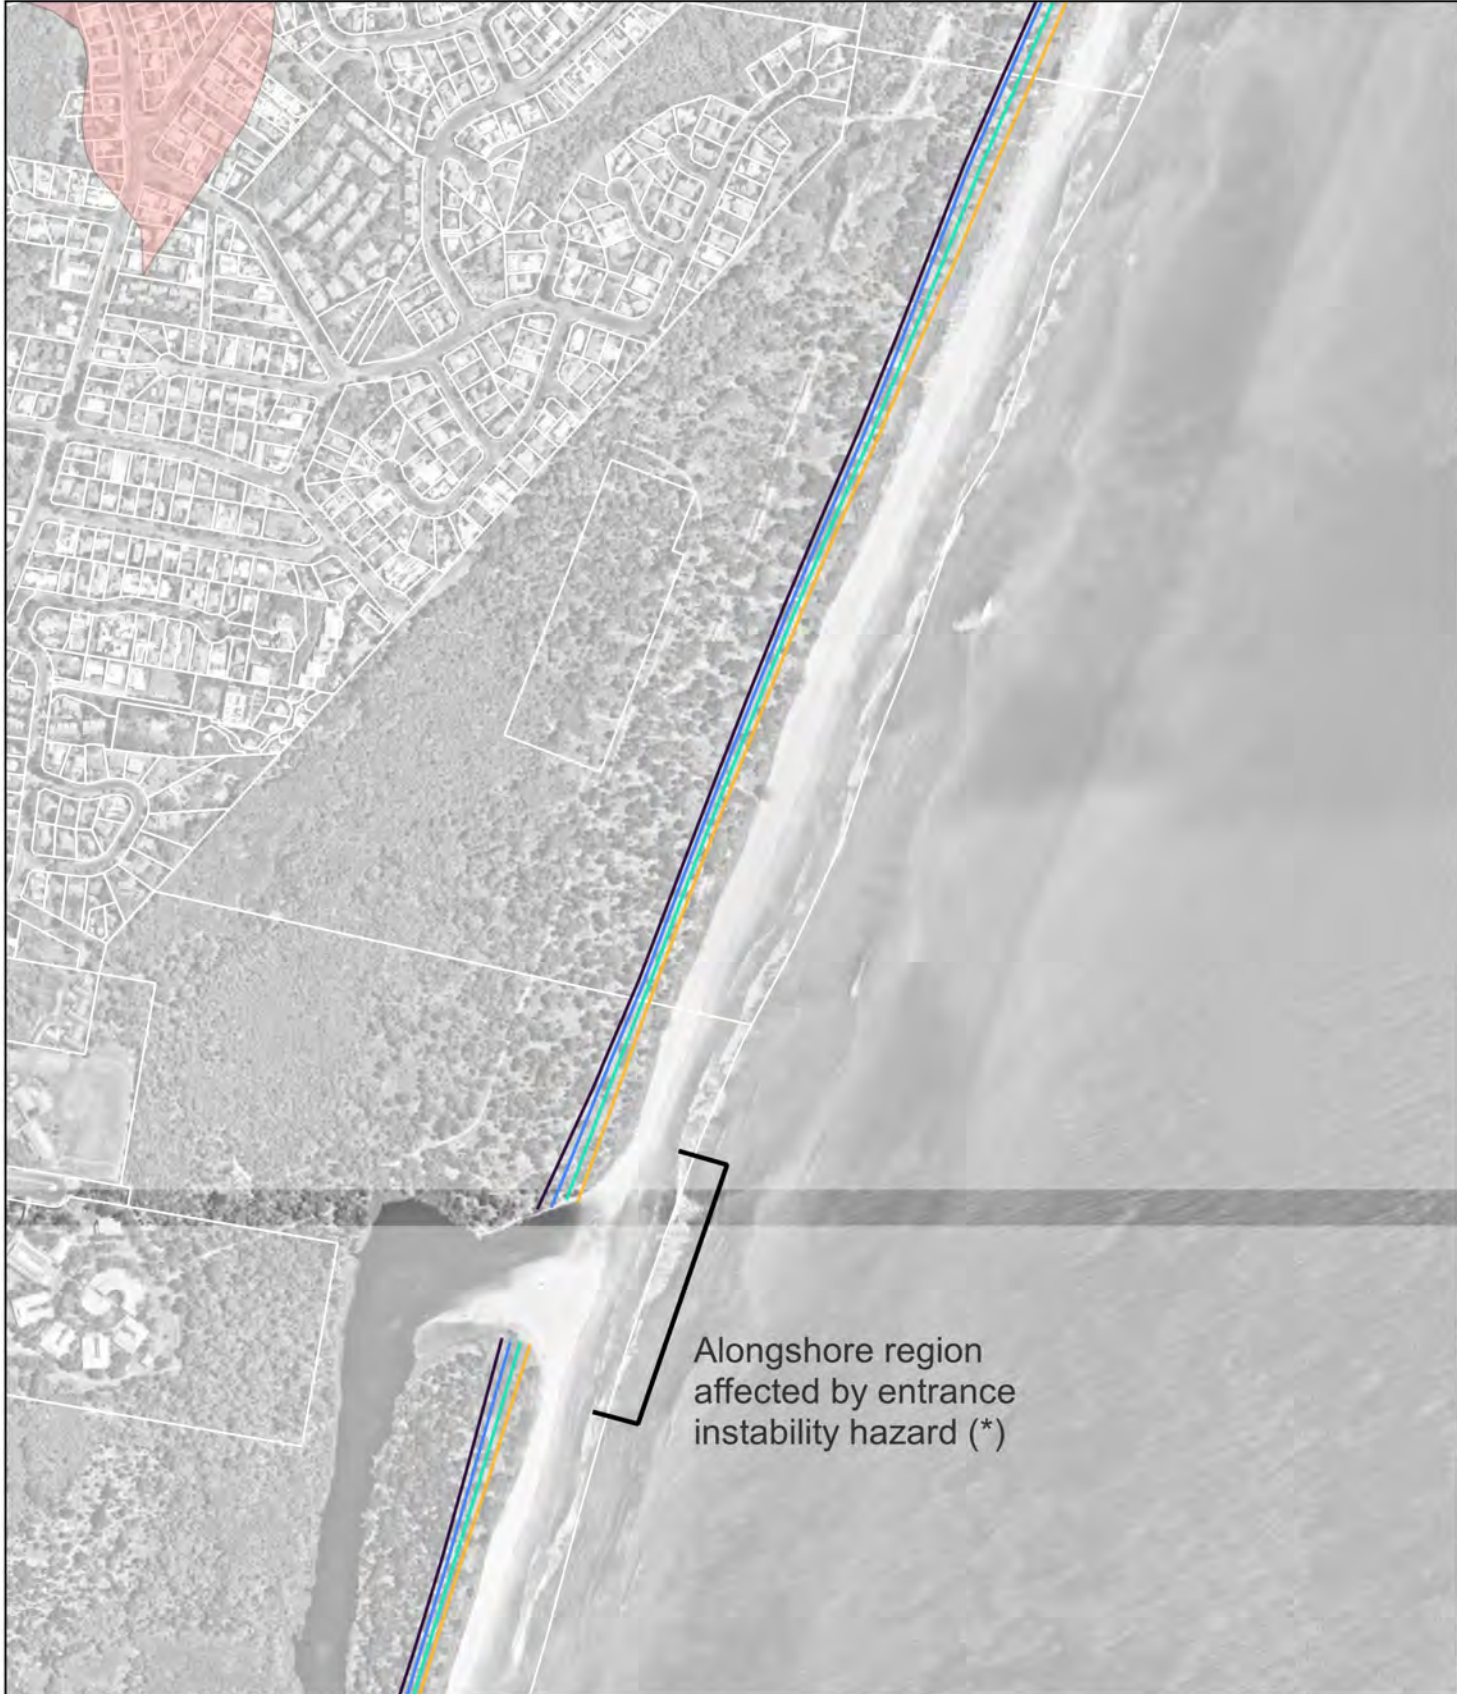
### Tallow Creek erosion and recession hazard (Immediate, ZRFC)

\*Refer to Section 8.2 in main report for further detail

Exceedance probability (%)

- 1
- 2
- 5
- 10

- Rock structure (non erodible)
- - Rock structure (low design standard)
- Geobag (low design standard)

The erosion and recession hazard extends to bedrock. Location and level of bedrock subject to confirmation through geotechnical assessment.

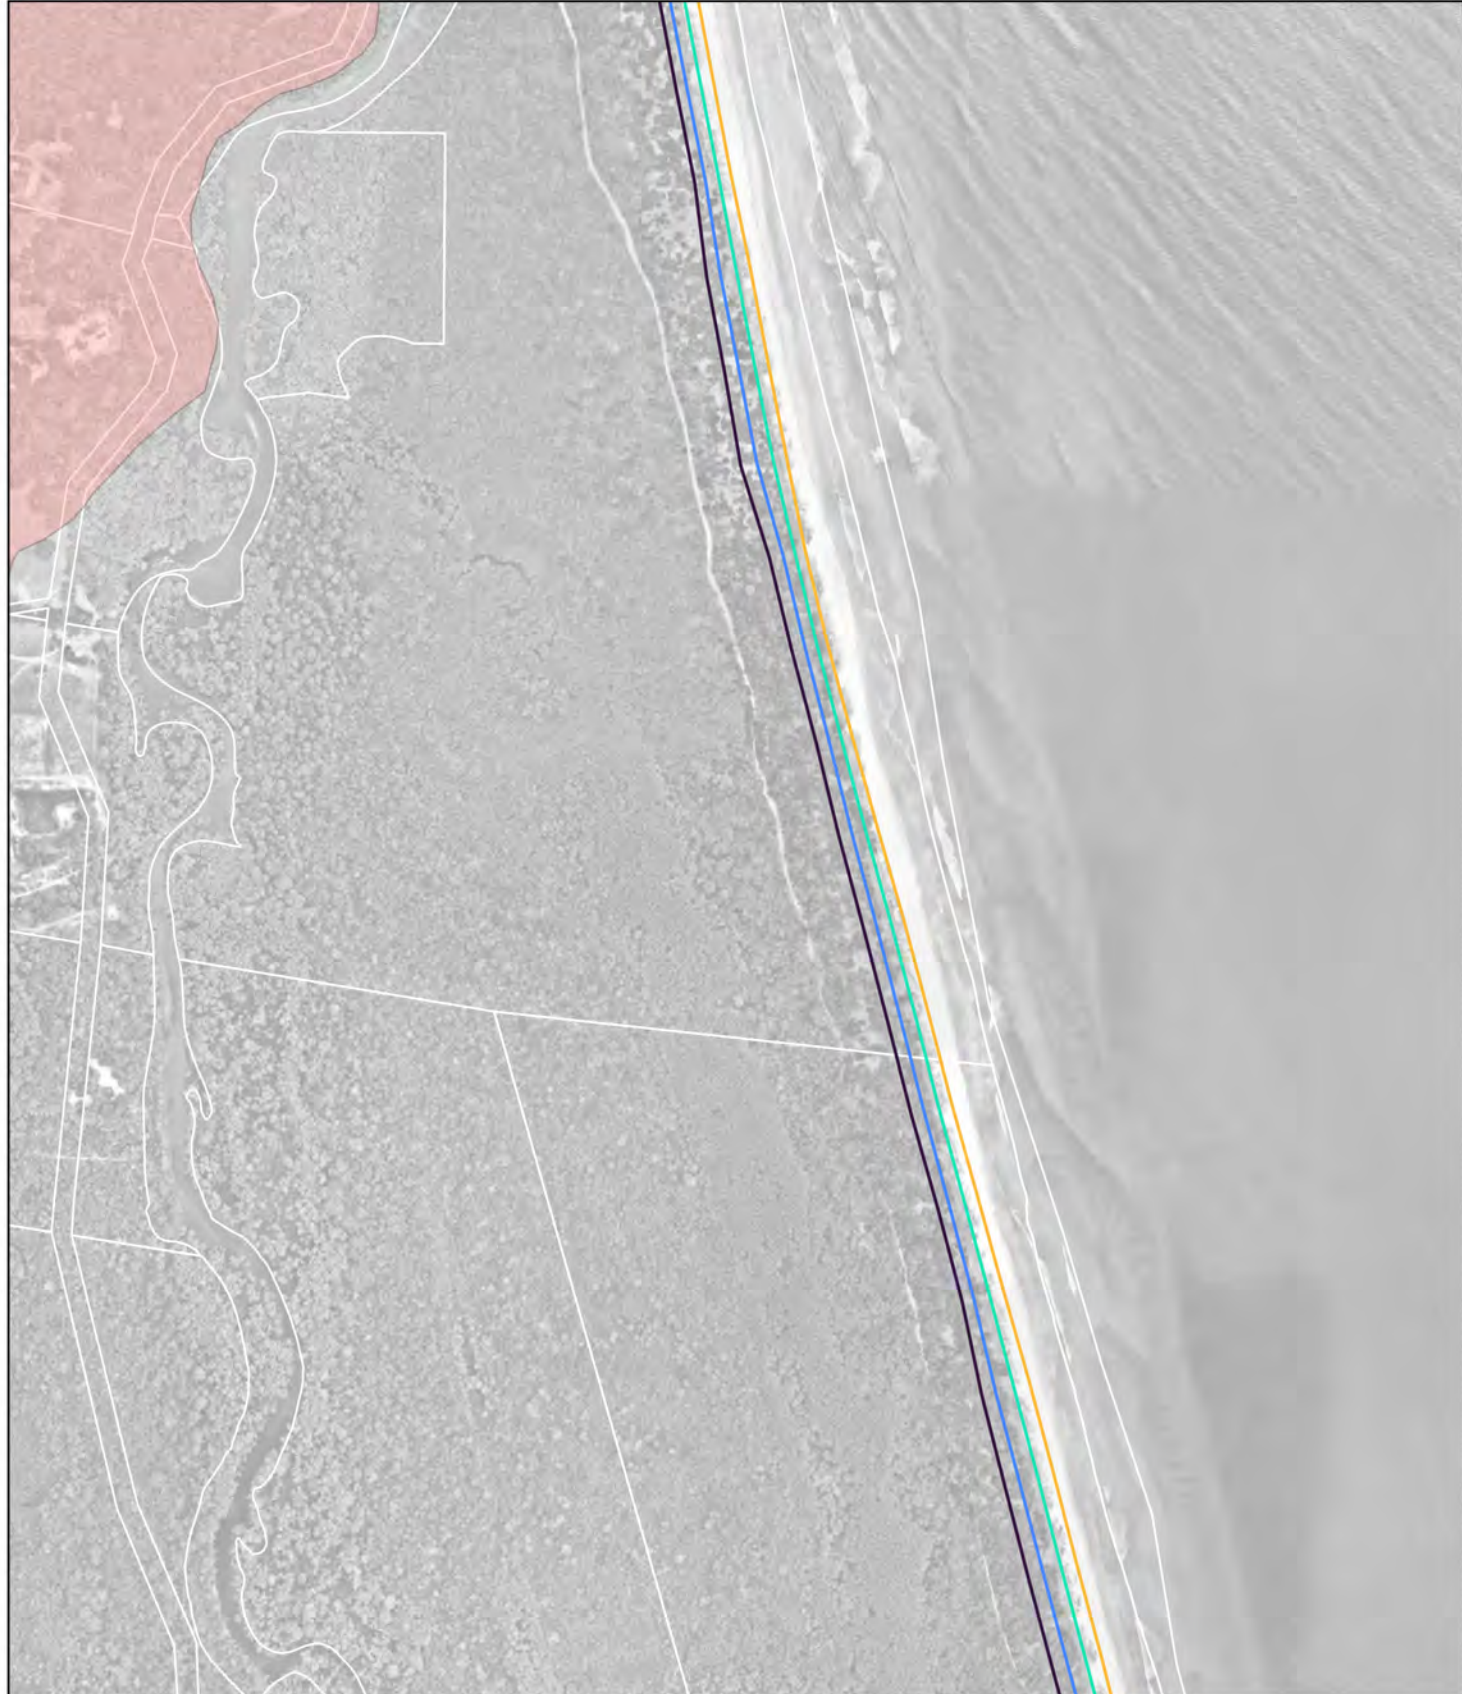
### Tyagarah Beach (south) erosion and recession hazard (Immediate, ZRFC)

- Exceedance probability (%)
  - 1 (dark purple line)
  - 2 (blue line)
  - 5 (green line)
  - 10 (orange line)
- Seawall/ revetment
  - Rock structure (non erodible) (solid grey line)
  - Rock structure (low design standard) (dashed grey line)
  - Geobag (low design standard) (dotted grey line)
- //// Outcrop/ reef
- Sandstone unit^ (pink shaded area)
- Cadastre (white lines)

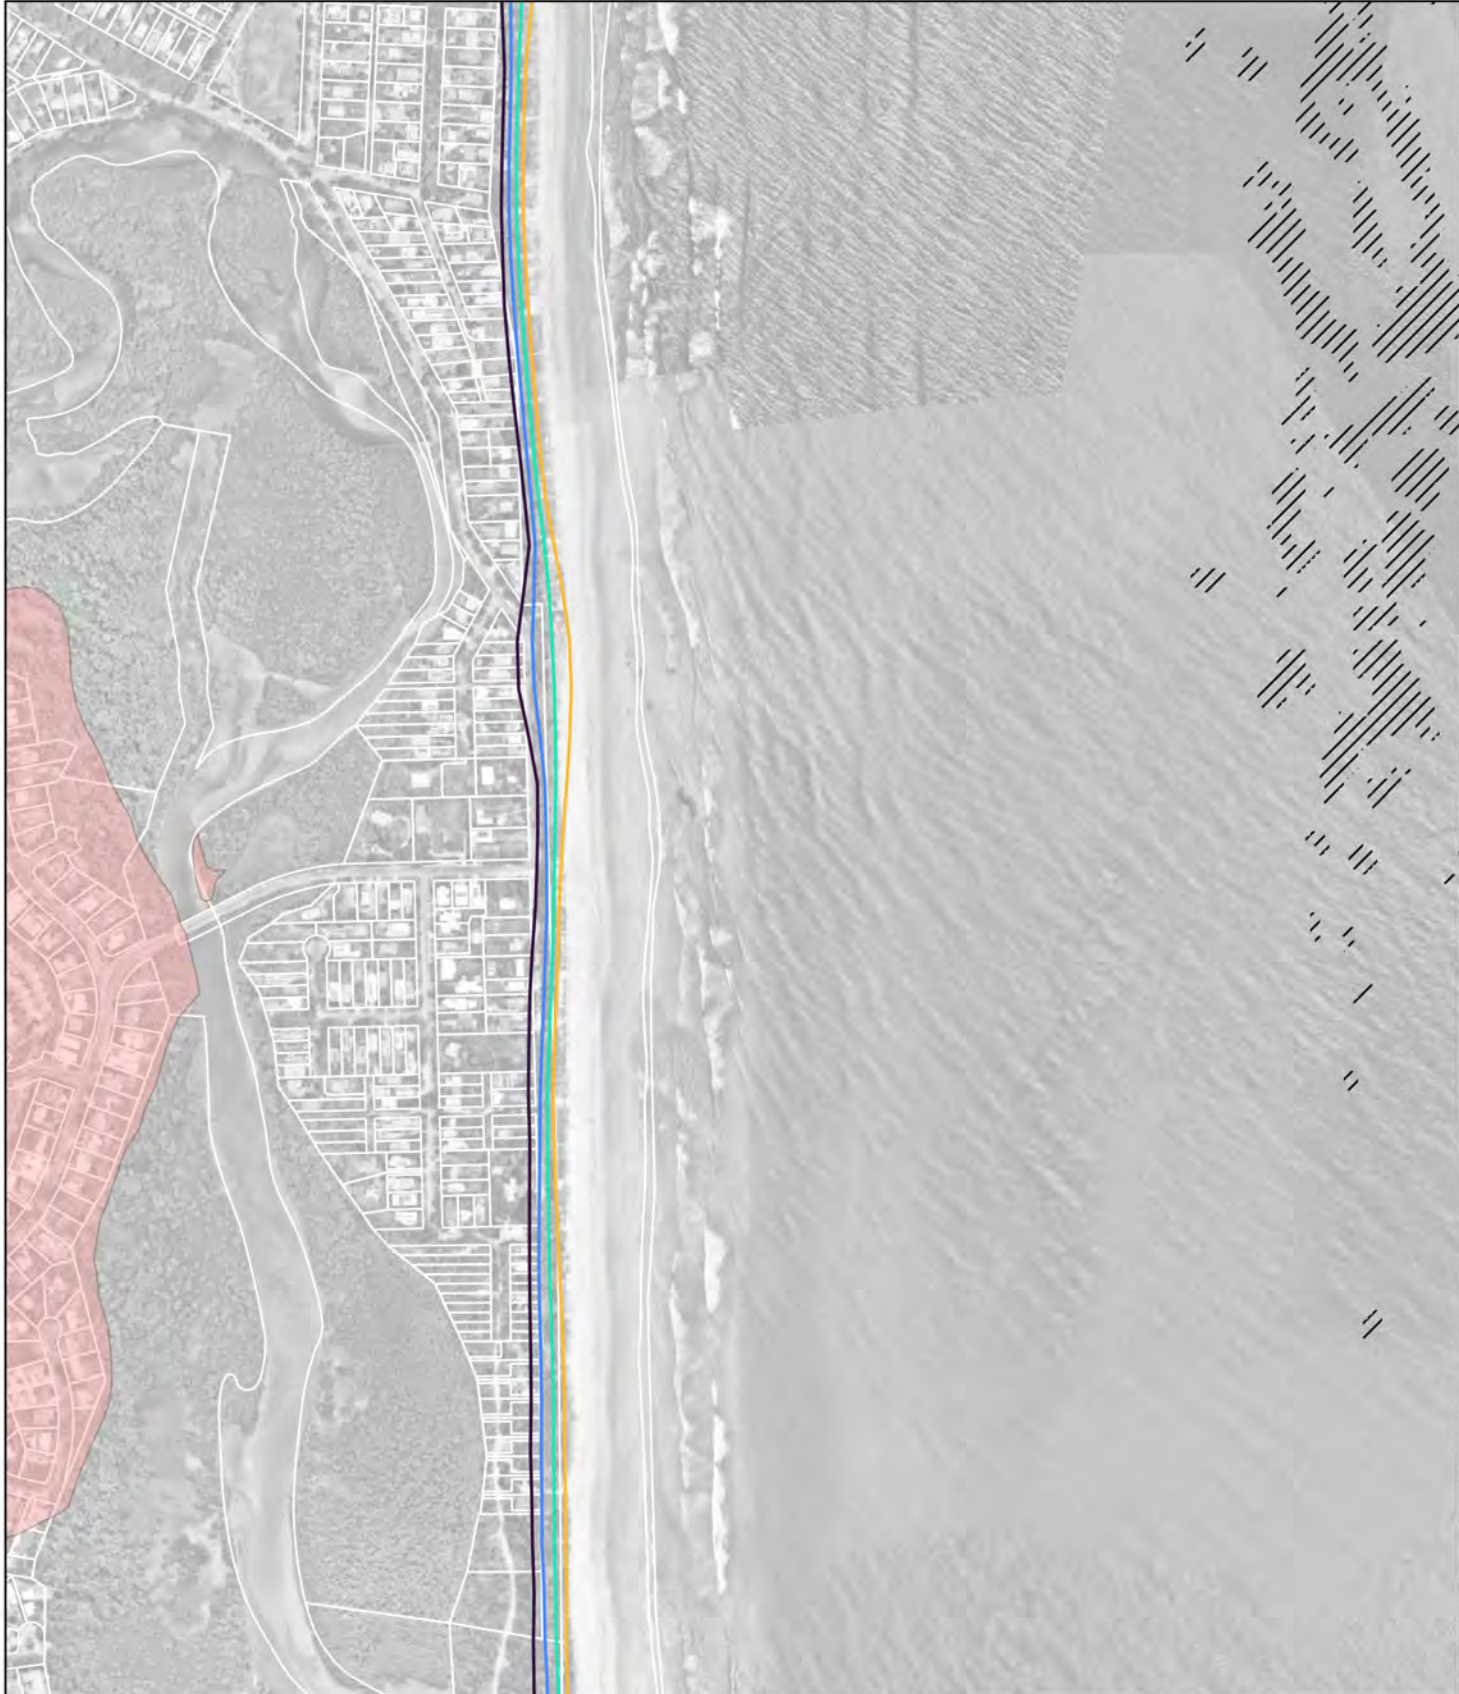
### North Head erosion and recession hazard (Immediate, ZRFC)

The erosion and recession hazard extends to bedrock. Location and level of bedrock subject to confirmation through geotechnical assessment.

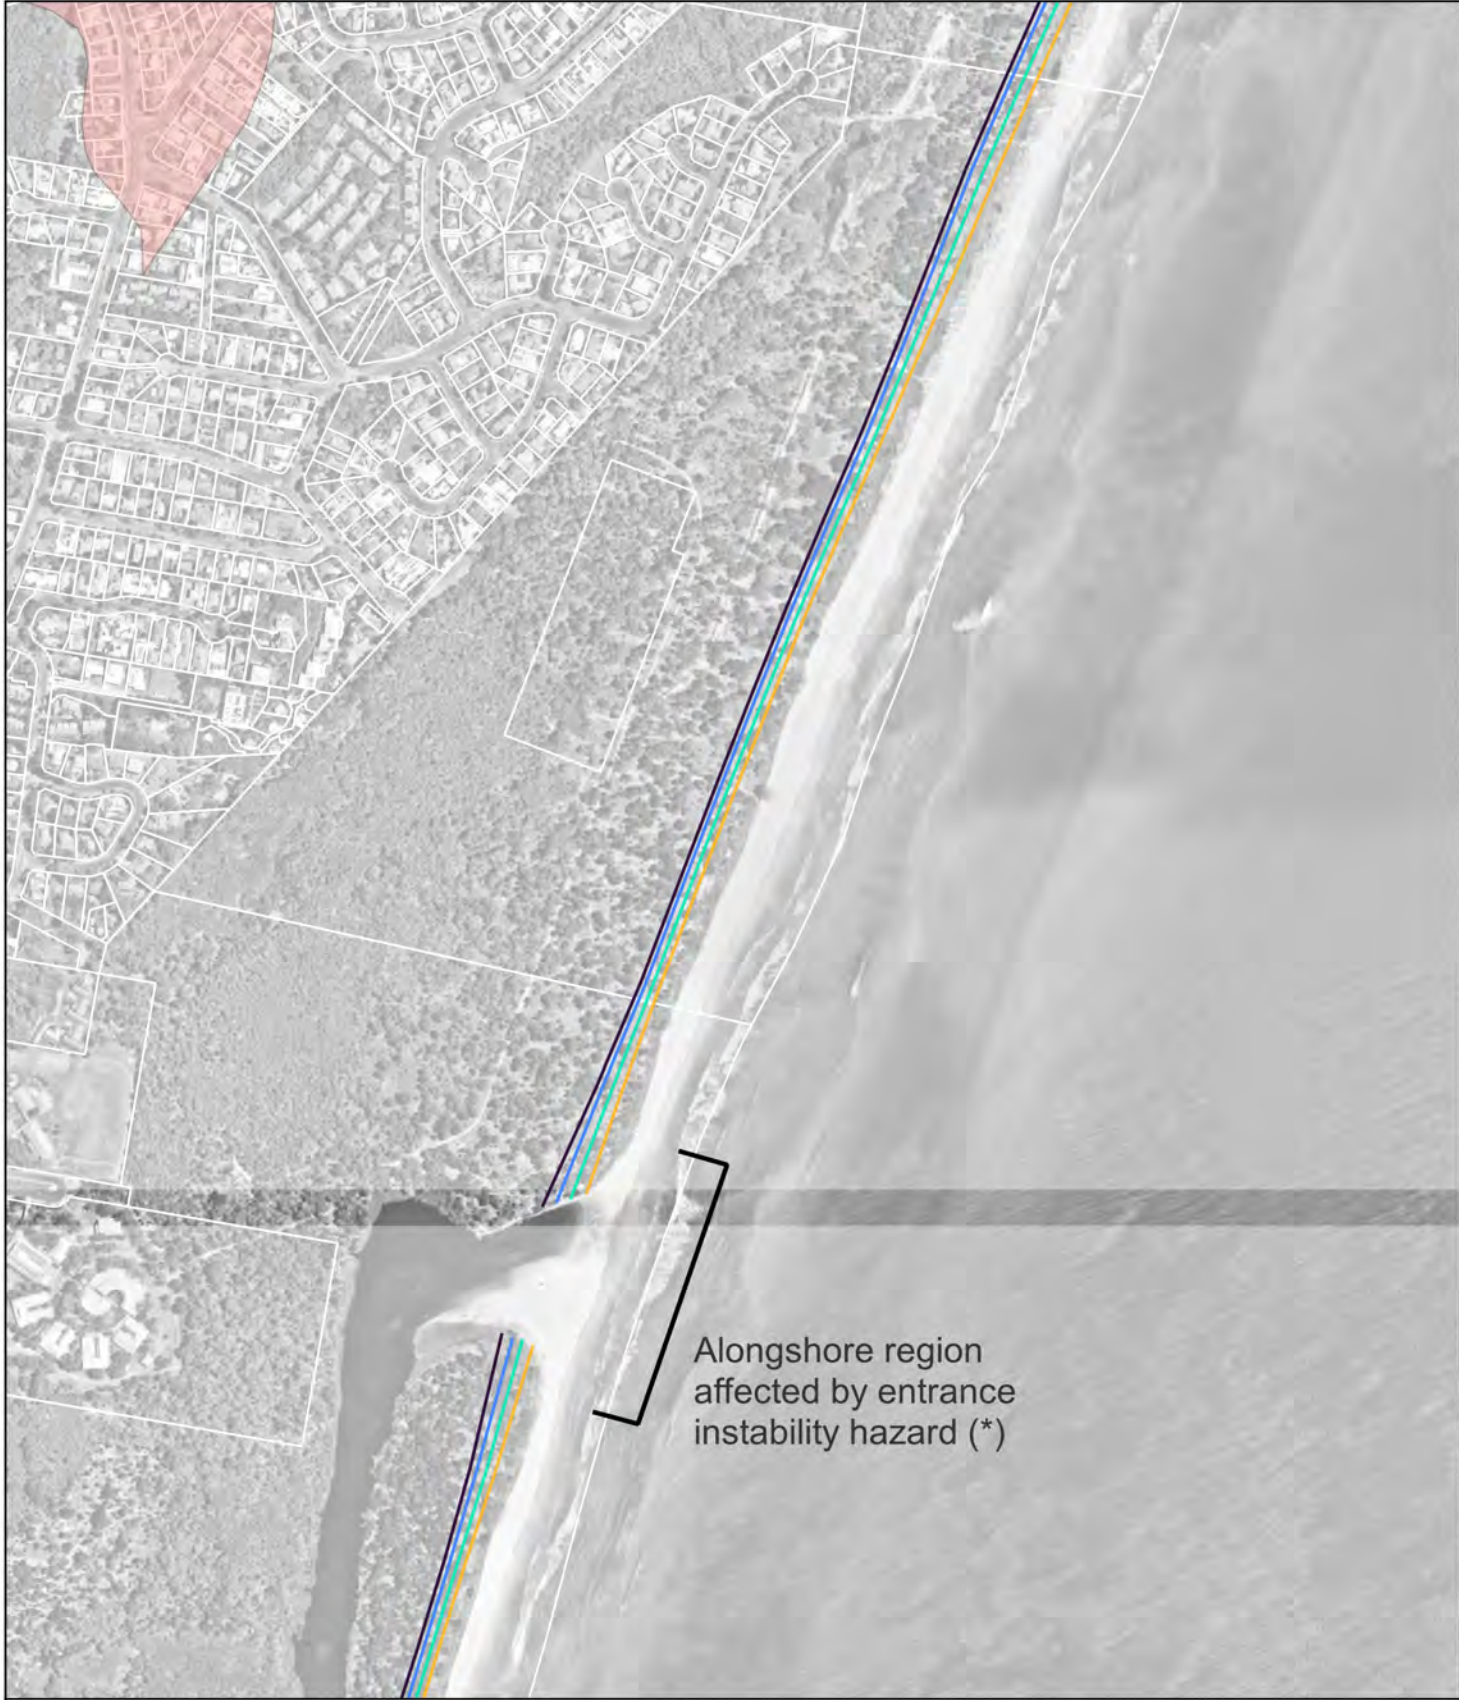
### Tallow Creek erosion and recession hazard (2040, ZRFC)

\*Refer to Section 8.2 in main report for further detail

The erosion and recession hazard extends to bedrock. Location and level of bedrock subject to confirmation through geotechnical assessment.

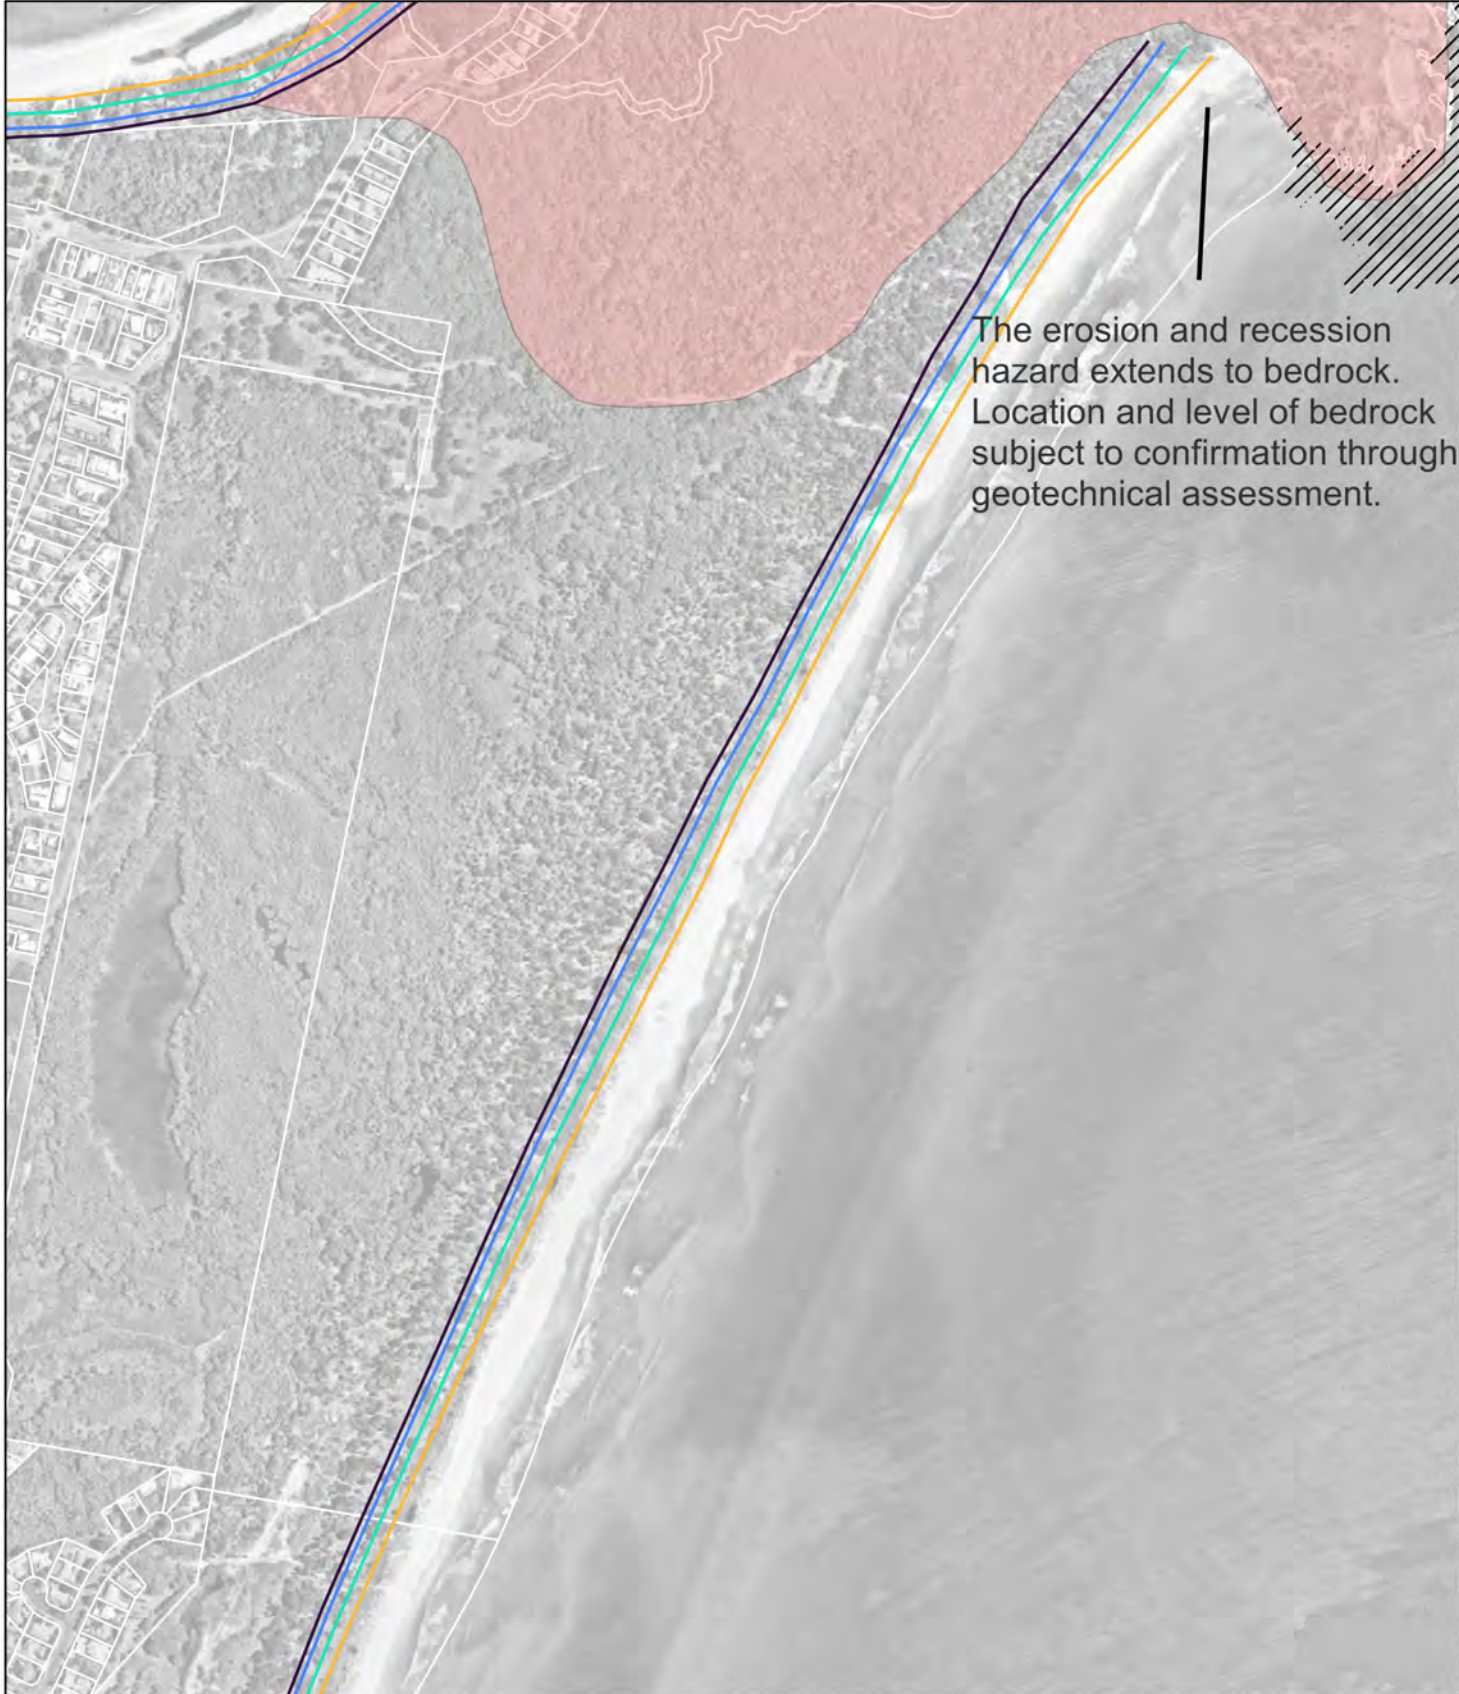
### Tallow Creek erosion and recession hazard (2050, ZRFC)

\*Refer to Section 8.2 in main report for further detail

The erosion and recession hazard extends to bedrock. Location and level of bedrock subject to confirmation through geotechnical assessment.

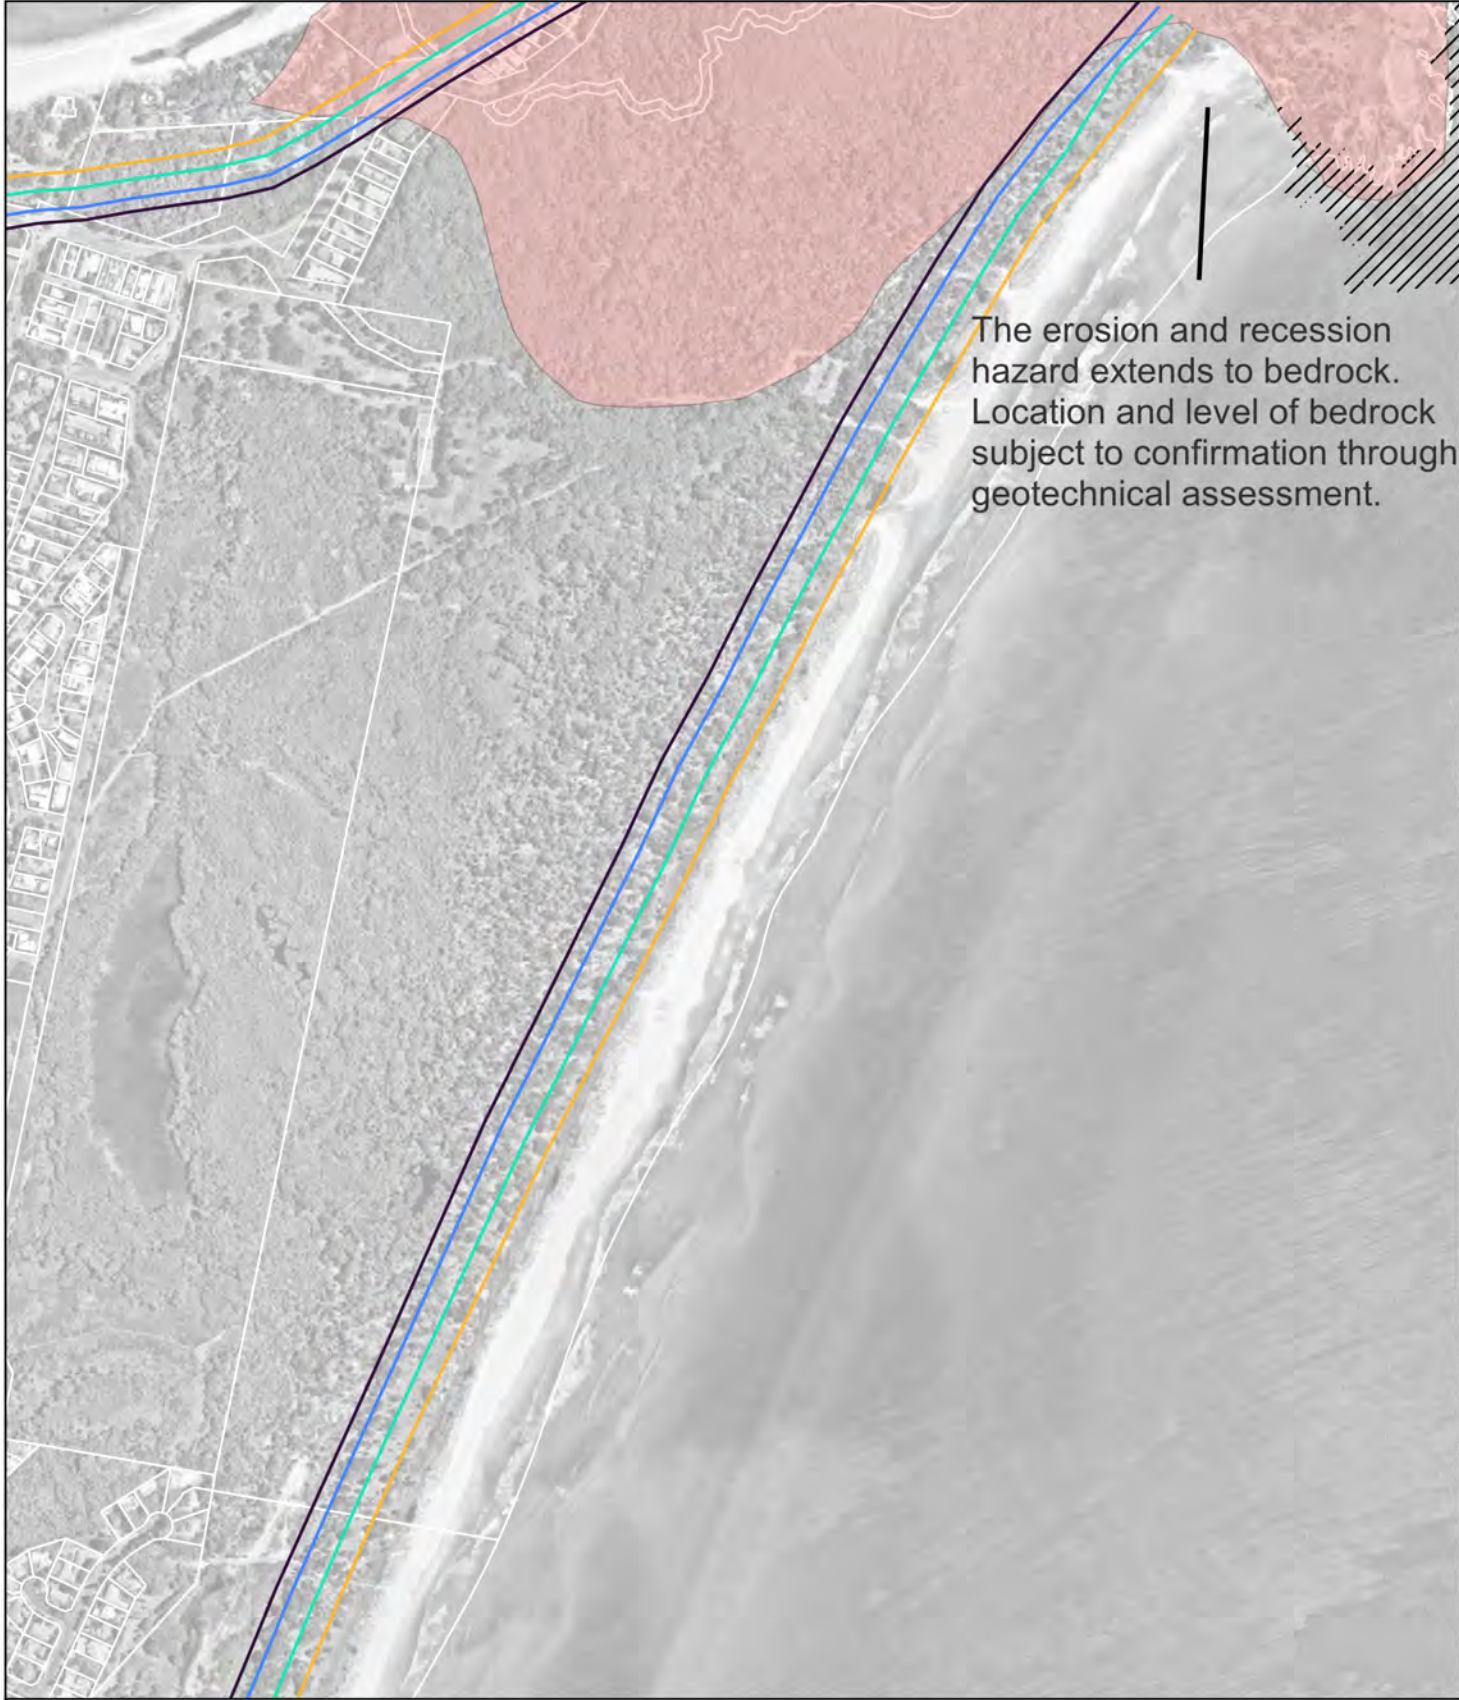
### Tallow Creek erosion and recession hazard (2120, ZRFC)

\*Refer to Section 8.2 in main report for further detail

The erosion and recession hazard extends to bedrock. Location and level of bedrock subject to confirmation through geotechnical assessment.

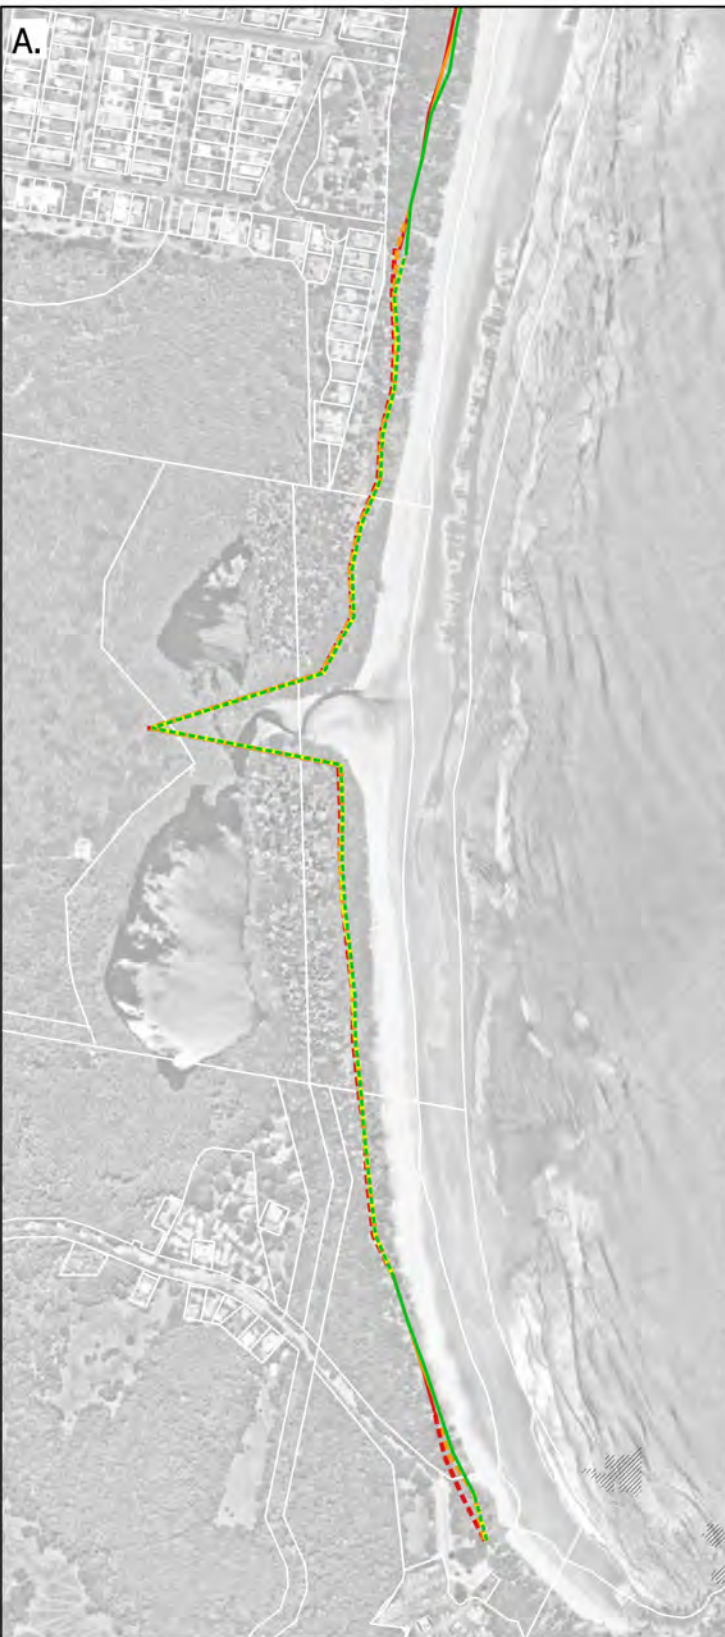
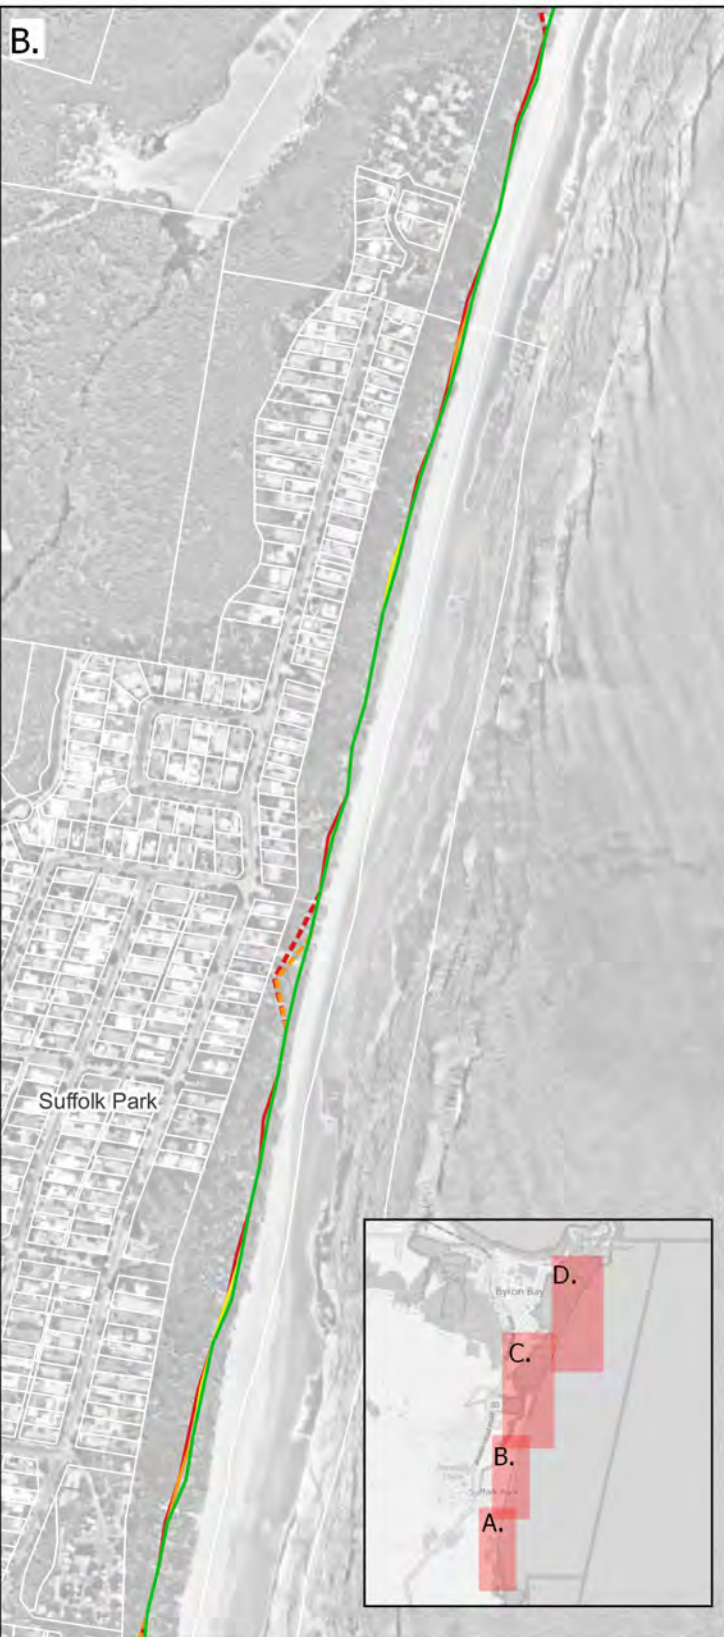
### Broken Head Beach to Suffolk Park Beach – coastal inundation hazard

Inundation extents based on 29-year hindcast using empirical wave runup (R2%, max) and bore propagation (overwash) formulate. Allowance for sea level rise included. No allowance for possible future changes to dune height/position.
