## Maps

**Seven Mile Beach (south) erosion and recession hazard (Immediate, ZRFC)**

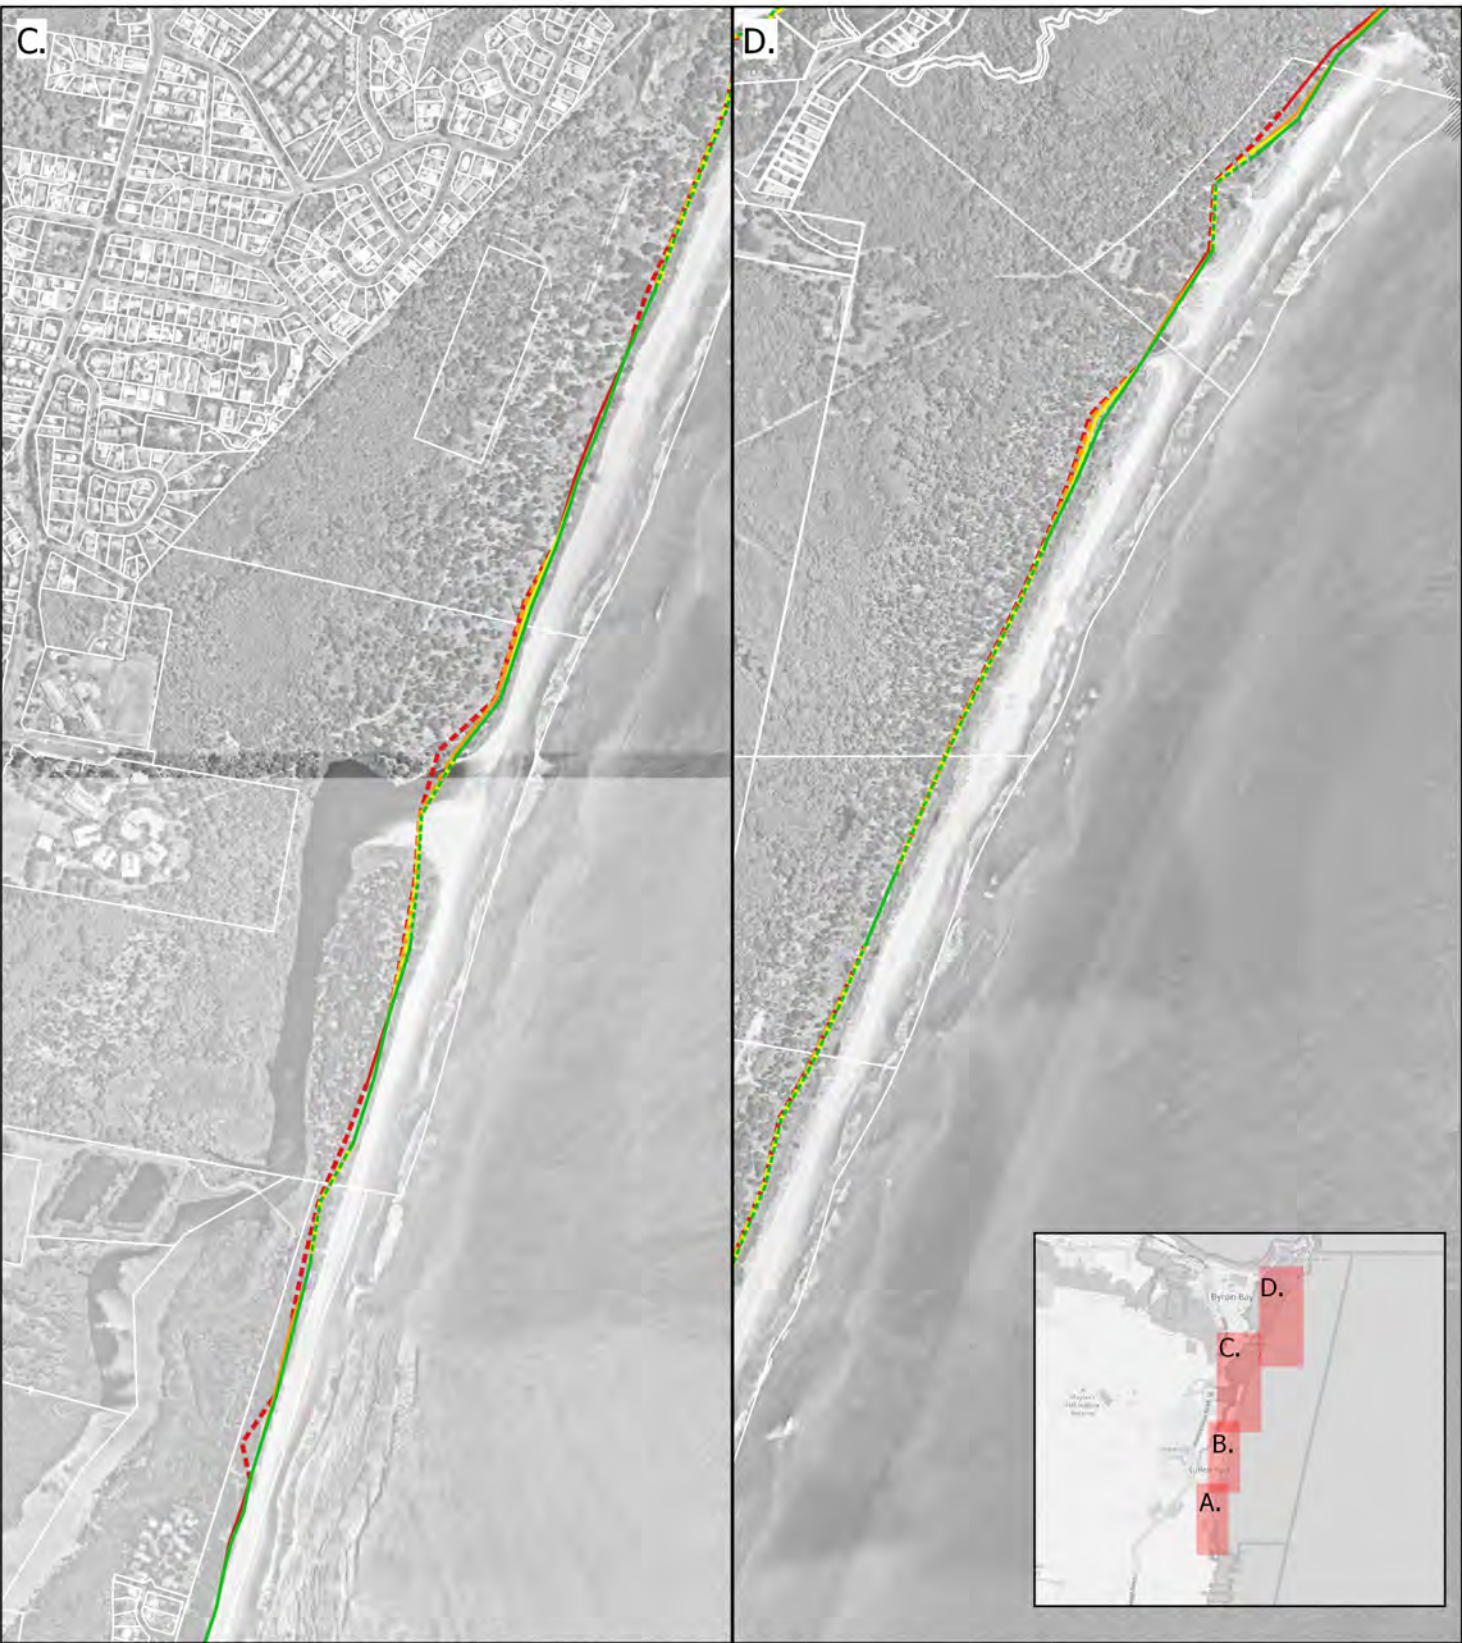
### Tallow Beach to Cosy Corner – coastal inundation hazard

Inundation extents based on 29-year hindcast using empirical wave runup (R2%, max) and bore propagation (overwash) formulate. Allowance for sea level rise included. No allowance for possible future changes to dune height/position.

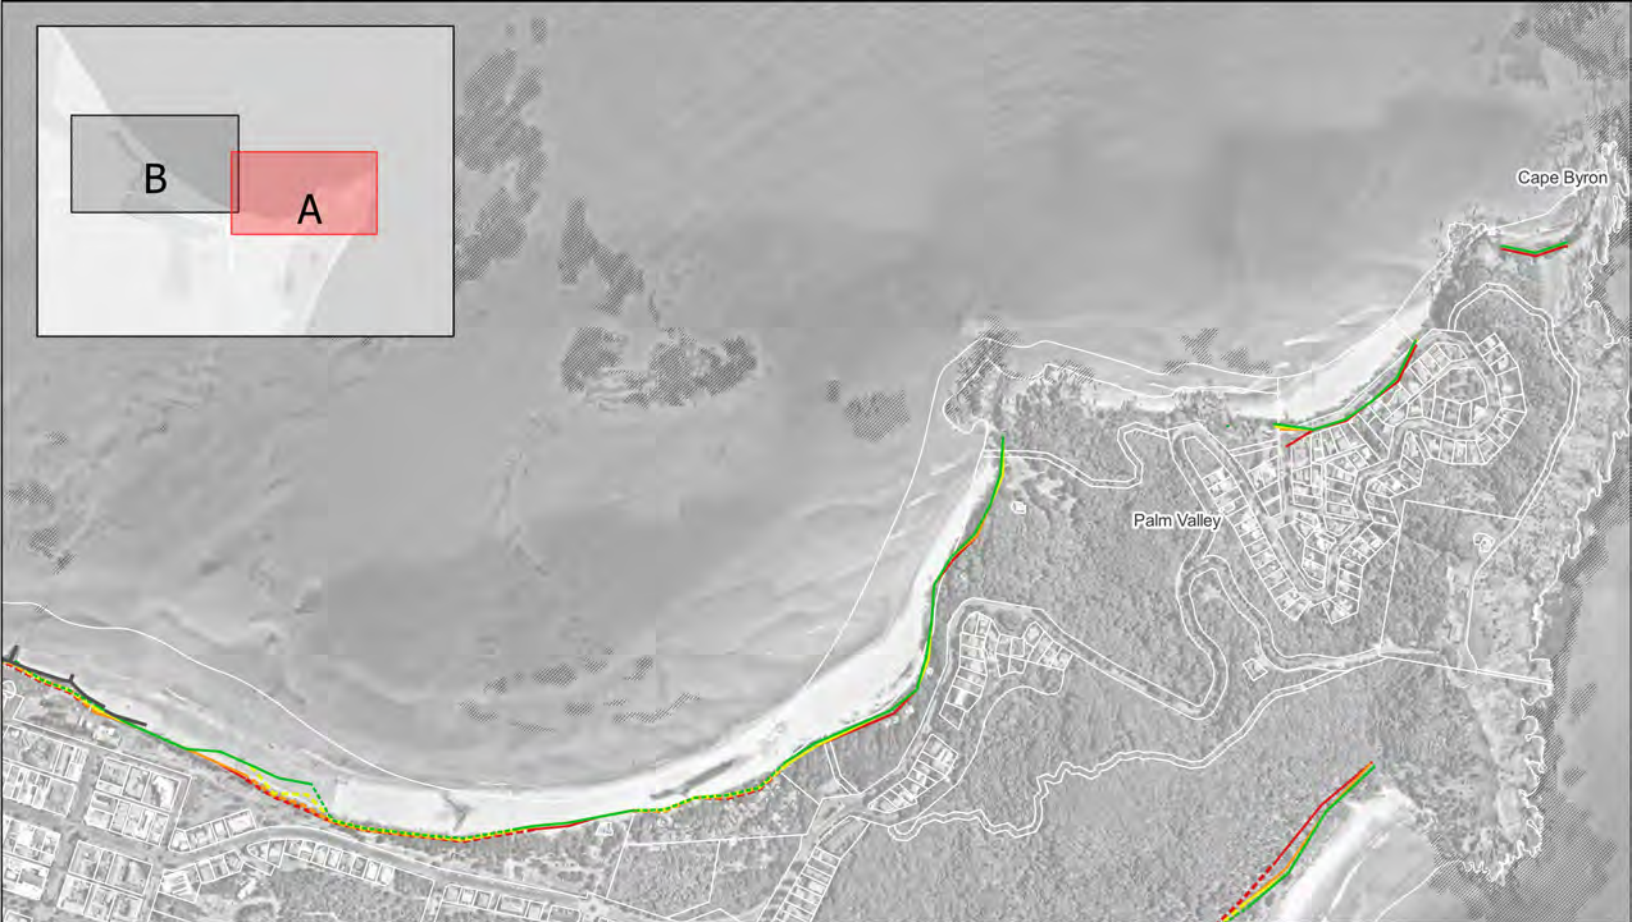
### Byron embayment – coastal inundation hazard

Wave runup limit (Rmax)

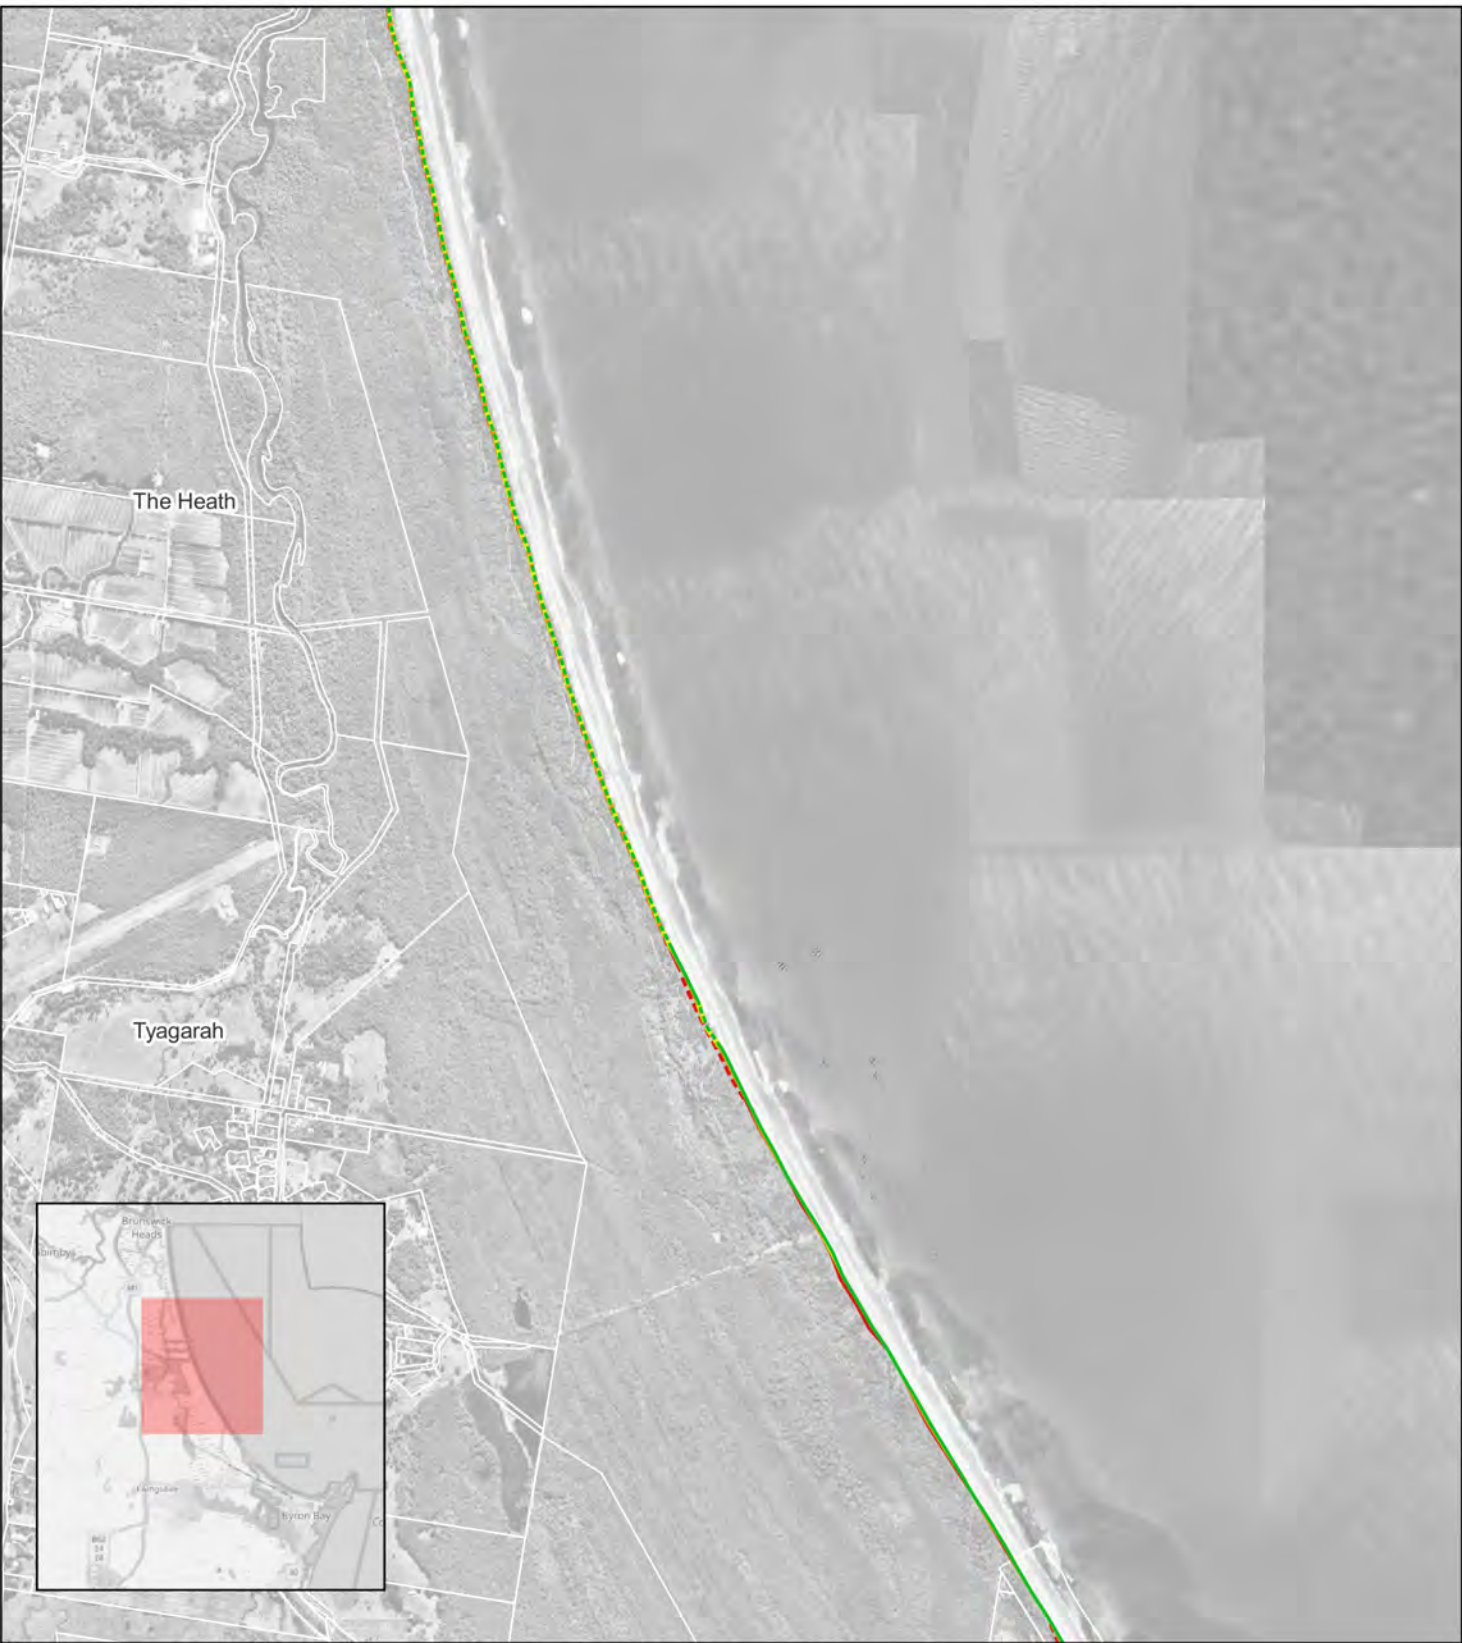
Data sources:  
 Nearmap aerial (captured 16-11-2022)  
 Topography/bathymetry 2018 LIDAR  
 MHL Nearshore Wave Data  
 Refer to main report for further details

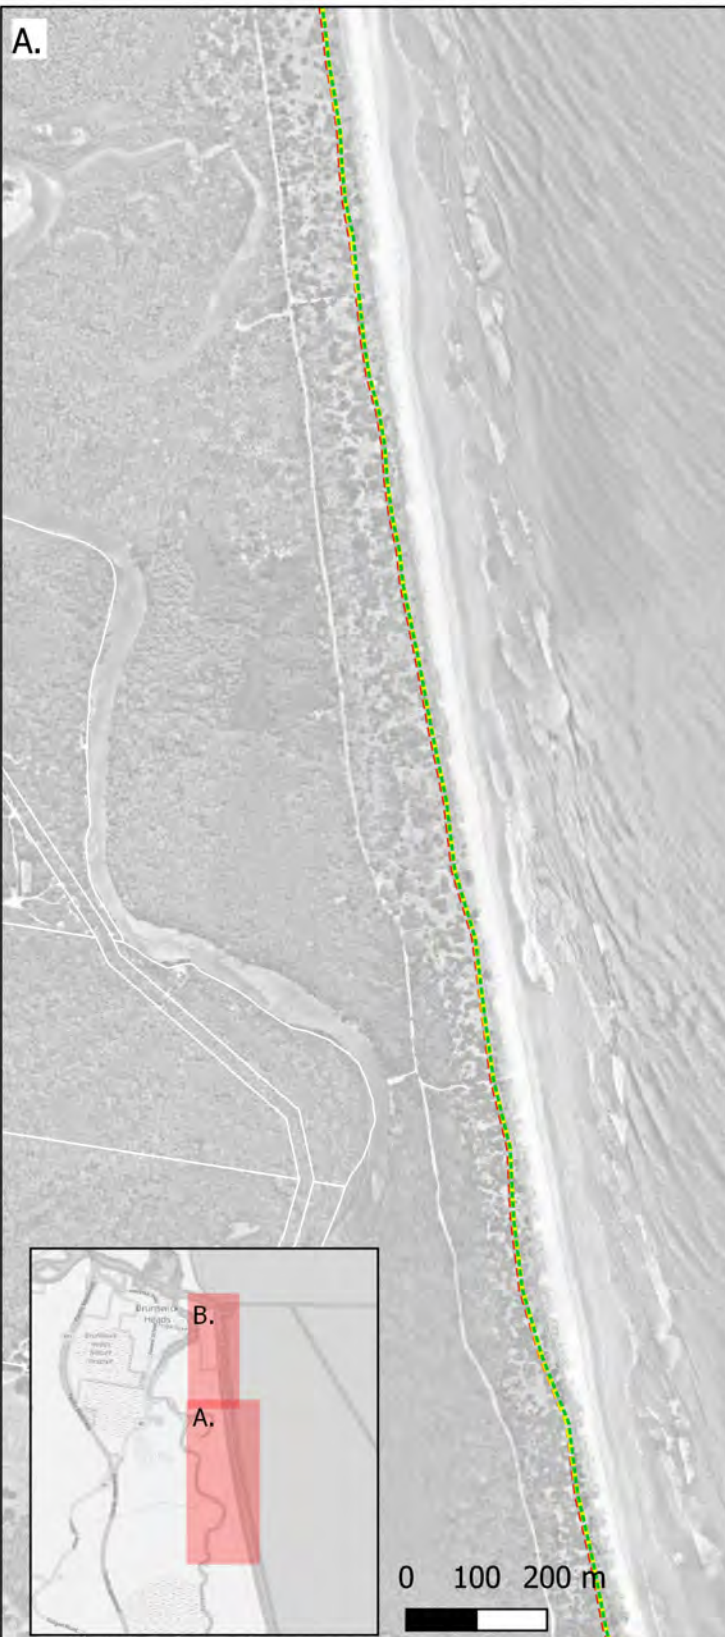
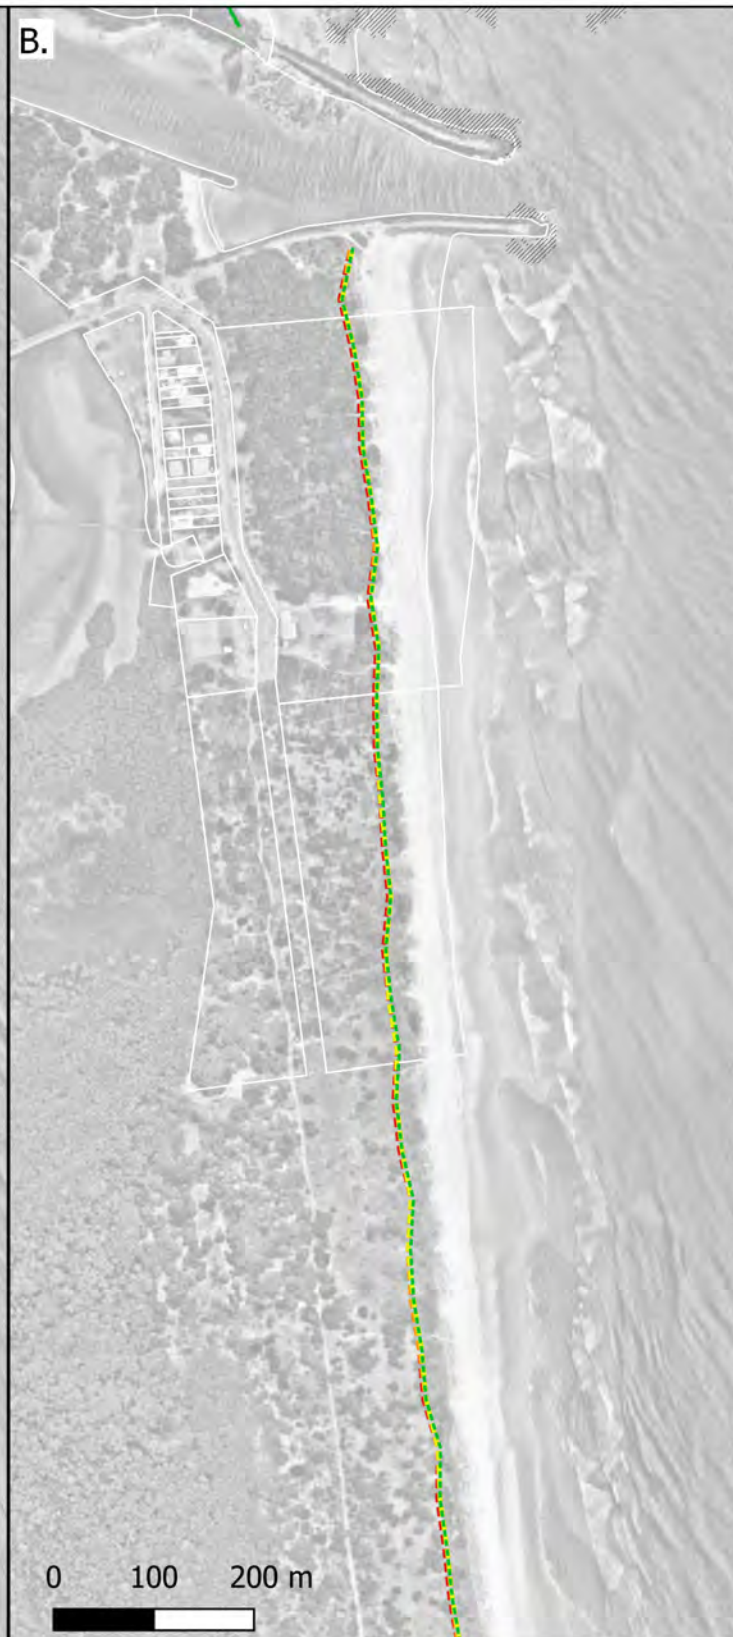
### Tyagarah Beach – coastal inundation hazard

Inundation extents based on 29-year hindcast using empirical wave runup (R2%, max) and bore propagation (overwash) formulate. Allowance for sea level rise included. No allowance for possible future changes to dune height/position.

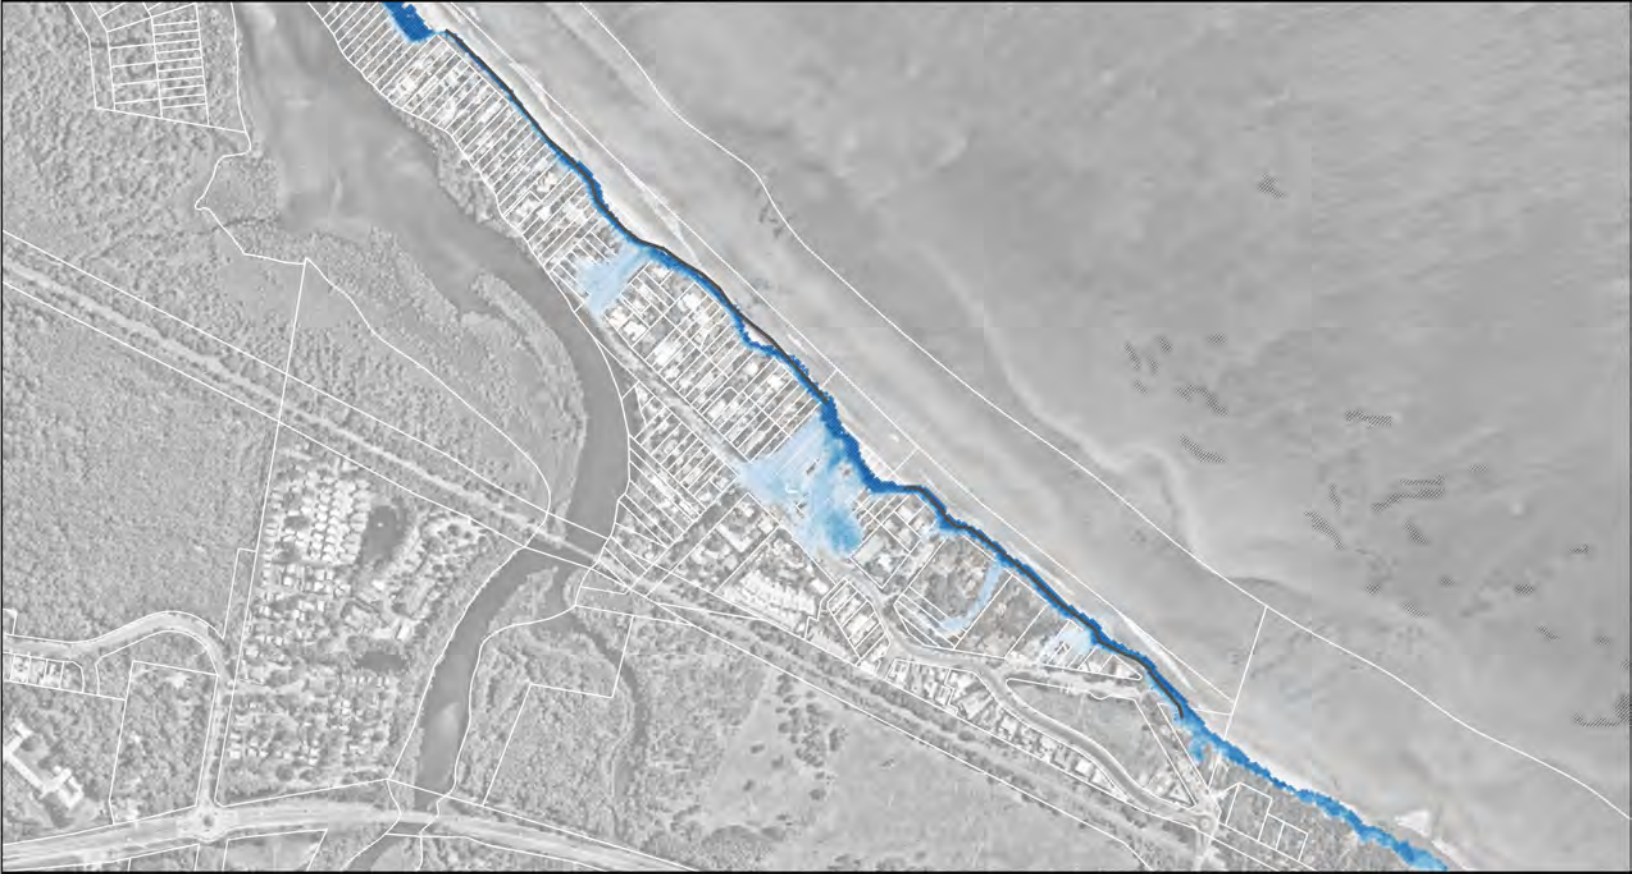
## Belongil Beach – 100-year ARI coastal inundation hazard Immediate

Maximum water depth (m)

Data sources:  
Nearmap aerial (captured 16-11-2022)  
Topography/bathymetry 2018 LIDAR  
MHL Nearshore Wave Data  
Refer to main report for further details

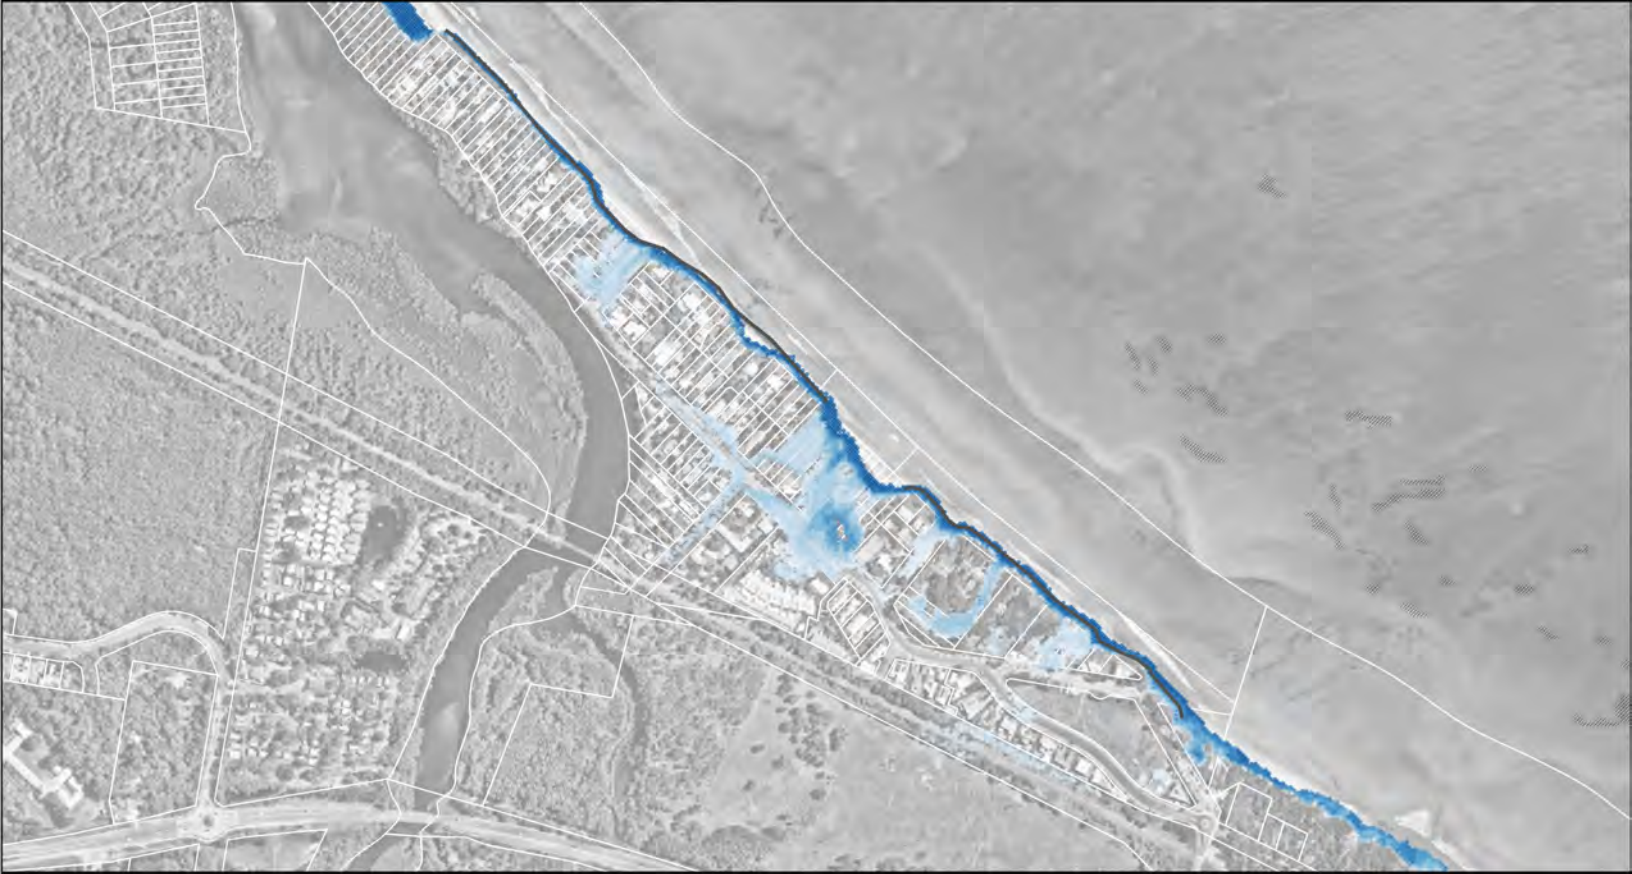
**Belongil Beach – 100-year ARI coastal inundation hazard  
2050 (SLR +0.23m)**

Maximum water depth (m)

Data sources:  
Nearmap aerial (captured 16-11-2022)  
Topography/bathymetry 2018 LIDAR  
MHL Nearshore Wave Data  
Refer to main report for further details

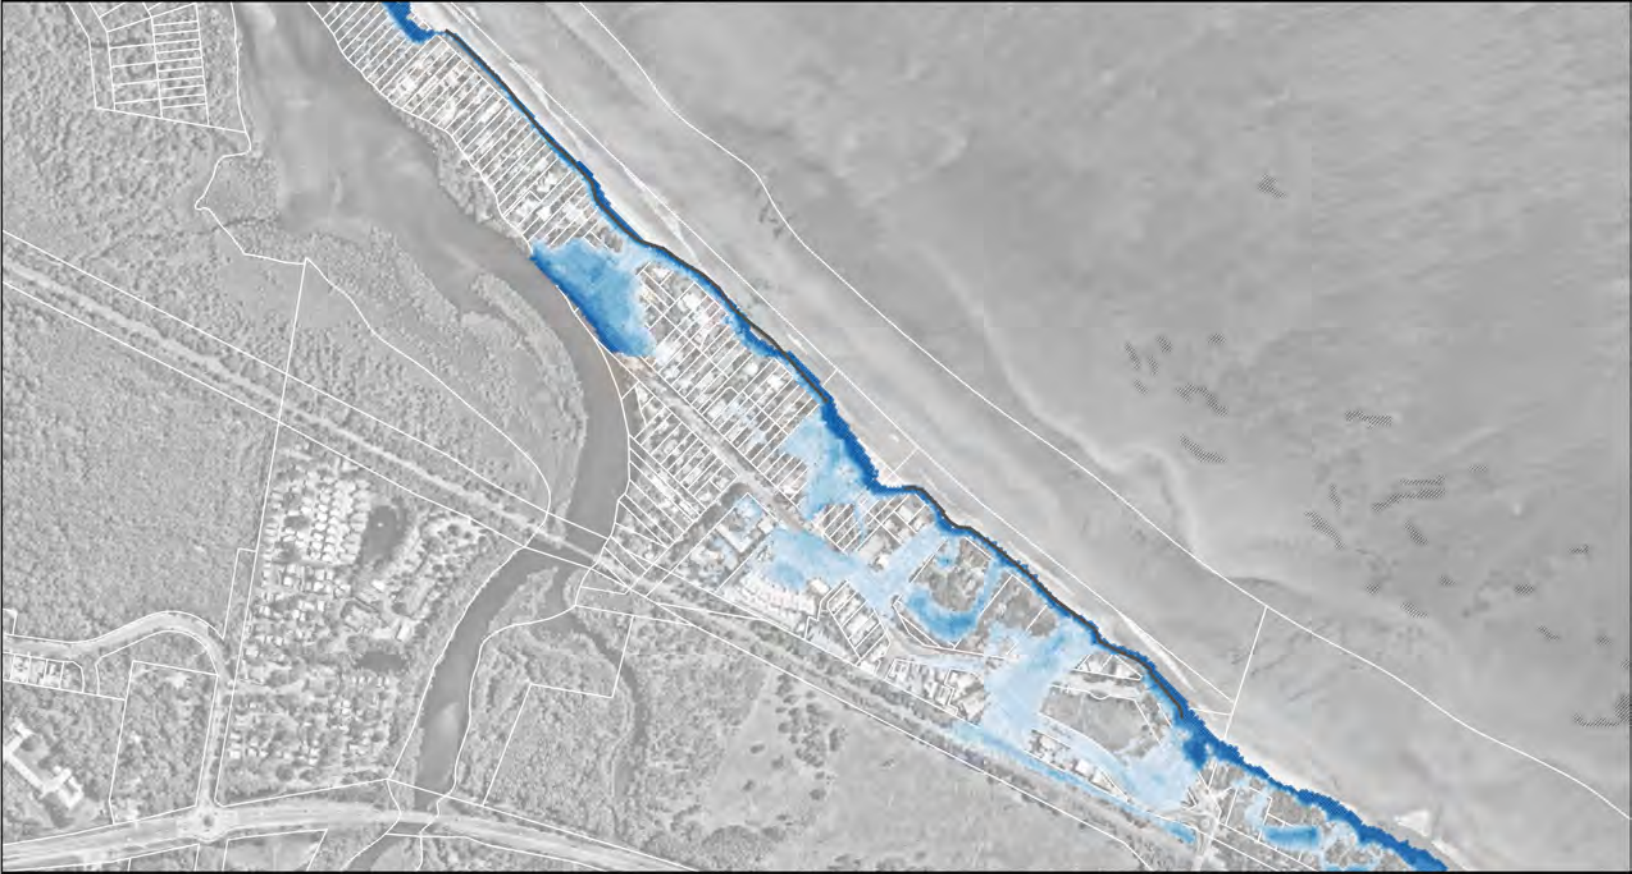
**Belongil Beach – 100-year ARI coastal inundation hazard  
2120 (SLR +0.93m)**

Maximum water depth (m)

Data sources:  
Nearmap aerial (captured 16-11-2022)  
Topography/bathymetry 2018 LIDAR  
MHL Nearshore Wave Data  
Refer to main report for further details

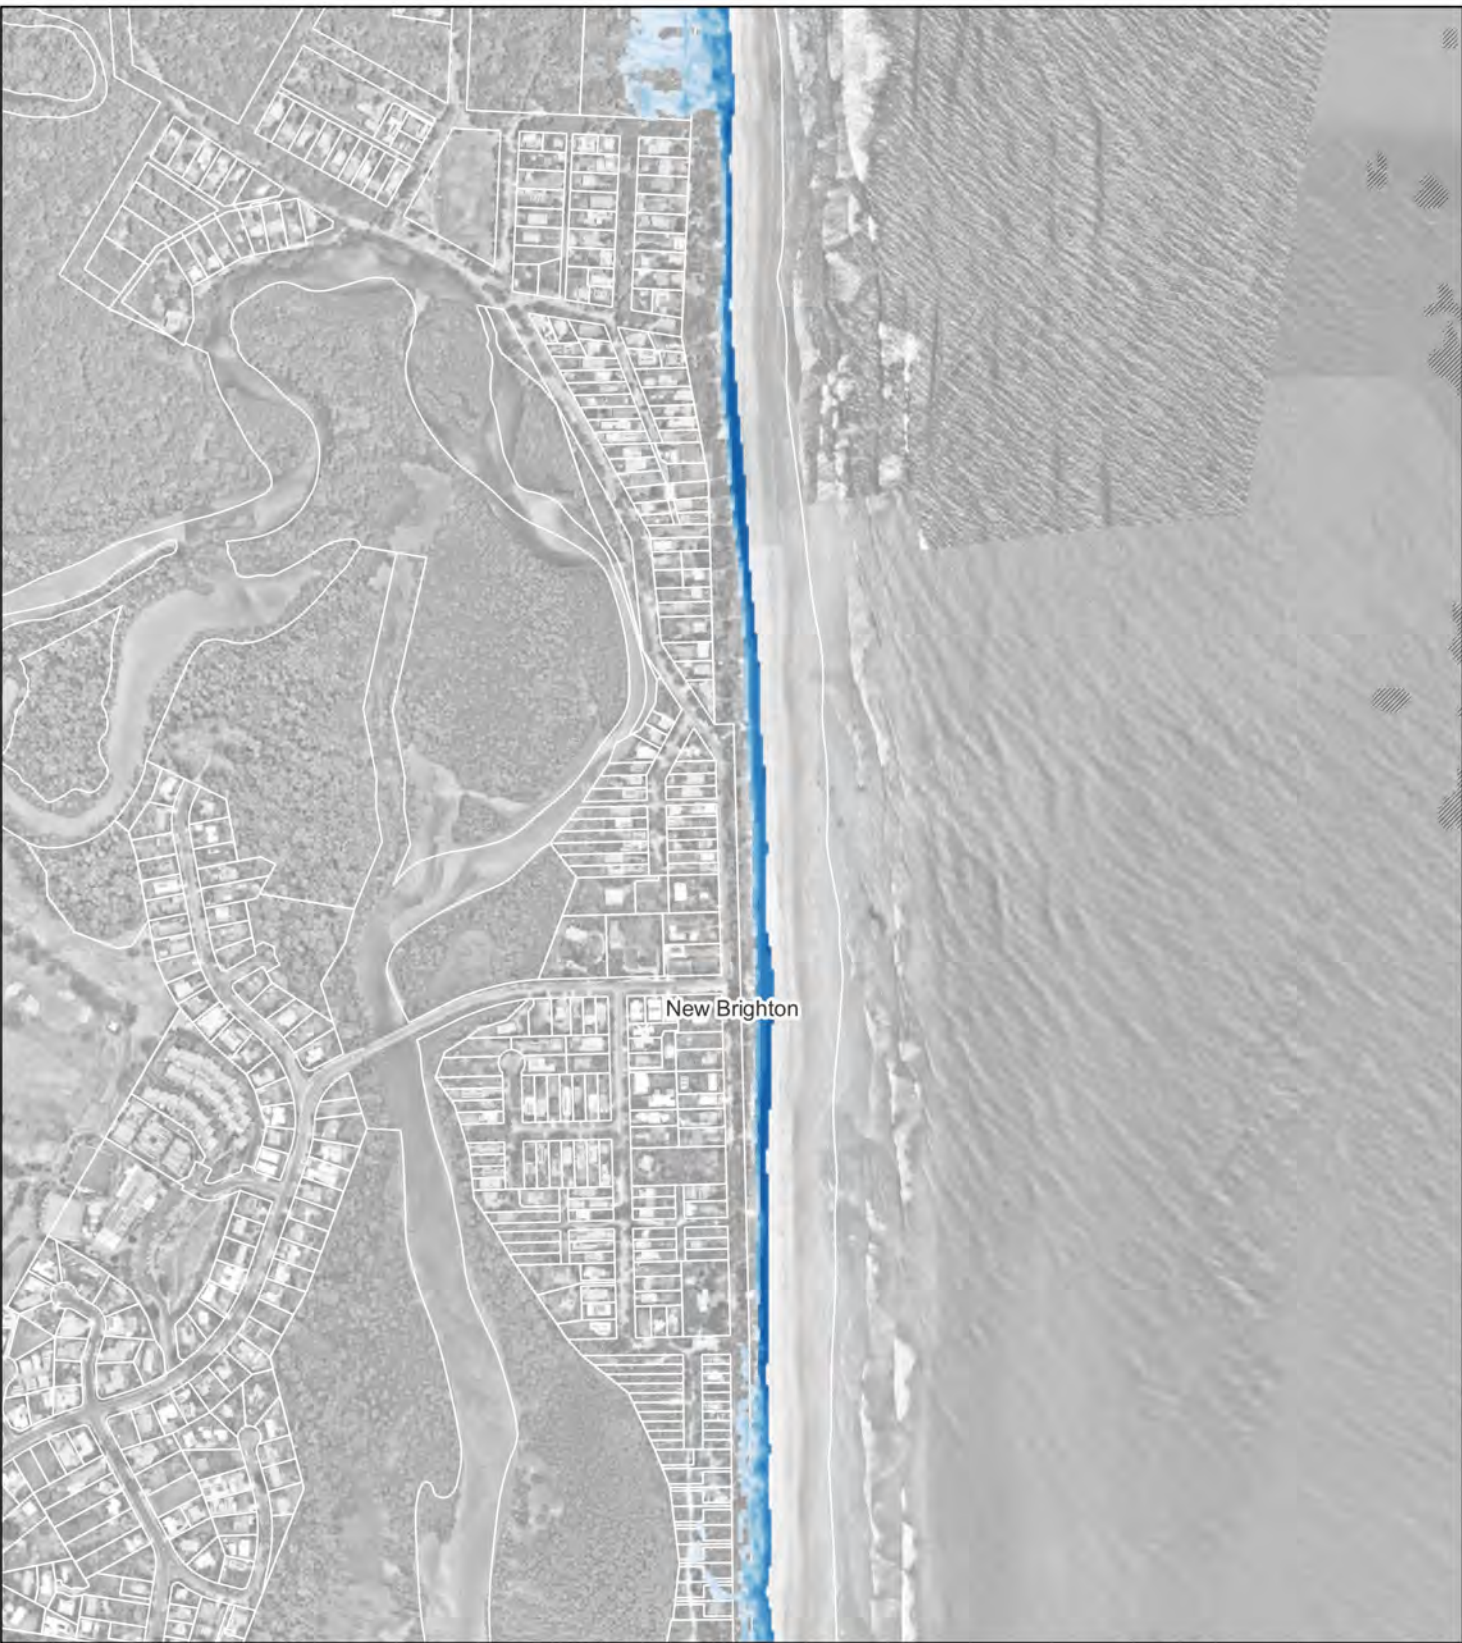
### New Brighton Beach – 100-year ARI coastal inundation hazard Immediate

Inundation extents based on detailed coastal inundation assessment using XBeach model. No allowance for possible future changes to dune height/position.
