**Byron Shire Council**

# **Byron Shire Coastal Hazard Assessment Study**

**Byron Shire CMPs Stage 2**

Report No: P19109\_ByronShireCMPs\_Stage2\_R4.00

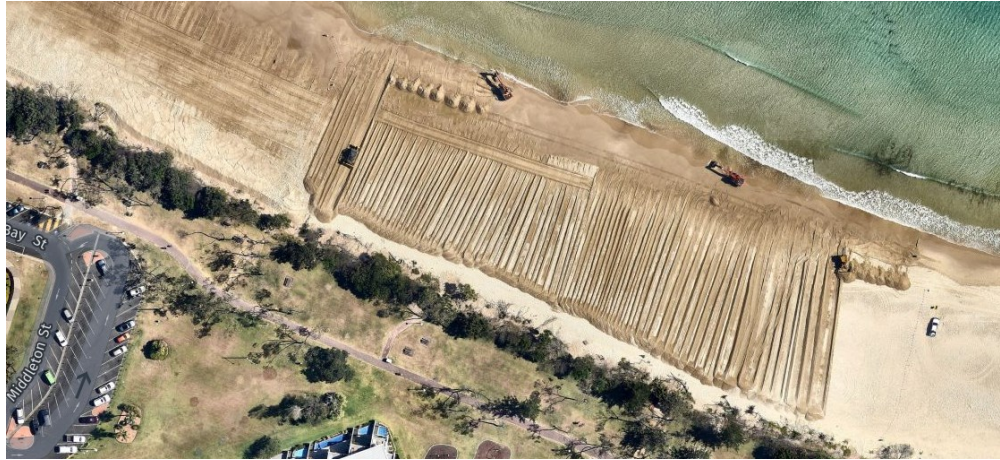
**Figure 9: Aerial photograph showing beach scraping operation at Main Beach.**

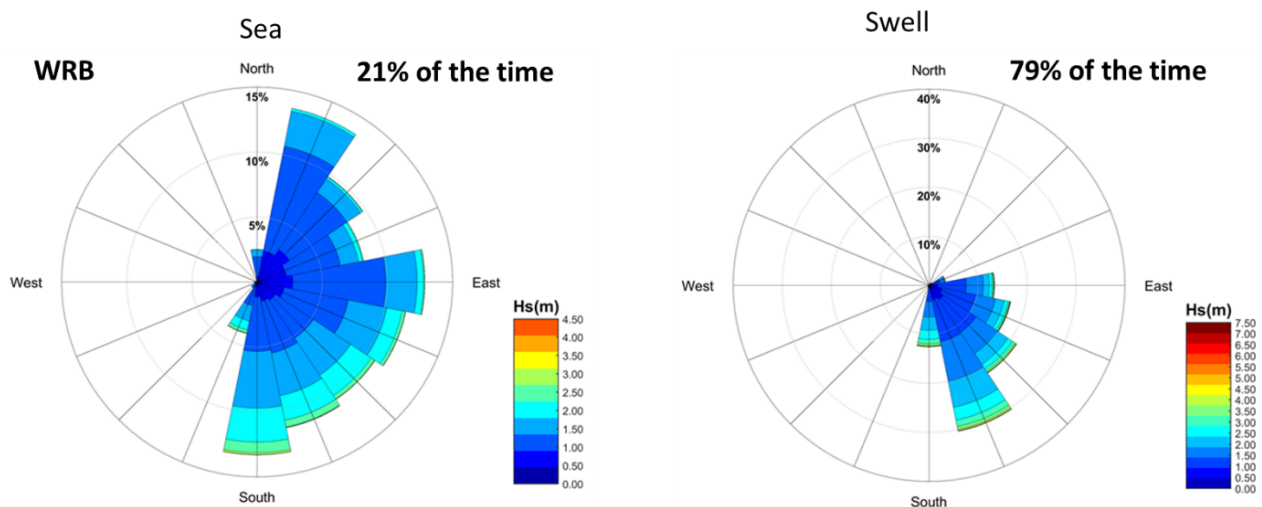
**Figure 21: Long-term wave roses for sea conditions ( $T_p < 8s$ ) and swell conditions ( $T_p > 8s$ ) at the Byron Bay Wave Rider Buoy.**

- Wave roses for sea (local sea,  $T_p < 8s$ ) and swell (swell waves,  $T_p > 8s$ ) for the Byron Bay WRB are provided in Figure 21. Swell waves dominate 79% of the time.
- The observed average as well as seasonal wave climate statistics are provided in Table 3.
- Monthly average significant wave heights and peak wave periods are presented in Figure 22.
- The joint occurrence of observed significant wave heights and peak wave directions is shown in Figure 23.

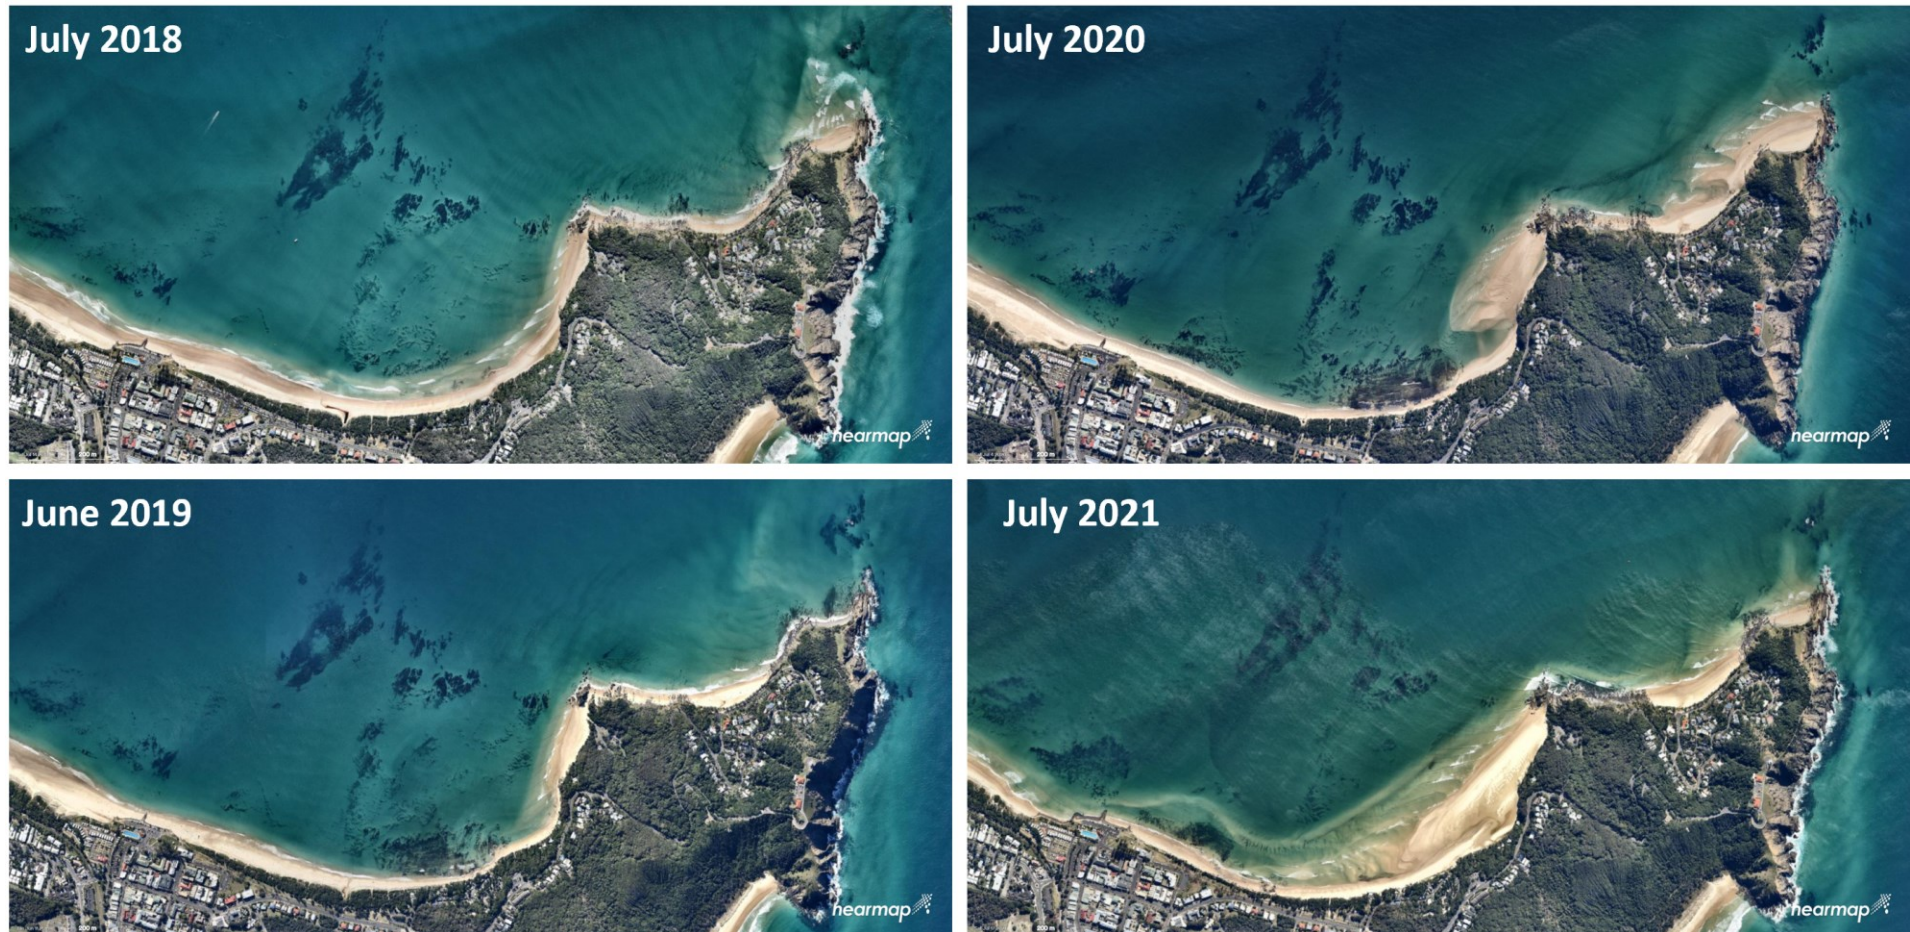
**Figure 54: Aerial imagery showing the movement of sand through the southern embayment via the littoral pathway including the prominent sand wave and spit with a rip channel in the lee of the spit (data source: Nearmap).**

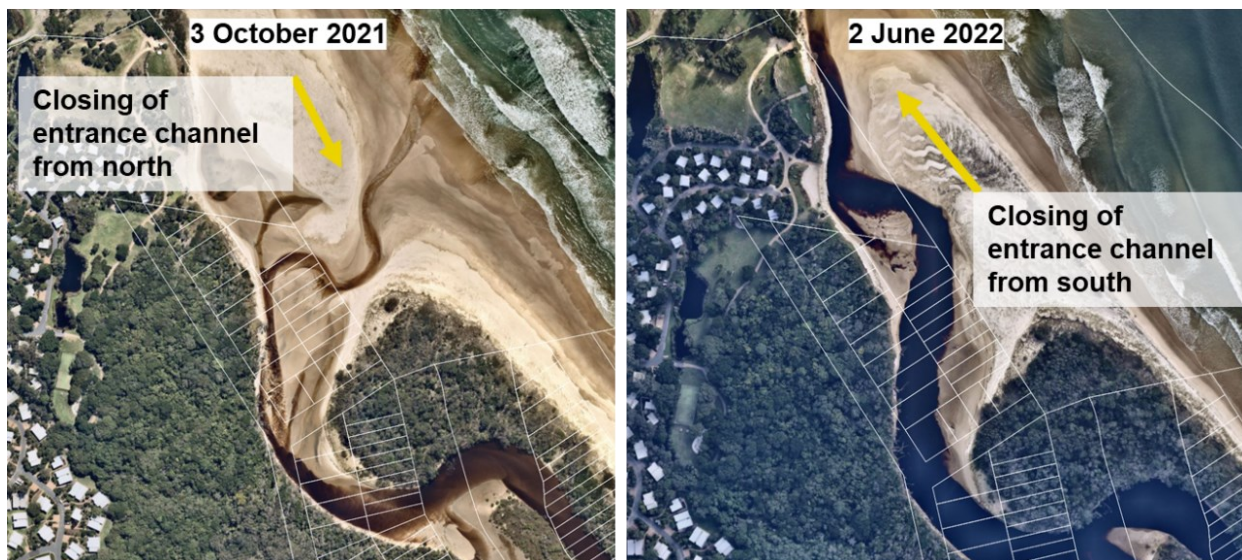
**Figure 96: Aerial photographs captured during entrance closing.**

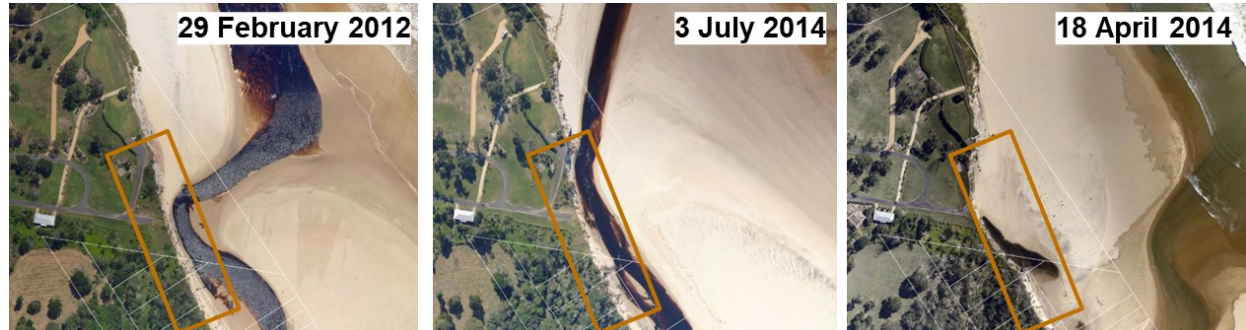
**Figure 97: Aerial photographs showing progressive erosion of northern entrance embankment at Belongil Creek prior to geotextile container revetment construction in 2015.**

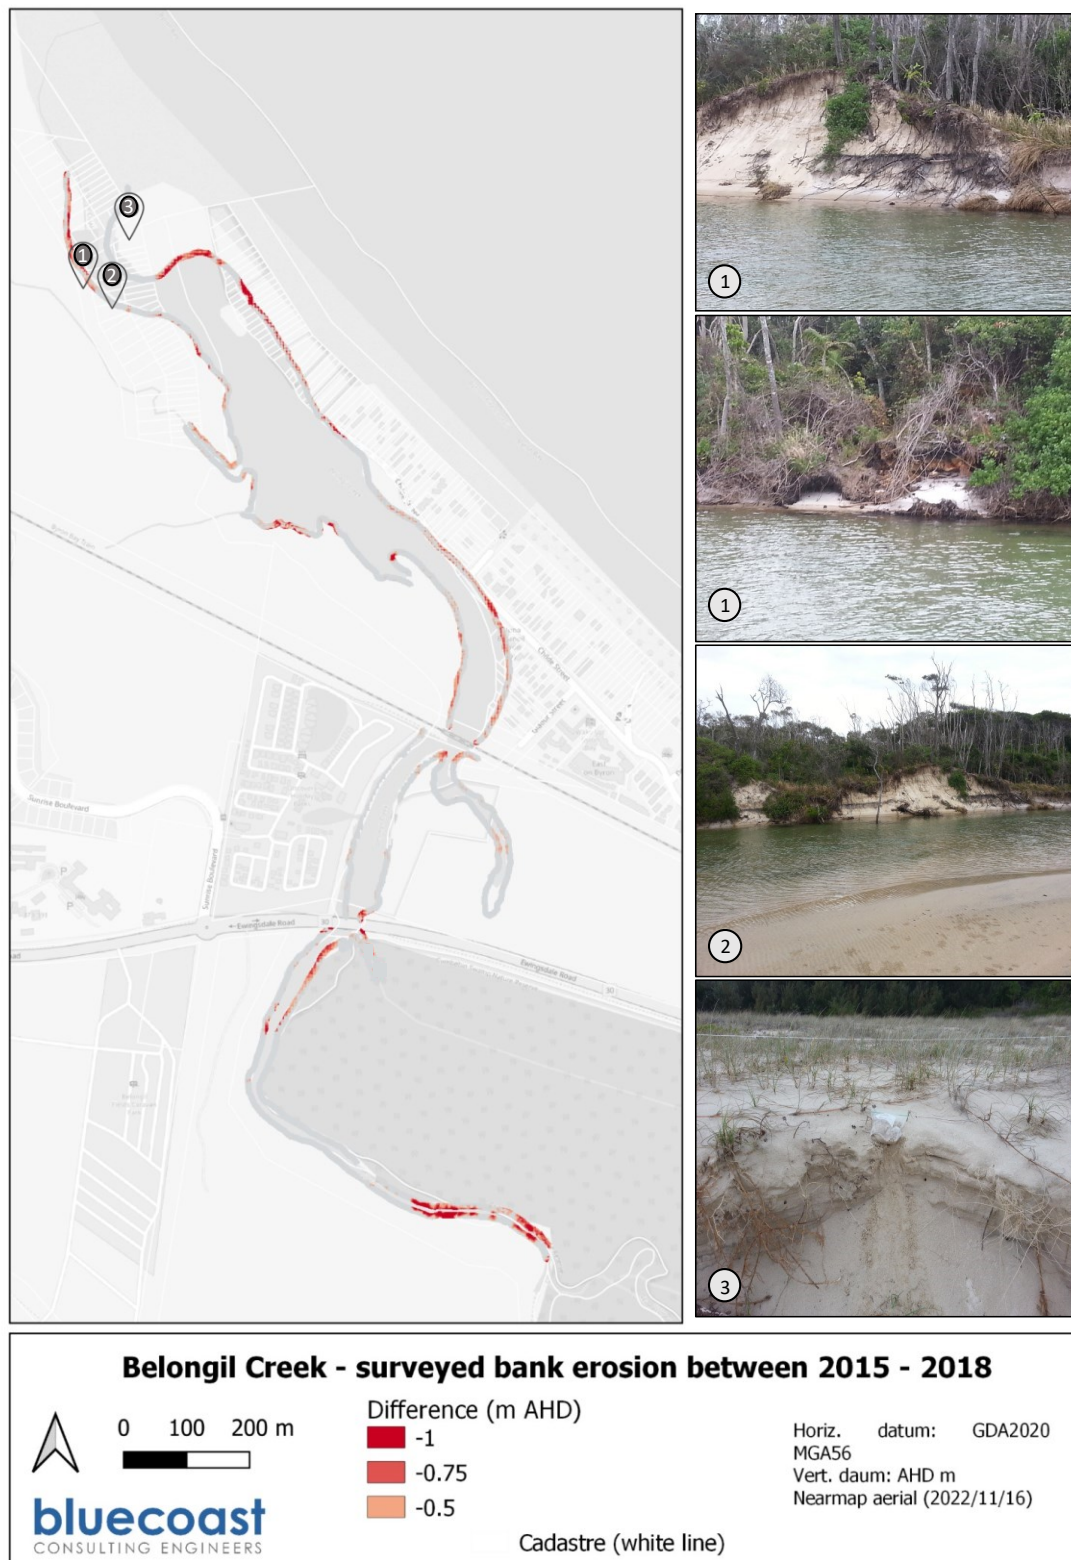
**Figure 106: Surveyed elevation changes along riparian area in Belongil Creek with photos from July 2015.**

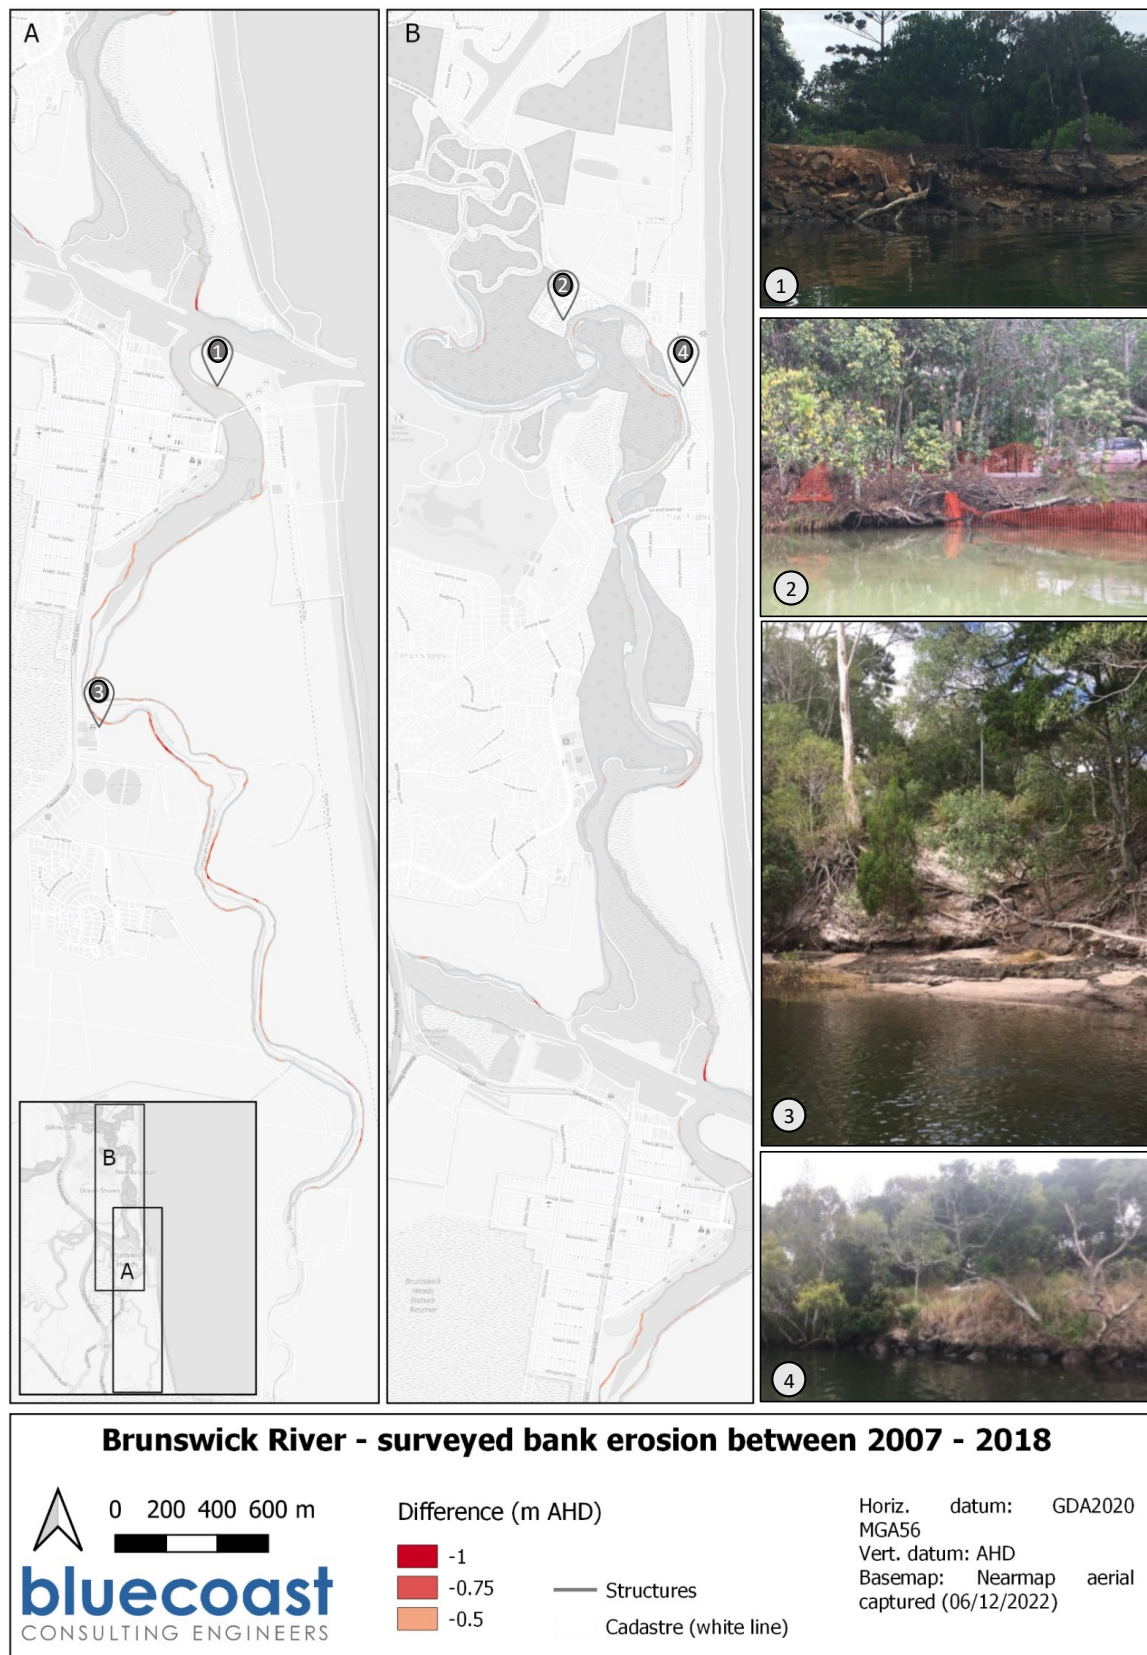
**Figure 108: Surveyed elevation changes along riparian area in the lower Brunswick River estuary with photos sourced from Byron Shire Council (2018b).**
