Marshalls Creek Foreshore Rehabilitation

Options and design report

**JOB 25-011: MARSHALLS CREEK FORESHORE REHABILITATION
OPTIONS AND DESIGN REPORT**

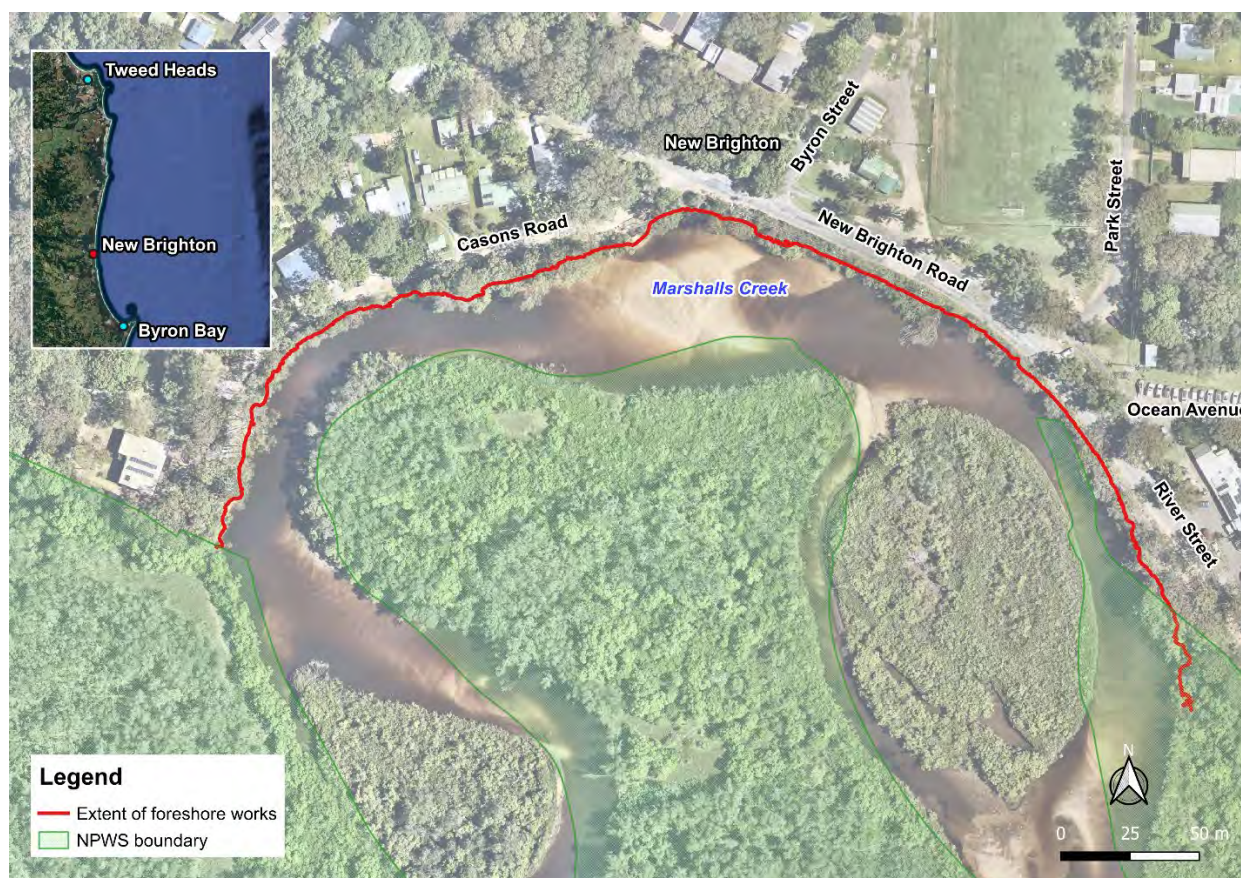
Figure 1: Study area

The study area encompasses the foreshore area of riverside land at New Brighton adjacent to Marshall's Creek (the northern arm of Brunswick River) along River Street and Casons Road. The site extends from the main grassy area opposite the store/ café on the eastern side of the creek upstream to the end of Casons Road (Figure 1).

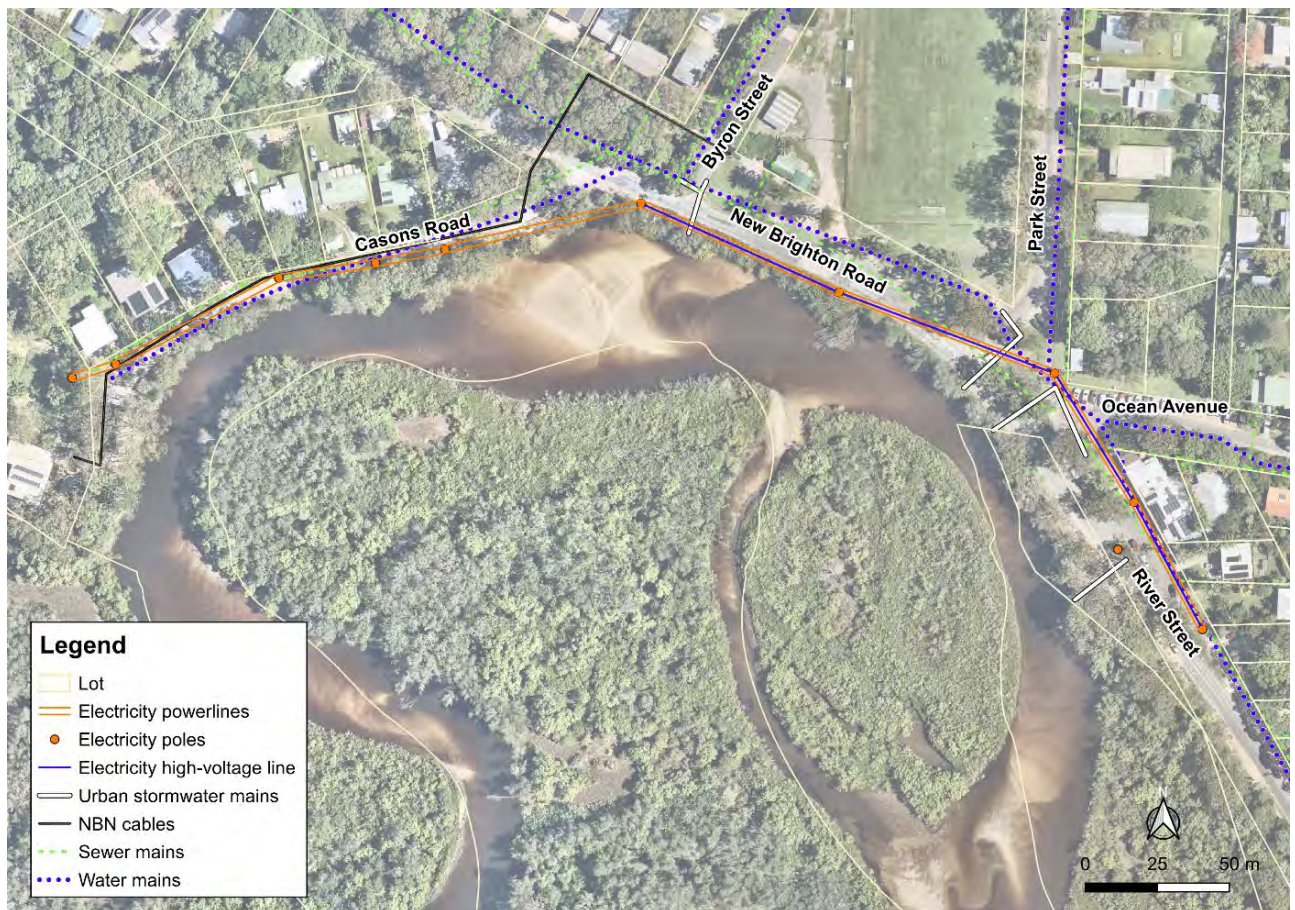
Figure 3: Public assets along the foreshore

Council assets in the precinct include stormwater, water, sewer and roads and park assets. Other public assets include power poles and telecommunications (Figure 3).

BSC reviewed the drainage in the area (specifically the stormwater pipe opposite the shops, Figure 3) and noted that the stormwater outlet and overland flow are not the main cause of riverbank erosion, which is supported by the findings in Fruition Environmental (2024).

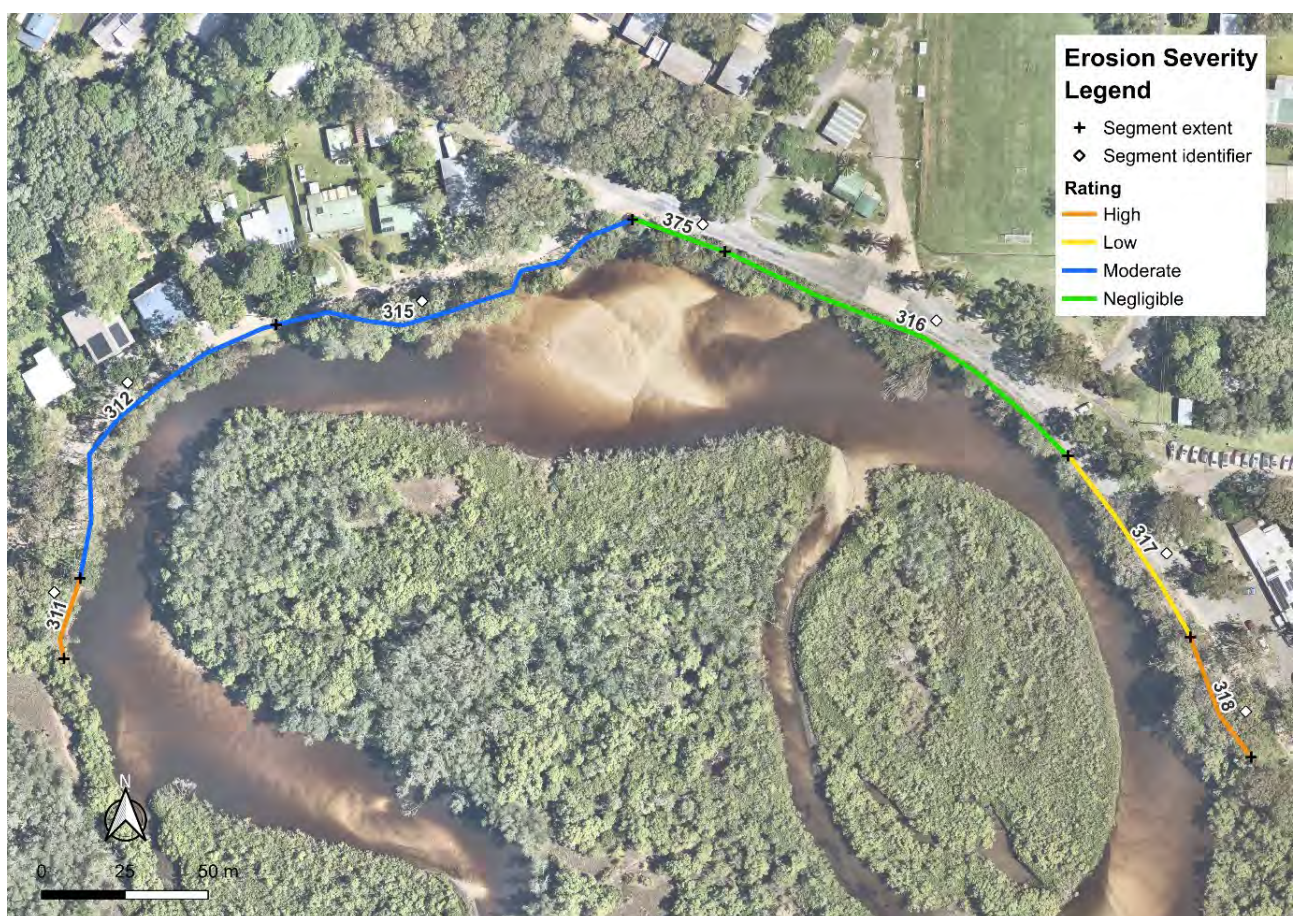
Figure 4: NEAP bank and riparian condition assessment - severity of erosion

Fruition Environmental (2024) conducted a comprehensive Bank and Riparian Assessment in 2024. The report provides an updated bank condition mapping dataset using the DST as the basis of the assessment with additional criteria related to erosion processes and riparian vegetation attributes. Key outputs for the relevant bank segments are provided in the following figures. The full report and mapping can be accessed via the NEAP Bank Resilience web page (<https://www.dpi.nsw.gov.au/dpi/fishing/estuary-asset-protection-program/riverbank-resilience>).

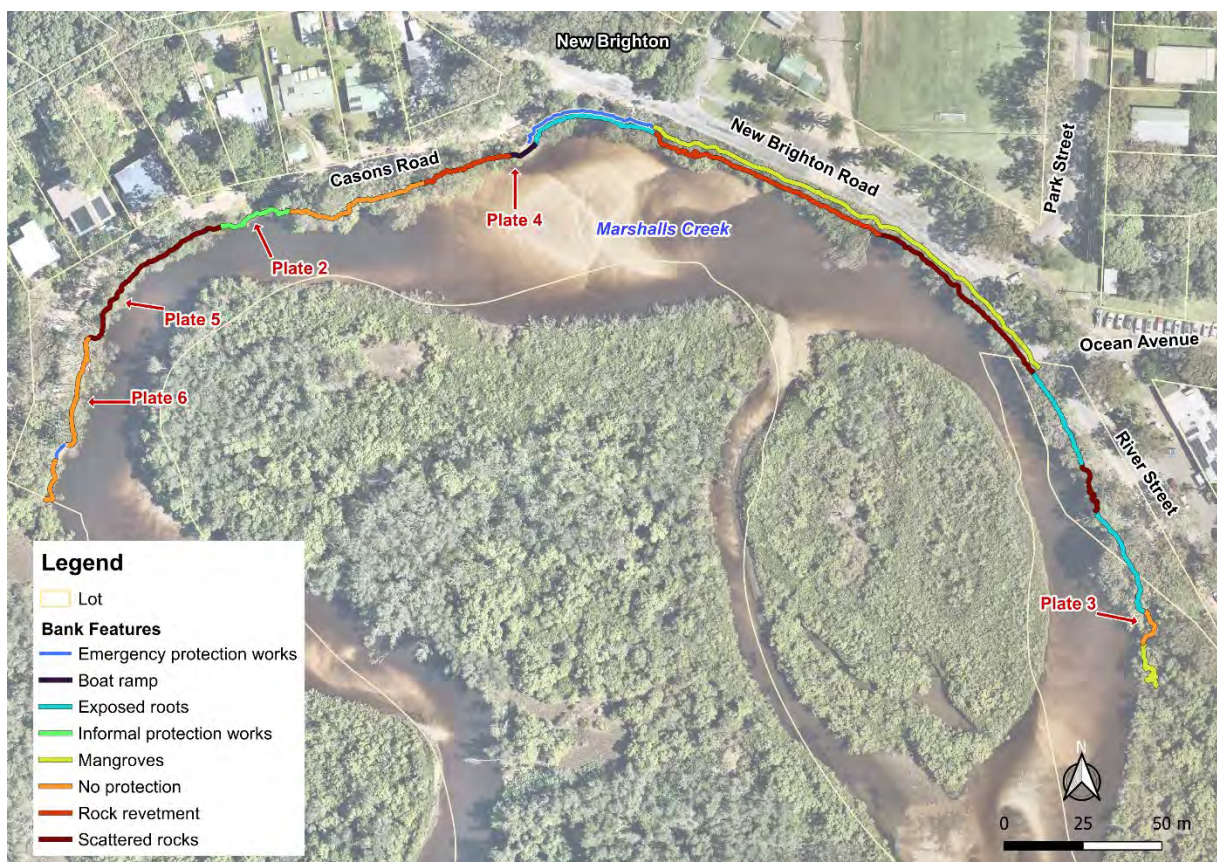
Figure 10: Existing foreshore features showing locations of Plates 2-6

Ongoing attempts have been made to control the erosion in this area including installation of coir logs, revegetation and rock armouring. Bank protection works consist of rock revetment (varying condition) and informal works (e.g. concrete, tyres) as shown in Figure 10 and Plate 2 to Plate 6.

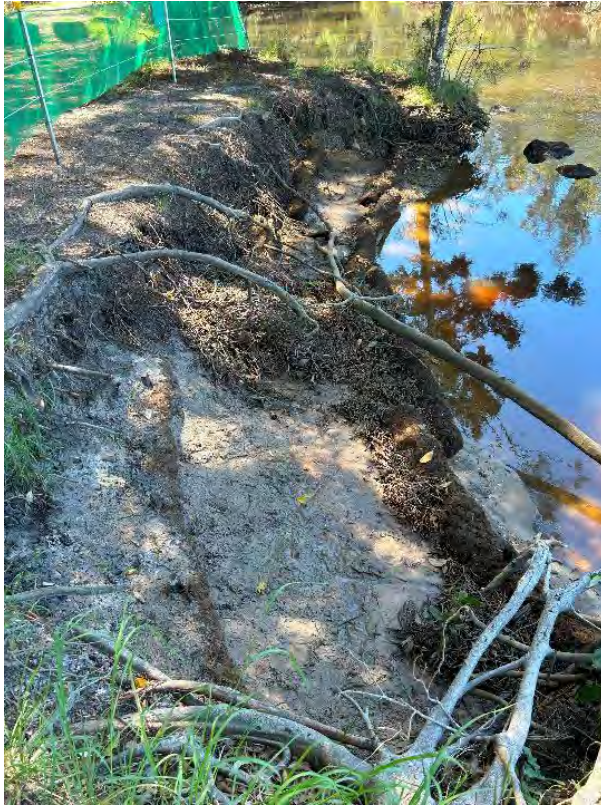
- Rope swing removed from dead branch on large tree (safety risk to people due to rock/ concrete boulders in the creek and potential fall).
- Placement of coir log to dissipate flow, mitigate further erosion, trap sediment and recruit mangroves - 4 x 3 m length of coir log (seaward) and 3 x 3 m length of coir log (landward).
- Timber stakes for anchoring coir logs.

Plate 7: Site 1 – fencing and coir logs (April 2025)

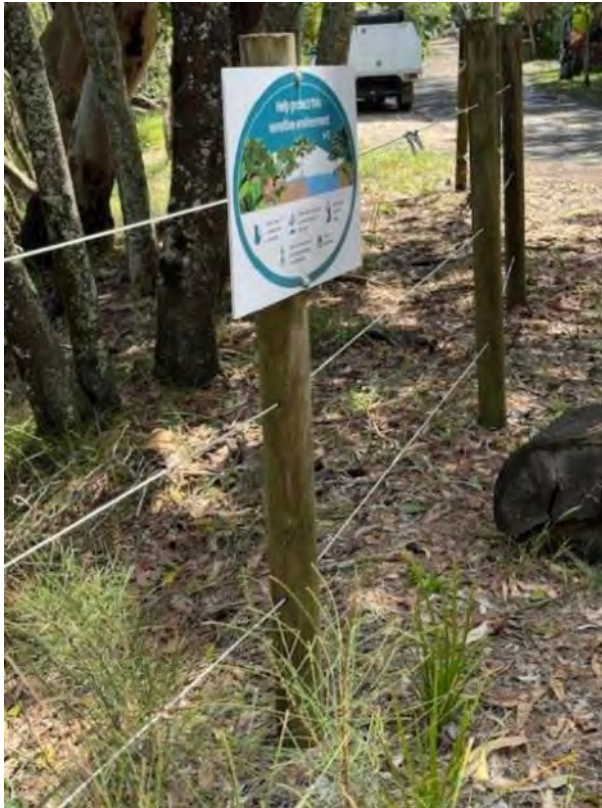
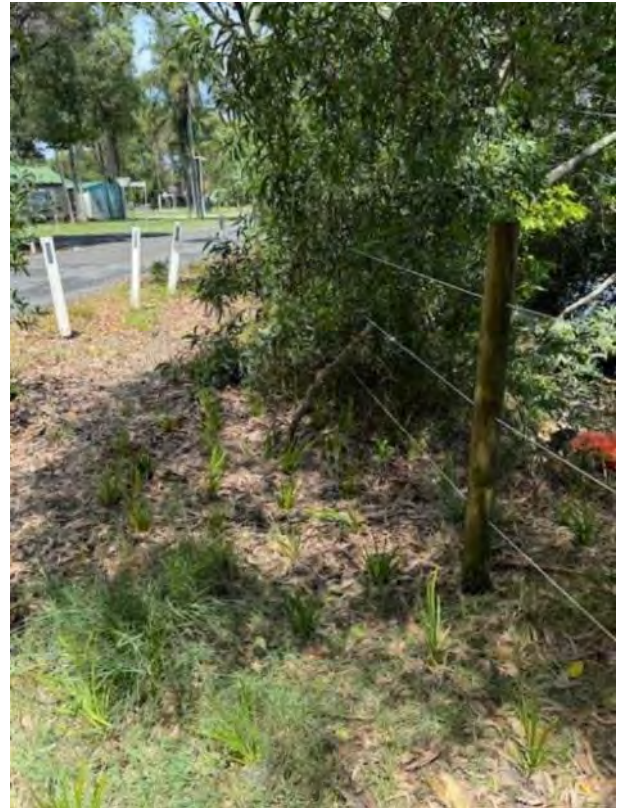
- Site 2 - the corner of Casons Road and New Brighton Road:
 - Corflute signage on existing timber fence posts, fence repairs and *Lomandra longifolia* plantings in small drainage swale to mitigate stormwater flow from road down riverbank (Plate 8).
 - Dead tree removed from upper riverbank and cut into pieces for placing into holes/ undercut areas of riverbank (Plate 9).
 - Placement of coir log to dissipate flow, mitigate further erosion, trap sediment and recruit mangroves - 3 x 3m length of coir log (downstream of dead tree) and 3 x 3m length of coir log (upstream of dead tree) with timber stakes for anchoring coir logs (Plate 10).

Plate 8: Site 2 - fencing, swale planting and signage (February 2025)

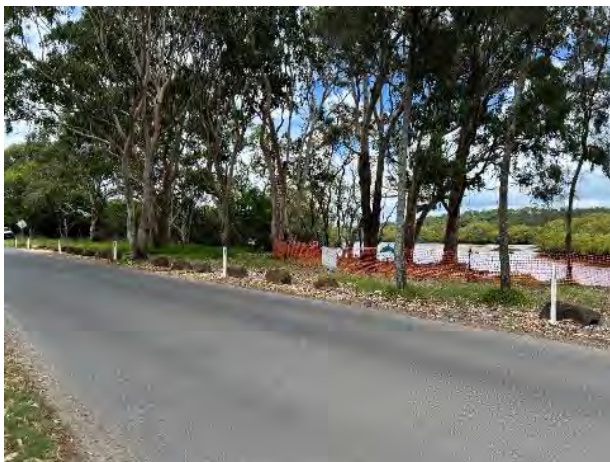
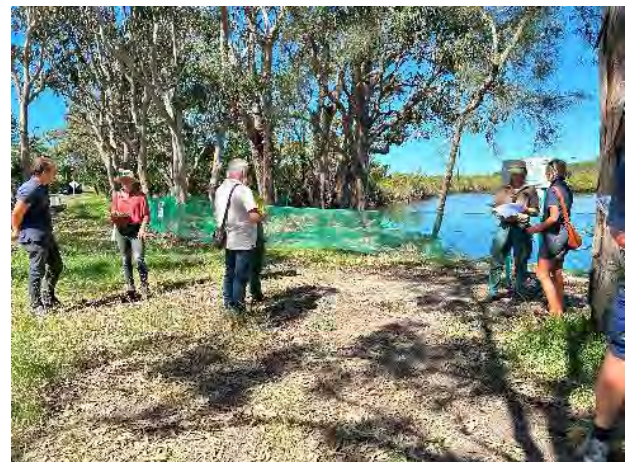
- Site 3 - road reserve opposite the post office.
 - Rock bollards to prevent parking along narrow riverbank and 'No parking' signage. Relocating existing rock bollards from picnic area closer to the road to have no parking along the entire riverbank area opposite the shops.
 - Barricading of erosion area along riverbank (Plate 11). Council completed barricading of erosion area along riverbank in January 2025 using orange plastic fencing. This fencing was replaced with star picket fencing and neat signage.
 - Removal of picnic tables and cleaning up the site.

Plate 11: Site 3 – rock barricade and fencing (April 2025)

Council completed barricading of erosion area along riverbank in January 2025 using orange plastic fencing. This fencing was replaced with star picket fencing and neat signage.

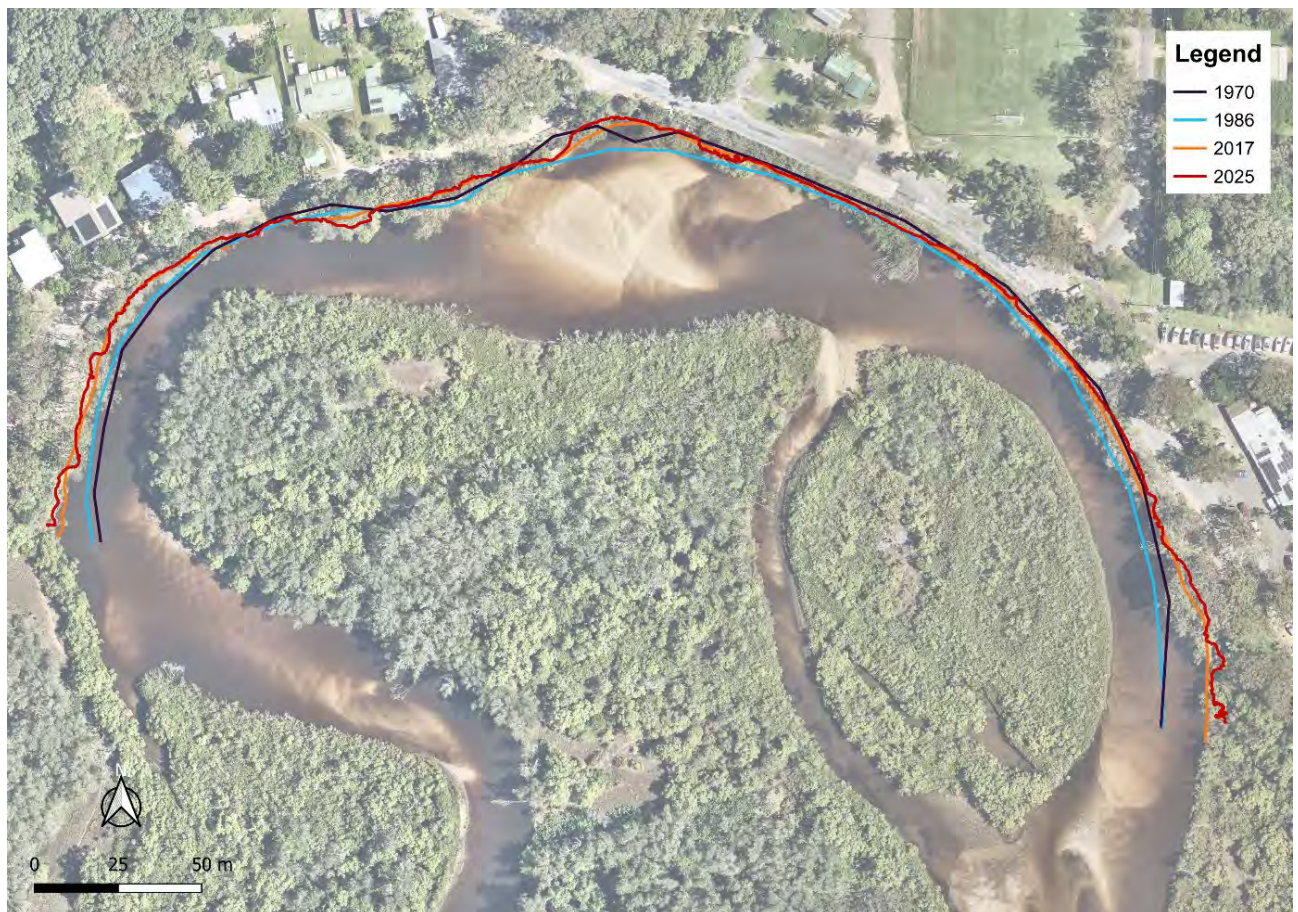
Figure 11: Historical bank transitions from 1970-2025

Figure 11 illustrates historical bank transitions between 1970 and 2025, based on digitised aerial imagery from the Historical Imagery Spatial Services. Progressive erosion and channel migration on the northern bank, with clear landward retreat over time, is evident, particularly since the 2022 flooding event. The most significant bank recession is apparent in recent years at the upstream and downstream extent of the works area and near the intersection of Casons Road and New Brighton Road.

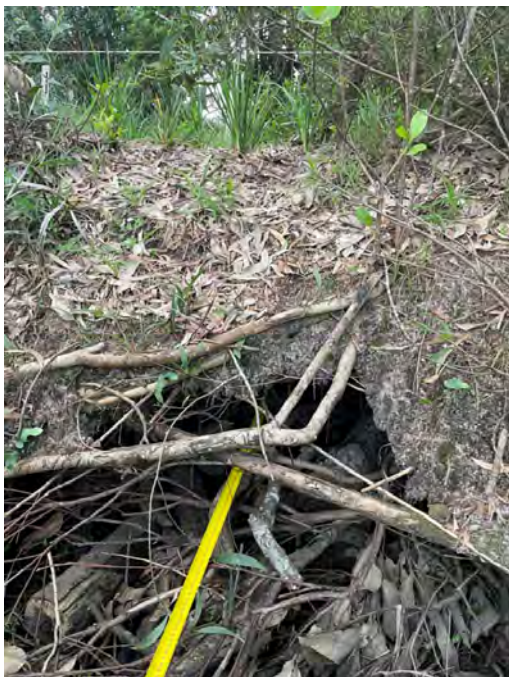
Once the creek banks become undercut, and/or the sediments supporting the toe of the bank are scoured by high flow velocities, mass failure of the bank face occurs, often exaggerated as large trees lose support and fall, thereby destabilising large areas around the root ball.

Plate 12: Undercut voids extending up to 1.5m into the bank occur along Marshall's Creek

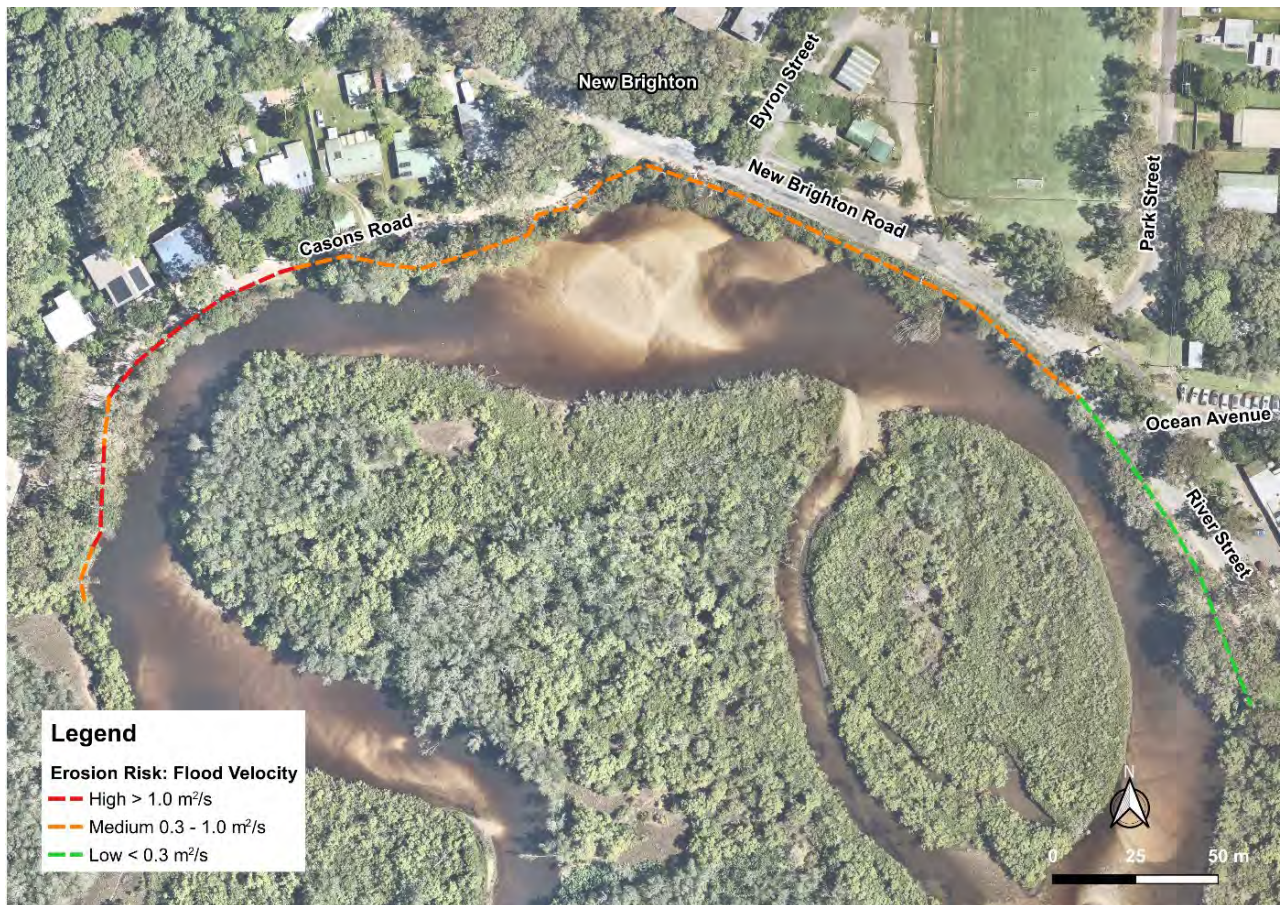
Figure 14: Erosion risk based on flood velocity x depth

modelled peak velocity x depth for 2050 for the study area indicates that approximately 60% of the outer bank is subject to medium-high peak flood velocity x depth (i.e. $0.3 - > 1.0 \text{ m}^2/\text{s}$) with two hotspots on Casons Road where erosion risk is high. Figure 14 indicates the locations where erosion risk is high, and thus bank rehabilitation methods are required to be robust to ensure protection from future flood events.

A behaviour analysis of the 2022 flood event in the Brunswick River (WMAwater, 2024, provided by BSC) found that the February 2022 flows at Orana Bridge on Marshall's Creek, approximately 4 km downstream of the confluence of Marshall's Creek and Yelgun Creek, were between the 2% and 1% average exceedance probability (AEP, equivalent to the 100-year ARI) flood flows based on flood frequency analysis. The behaviour analysis found that the Marshall's Creek system is characterised by a complicated interaction between Yelgun, Mooball and Marshall's Creeks and the flood may have been a lower AEP in the Marshall's Creek system. Based on this information, the 1% AEP flood velocity has been adopted as the design flood for this project.

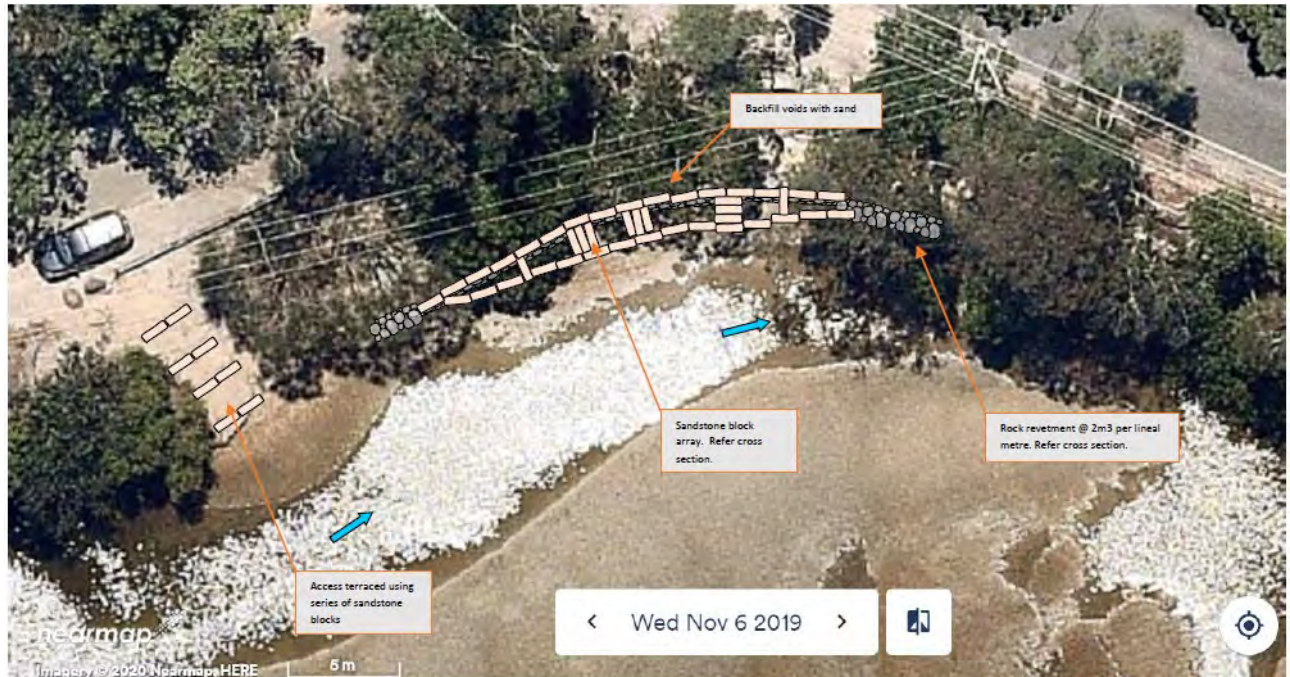
Figure 15: Site action plan (2019)

Soil Conservation Service (2019) provided a concept plan for stabilisation works at the corner of Casons Road and New Brighton Road (Figure 15 to Figure 17) as part of a Habitat Action Grant application which did not proceed.

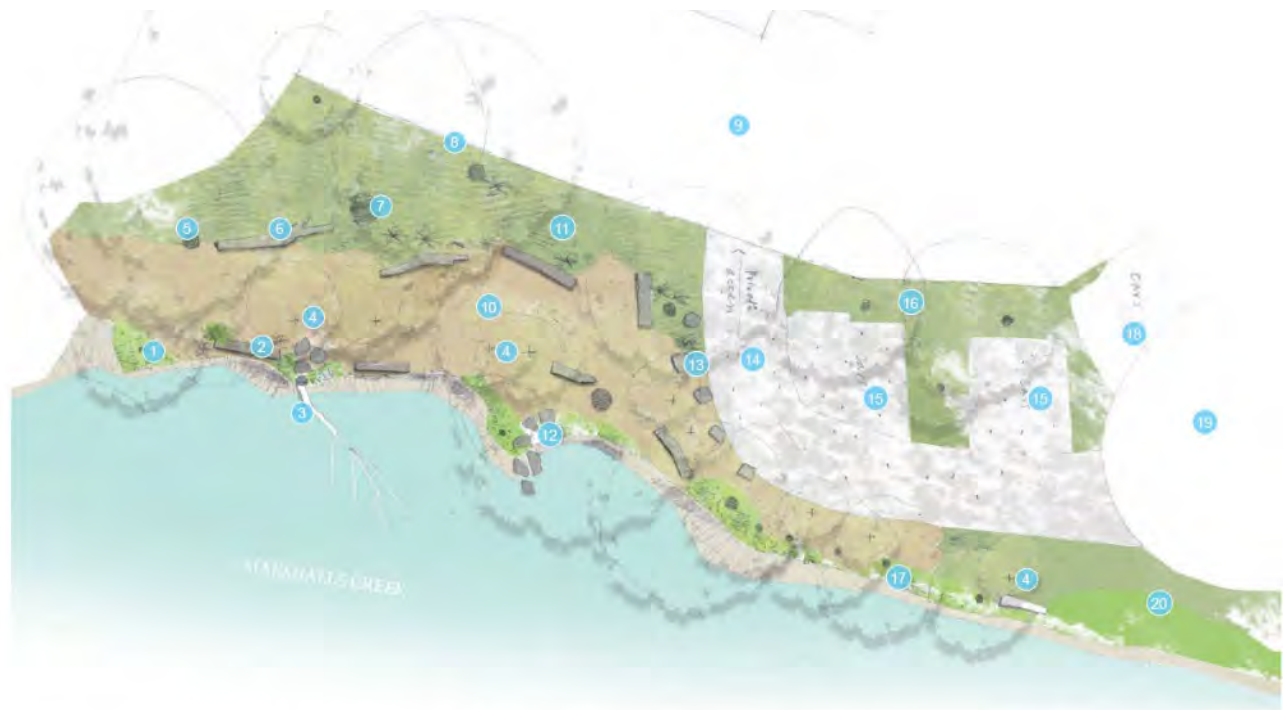
Figure 18: Casons Road sector sketch plan and concept

Council engaged Plummer and Smith (2020) to prepare some landscape concepts to provide images demonstrating how the road reserve and waterway could be repurposed to improve open space public use, amenity and environmental values including (Figure 18).

1. Areas of existing creek edge vegetation to be protected and extended where possible
2. Natural log elements provide informal furniture elements and can be utilised to limit access to particularly vulnerable creek edge areas

5. Existing trees to be retained
6. Natural logs provide casual seating and loosely define garden edges
7. Existing Fig tree to be retained
8. Existing timber fence

9. Private residence
10. Informal (and small) open spaces along the creek edge- mulch and sand surface with small moments of planting where possible
11. Garden areas- weed species to be removed and replaced with appropriate locally native species

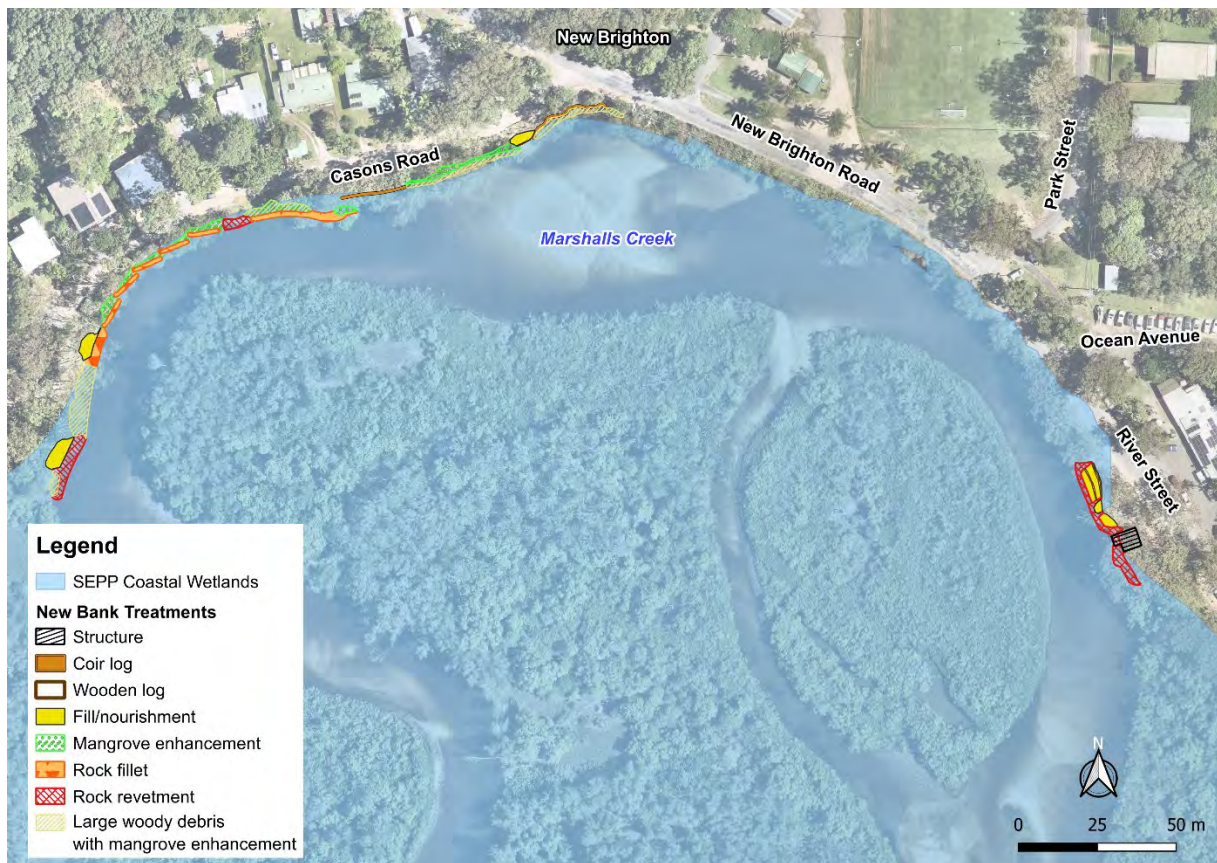
Figure 23: Proposed bank treatment work area and coastal wetlands mapped under the Resilience and Hazards SEPP 2021

The intertidal components of the proposed foreshore rehabilitation measures are located on land mapped as coastal wetlands (Figure 23). The proposed rock revetment (segment B coastal protection works) is located wholly within the mapped coastal wetlands.

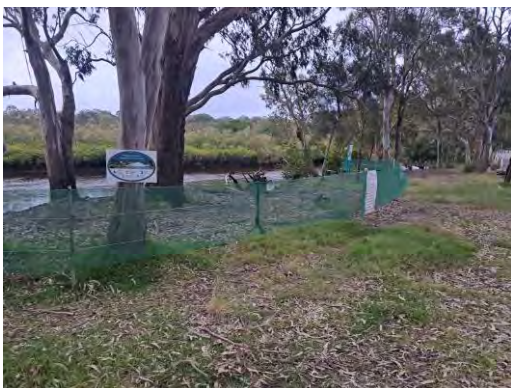
Figure 4: Site Conditions at P – S on Figure 1 on the drawings provided

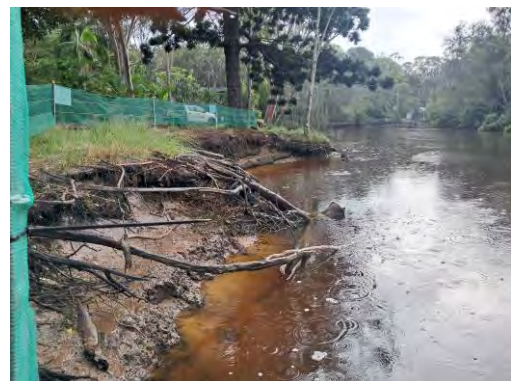
Figure 5: Site Conditions at A and B on Figure 1 on the drawings provided
