Vegetation Management Plan

Main Beach and Clarkes Beach Dune Recovery Byron Bay

Byron Shire Council

8 November 2022

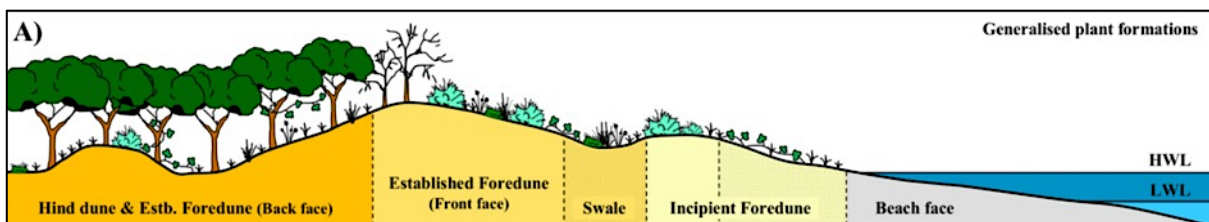
Figure 1: Illustration of dune surface zones (Source: Dune Rehabilitation Plan Clarkes Beach 2019)

The project will involve 'beach scraping' which involves moving, via mechanical means, small volumes of sand, in the context of annual littoral transport volumes, and 'dune reprofiling'. Sand is harvested from the swash zone and lower part of the beach to the back of the beach to help reinstate the frontal and incipient dune (Figure 1).

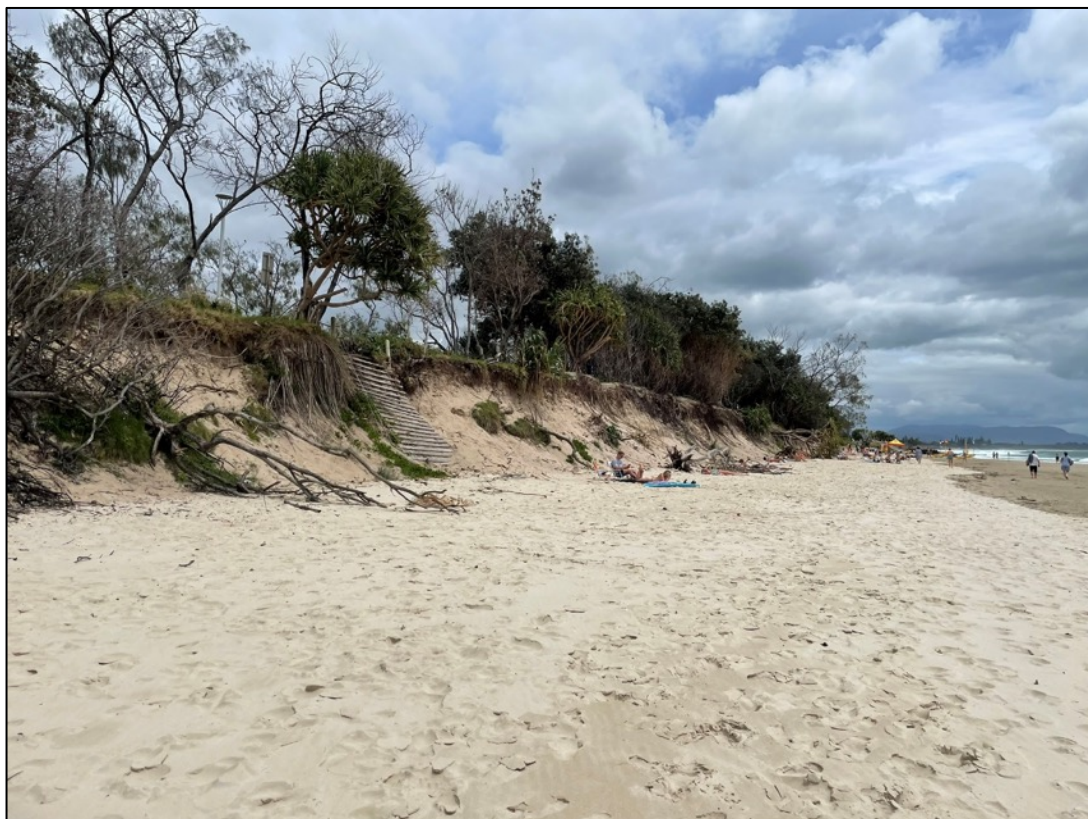
Plate 1: Dune scarping evident at the site.

Erosion under this walkway will be addressed through accessway closure.

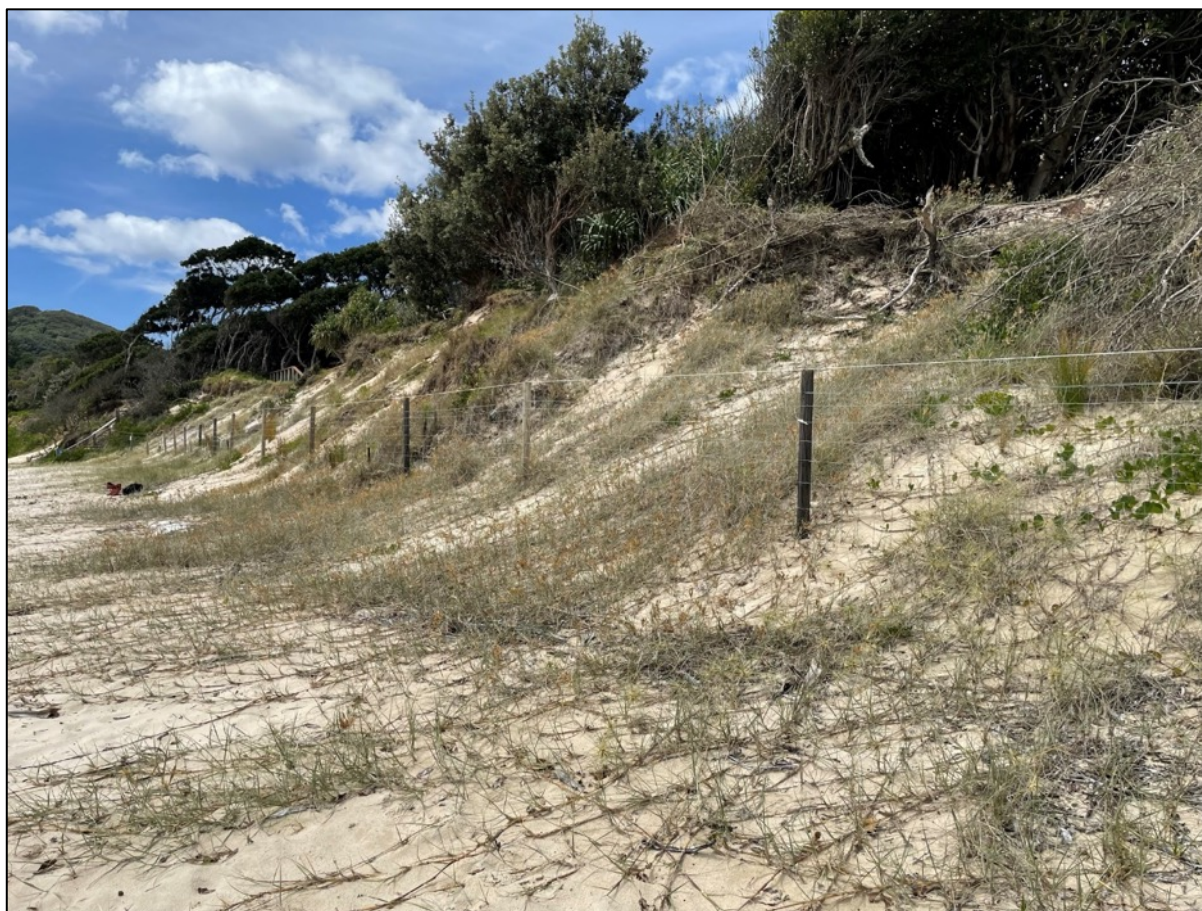
Plate 2: Revegetated dunes to the east of the site.

Zone 1 is the incipient and foredune area where the beach reprofiling and beach scraping will be taking place. The erosion is severe and has resulted in significant loss of sand from the beach and frontal dune, as well as significant loss and damage of dune vegetation (Plates 2 and 3). The aim of the revegetation in Zone 1 is to recreate the incipient dune with dune grasses and creepers.

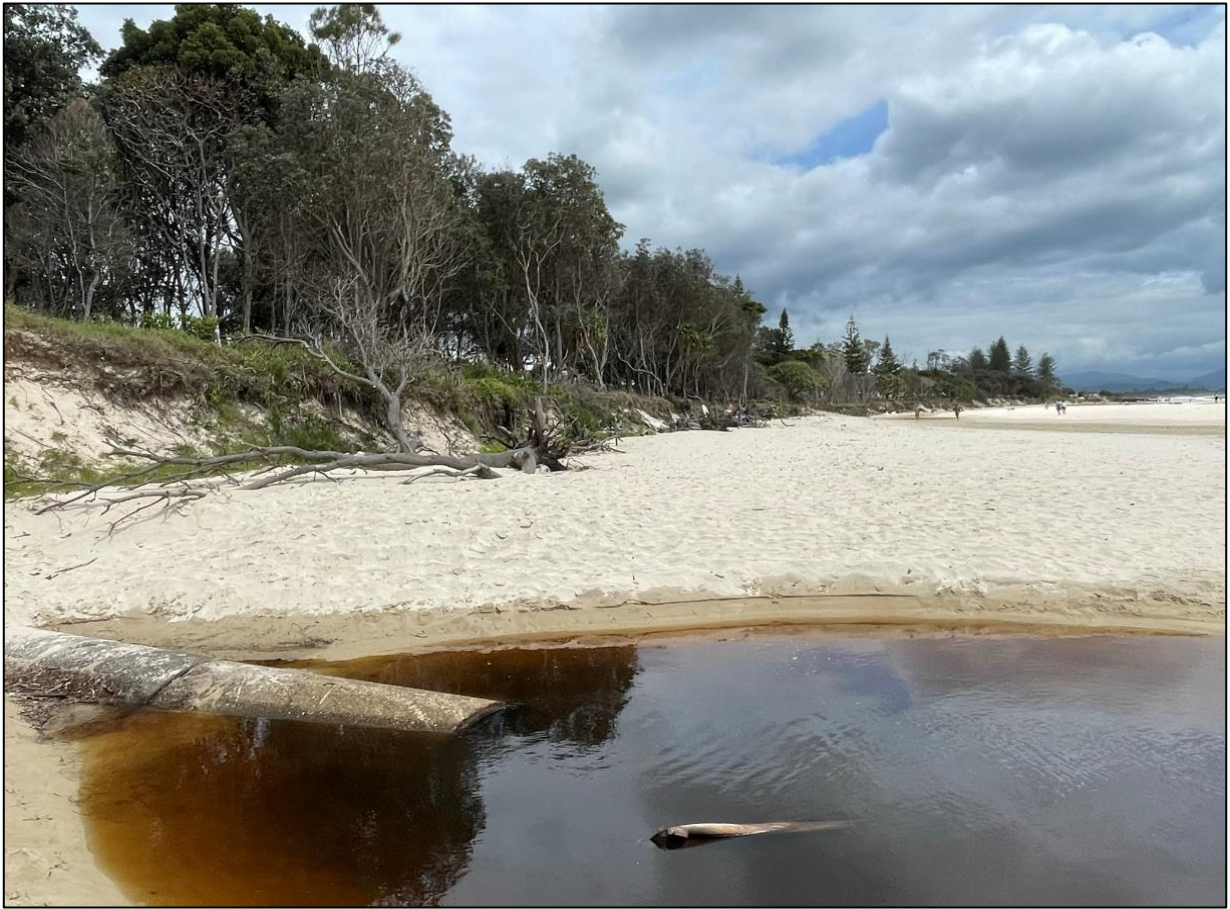
Plate 3: Stormwater drain at Clarkes Beach

A large stormwater drain currently empties to the beach and often forms a small lagoon. BSC is currently working to improve the outlet to slow the water flow to reduce scouring.

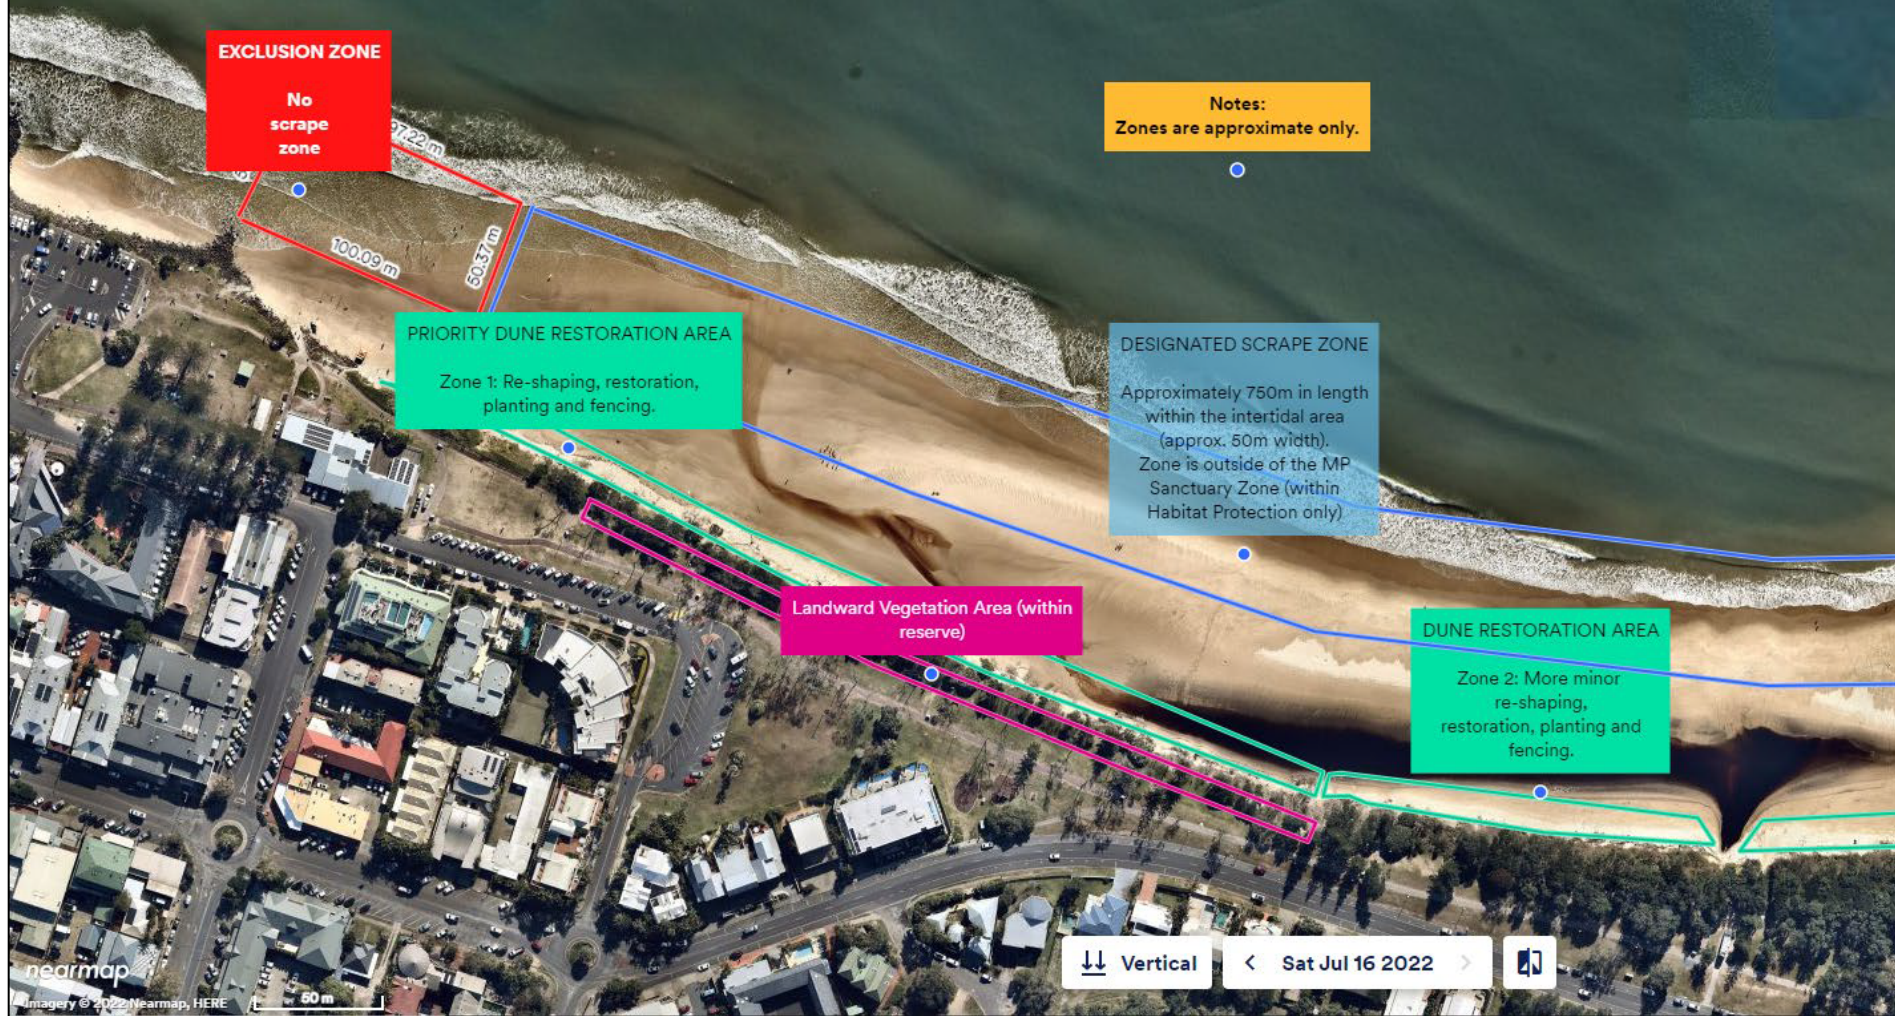
Figure 3: Spatial extent of project area.

The blue polygon above represents the Scrape Zone from which sand will be removed, green polygons represent Dune Restoration Areas (Zone 1) where strand species will be planted. The pink polygon represents the Landward Vegetation Area where trees will be planted. The red polygon is an exclusion zone which will be protected during scraping works. S

The site location is between Byron Bay Café (previously Clarkes Beach Café) and the Byron Bay Surf Life Saving Club at Main Beach, a distance of approximately 750m. See **Figure 3**, which shows the spatial extent of the site. The site occurs on mainland and barrier beach associated foredunes and hind dunes on Quaternary (Holocene) sands.

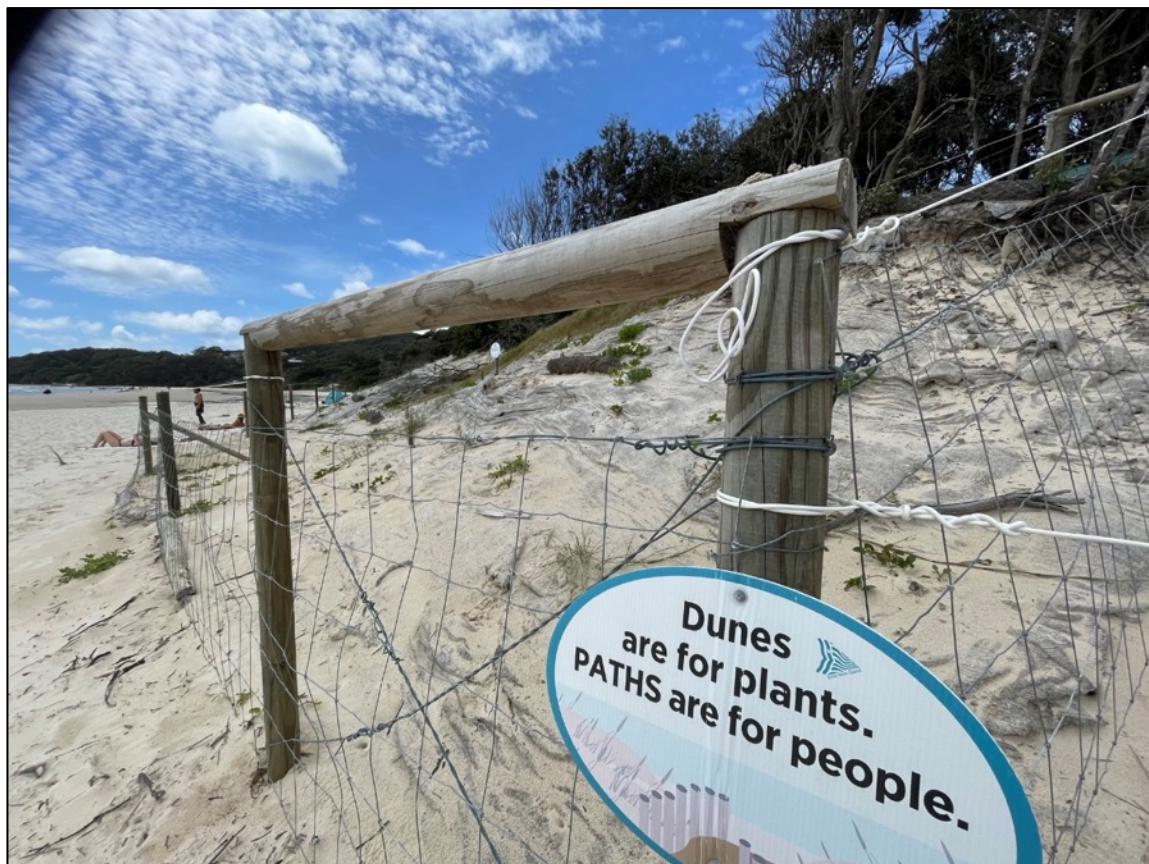
Plate 4: Existing dune fencing to the east of the subject site.

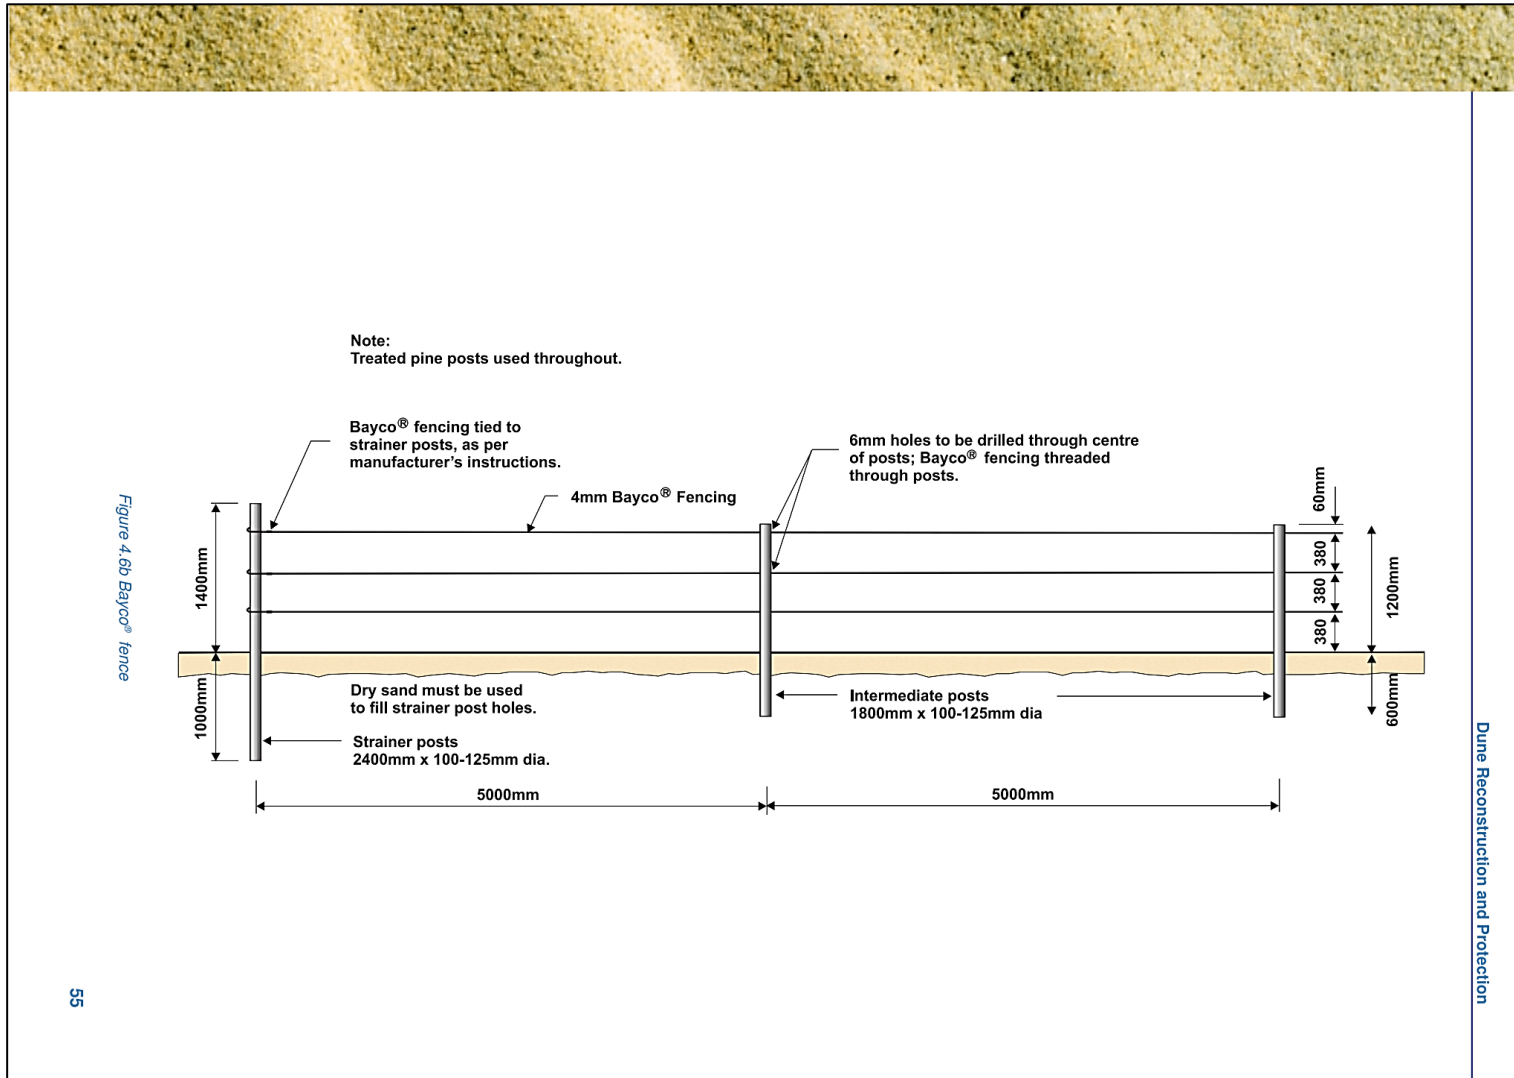
Figure 5: Timber posts and 3-line Bayco® wire fencing

The entire project area between the Beach Café and the Surf Club will be fenced, positioned slightly above the frontal crest of the dune, and above the potential wave run-up zone. Fencing will consist of timber posts and 3-line Bayco® wire (**Figure 5**). It is preferred that existing fence posts will be reused where possible.

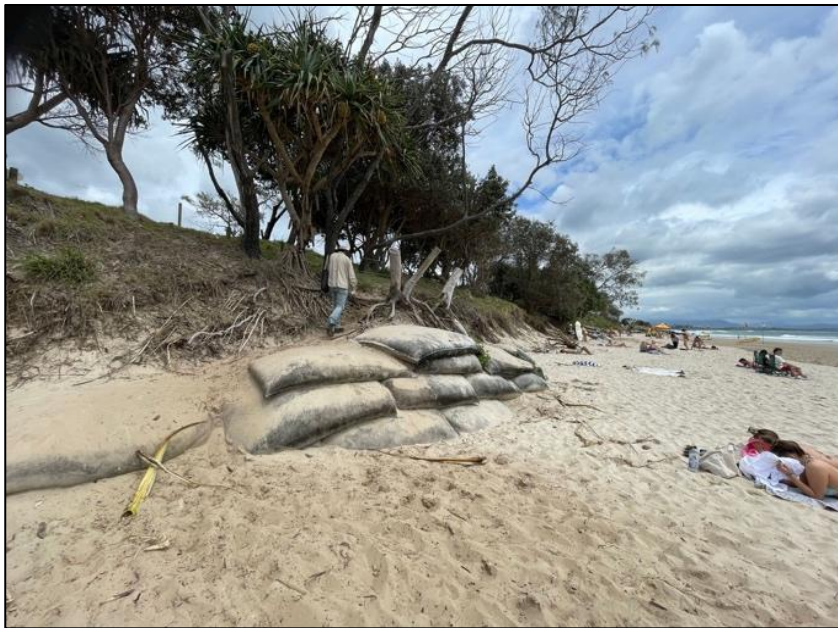
Plate 5: Eroded dune area towards Main Beach.

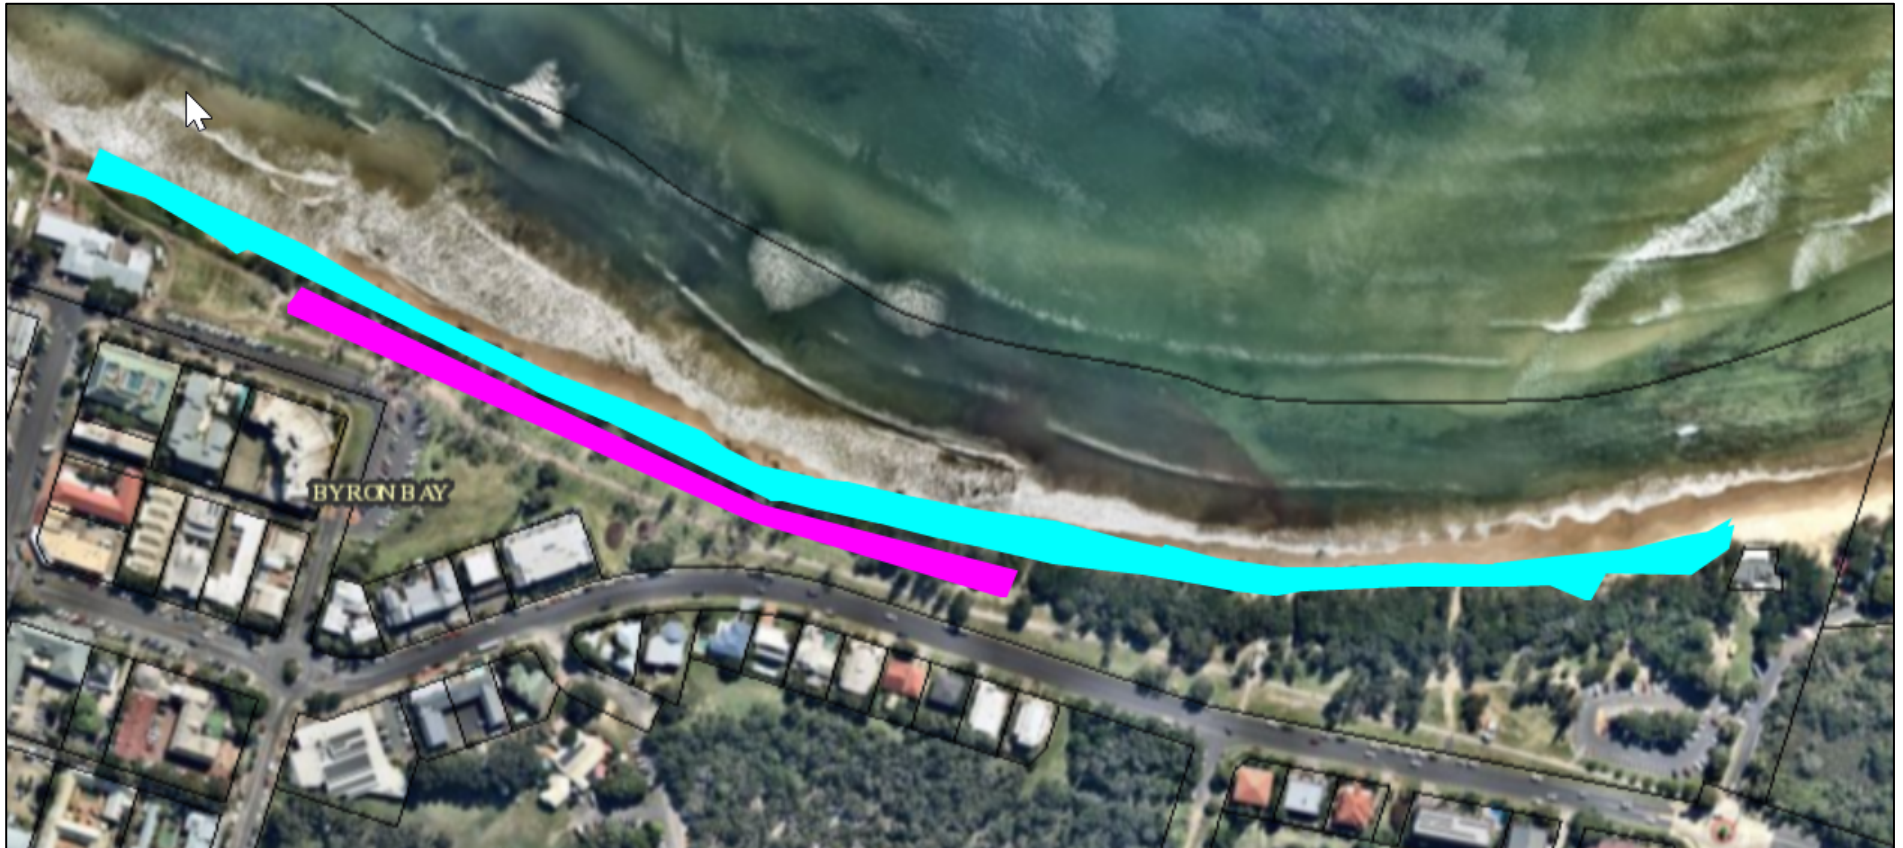
Figure 6: Restoration Zone 1 is approximately indicated by the blue shading above. Zone 2 is approximately indicated by the pink shading. Zone 2 will be concentrated on the parts of the zone where trees are thinnest (purple shading).

The site has been divided into two zones for restoration purposes. Zone 1 is the dunal zone where direct seeding and planting is proposed. Zone 2 is the hind dune area to be widened and planted. (Figure 6).

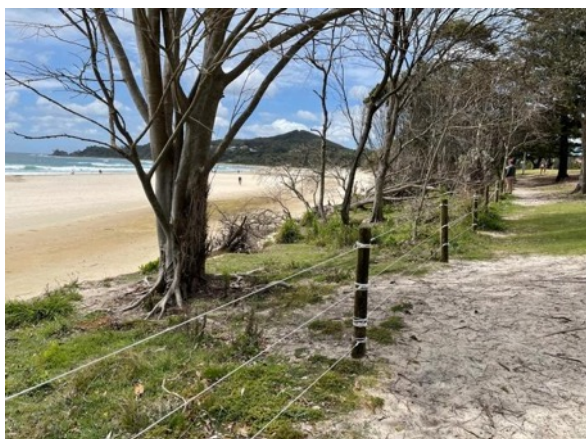
Plate 6: Loss of foredune and hind dune vegetation.

Zone 2 is located at the rear of the foredune and into the hind dune area, where the vegetation is currently very thin (one row of larger trees in some sections behind the mid dune species (**Plate 6**)). The vegetated dune buffer area will be expanded up to 4 metres or more landward, into the grassed area that is currently used as a recreational space (**Plate 7**). The tree planting area is approximately 1500m² (300m x 5m) and will be planted with tubestock, dominated by Coastal Banksia *Banksia integrifolia*, with the remainder consisting of littoral rainforest species (**Table 2**).

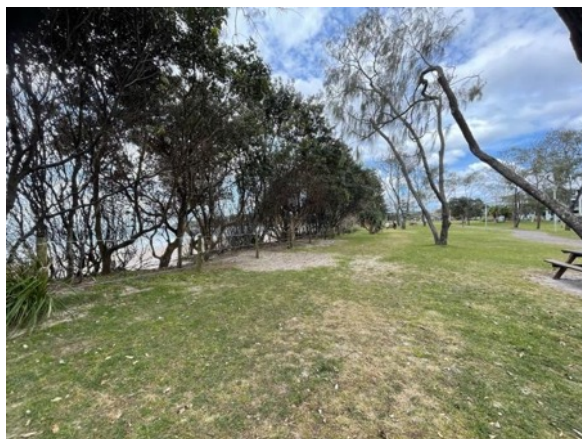
Plate 7: Parkland area to be replanted with trees.
