Main and Clarkes Beach Dune Recovery Project

Summary Report

January 2023

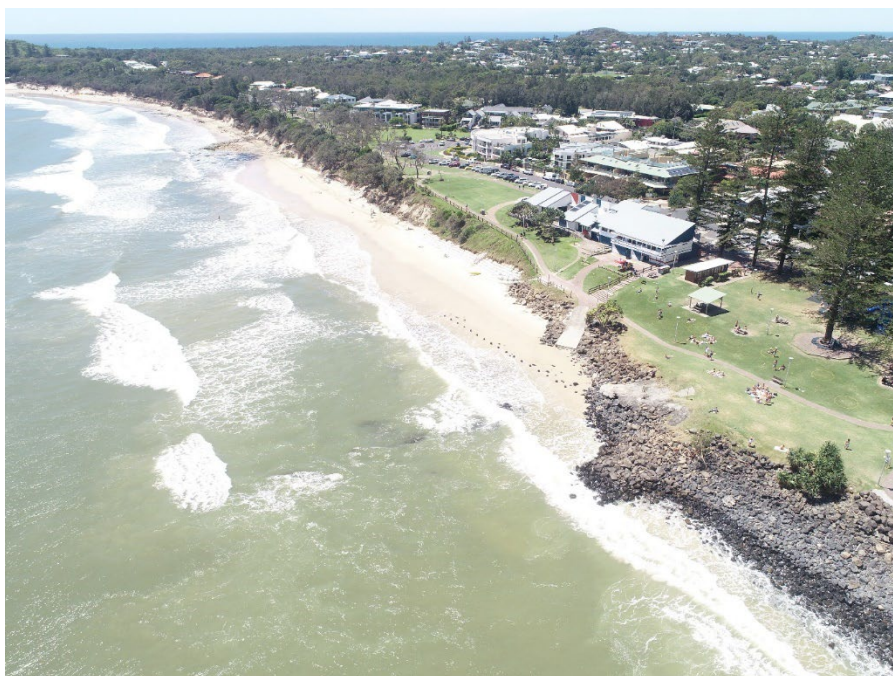
Figure 1: Aerial drone imagery of an eroded Main and Clarkes Beach, taken after the coastal erosion event (23 December 2020).

In the short timeframe between April 2020 and July 2021, the dune eroded up to 45 metres landward, resulting in the significant loss of dune vegetation, formation of an unstable dune scarp and damage to beach accessways and other infrastructure.

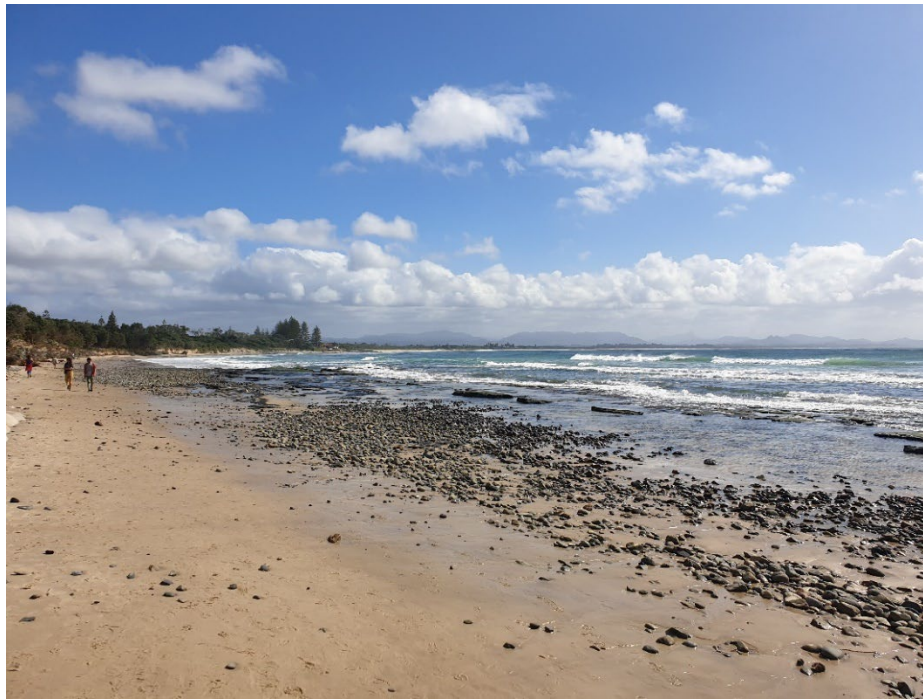
Figure 2: Photo of an eroded Clarkes Beach looking west, showing cobbles and coffee rock deposits (31 July 2020).

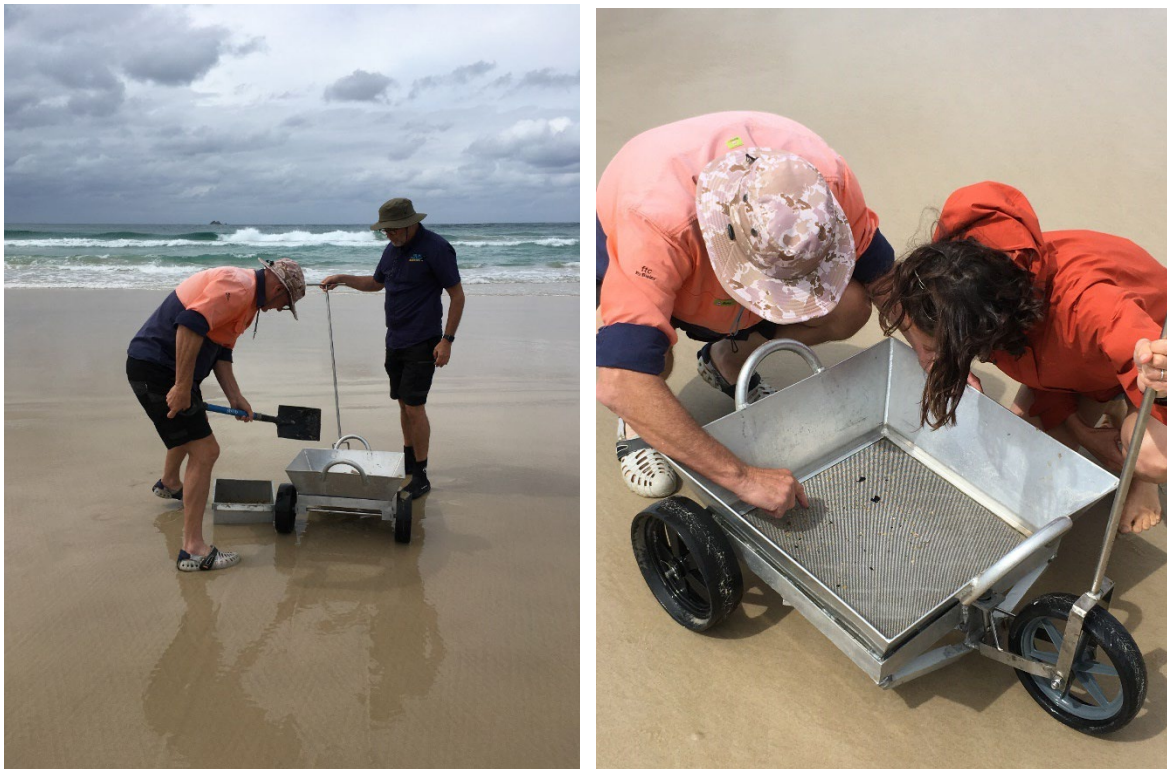
Figure 5: Scientists collect sand samples from intertidal zone for sieving and assessment (left) and scientists assessing sieved sample (right).

However, as the activity had not been undertaken at this location (or within the Cape Byron Marine Park) to date, it was acknowledged that preliminary surveys are advantageous to understand species composition and distribution at this location and to highlight any concerns related to biological assemblages at this location. As such, the Department of Planning and Environment reached out to the previous author and scientist at the NMSC to undertake preliminary surveys in the project area to identify infauna assemblages across transects. The primary objective of this study was to determine if there were any rare or unusual species or assemblages amongst the beach infauna, or unusual densities of specific taxa (e.g. ghost crabs) in the study area (Figure 5 and Figure 6).

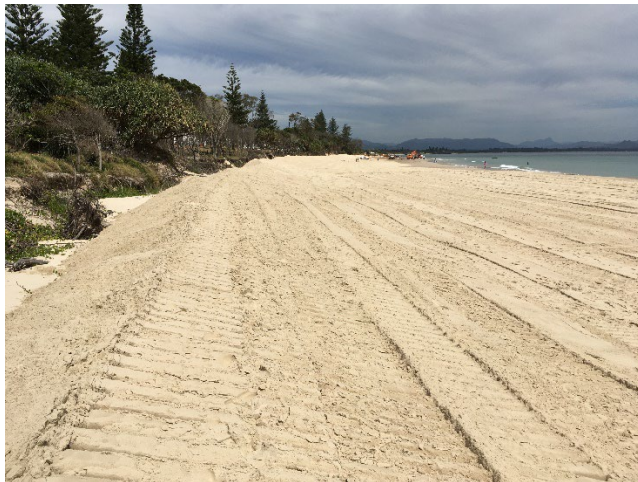
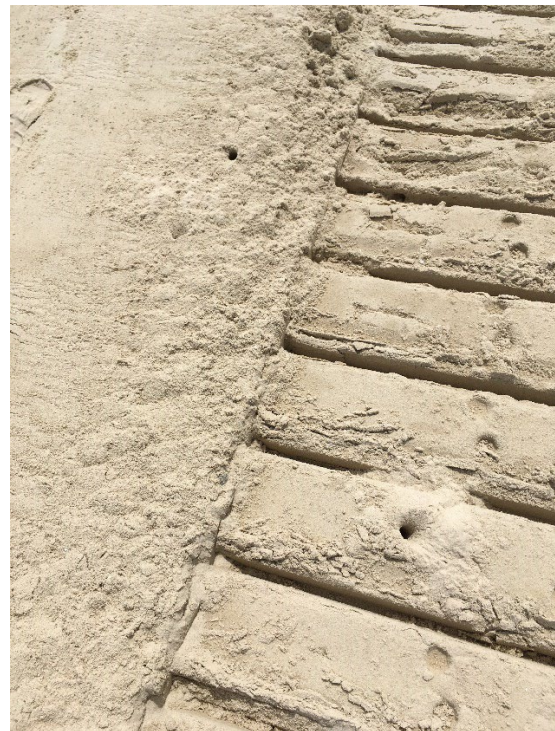
Figure 7: Newly built dune with machine tracks and machines in the background (left) and crab holes visible in machine tracks post-scraping works (right).

Outcomes of the study concluded that the beach infauna assemblages sampled during the preliminary investigation did not contain any rare species or unusual assemblages and based on the observations from previous beach scraping work in the region, were unlikely to be severely impacted by the planned beach scraping. While ghost crabs will be affected over the short-term through burial of their primary habitat they were predicted to make a rapid recovery as densities in the adjacent areas support good populations of these highly mobile crustaceans. This was evident by the newly established crab holes in the dune the day after scraping (Figure 7).

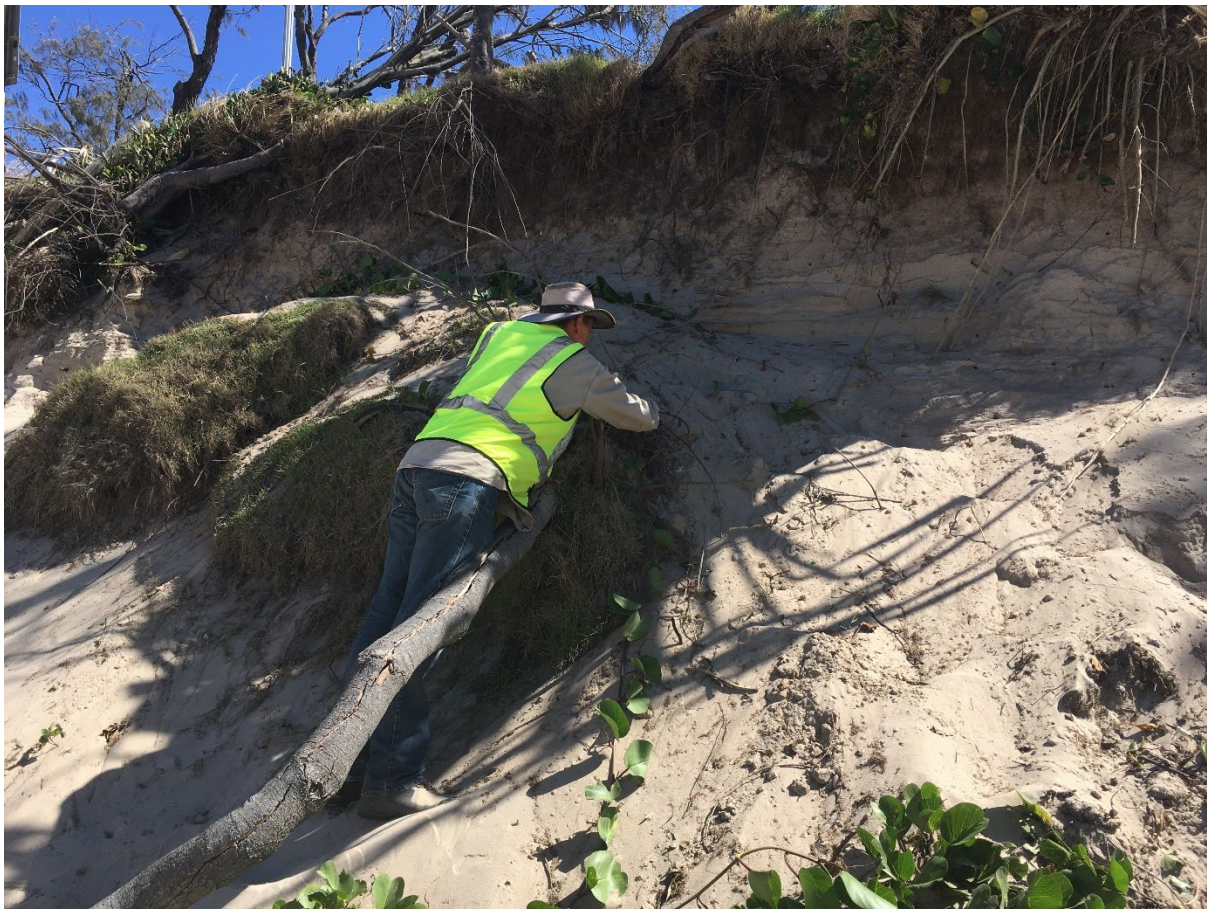
Figure 9: Vegetation specialist relocating Goats Foot ground cover to further up the dune face out of the impact area.

Minor smothering of existing vegetation was expected due to the placement of scraped sand. Some ground covers such as Spinifex are adapted to being buried by sand and are known to grow through the sand after beach scraping programs. However, any plants that were deemed to potentially not survive burial were considered for temporary re-location or placement above the sand placement zone. (Figure 9).

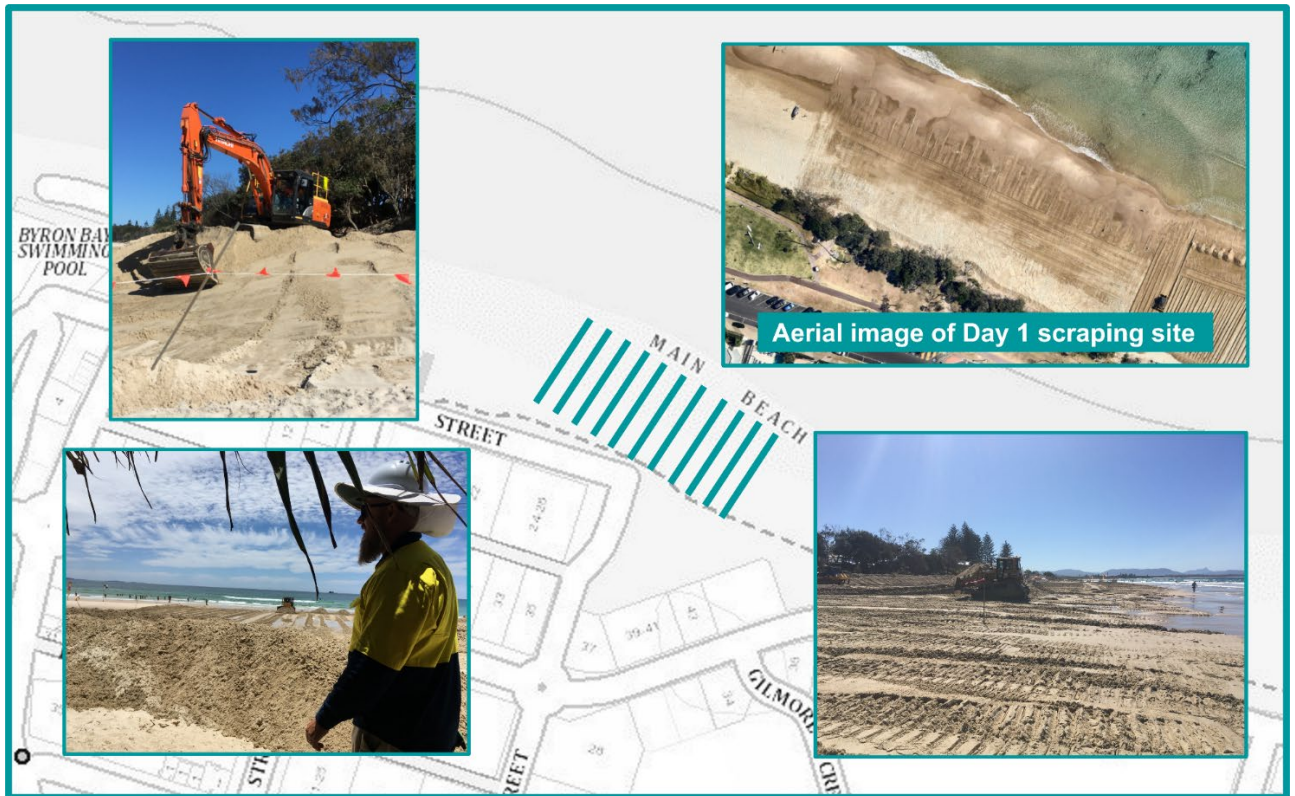
Figure 14: Day 1 (21/11/22) beach scraping works, located opposite 22 Bay St to opposite 43 Lawson St.

Figures 14 to 18 provide visual representation of the works area each day. The **green lines** indicate the extent of scraping completed each day (i.e. metres of work area).

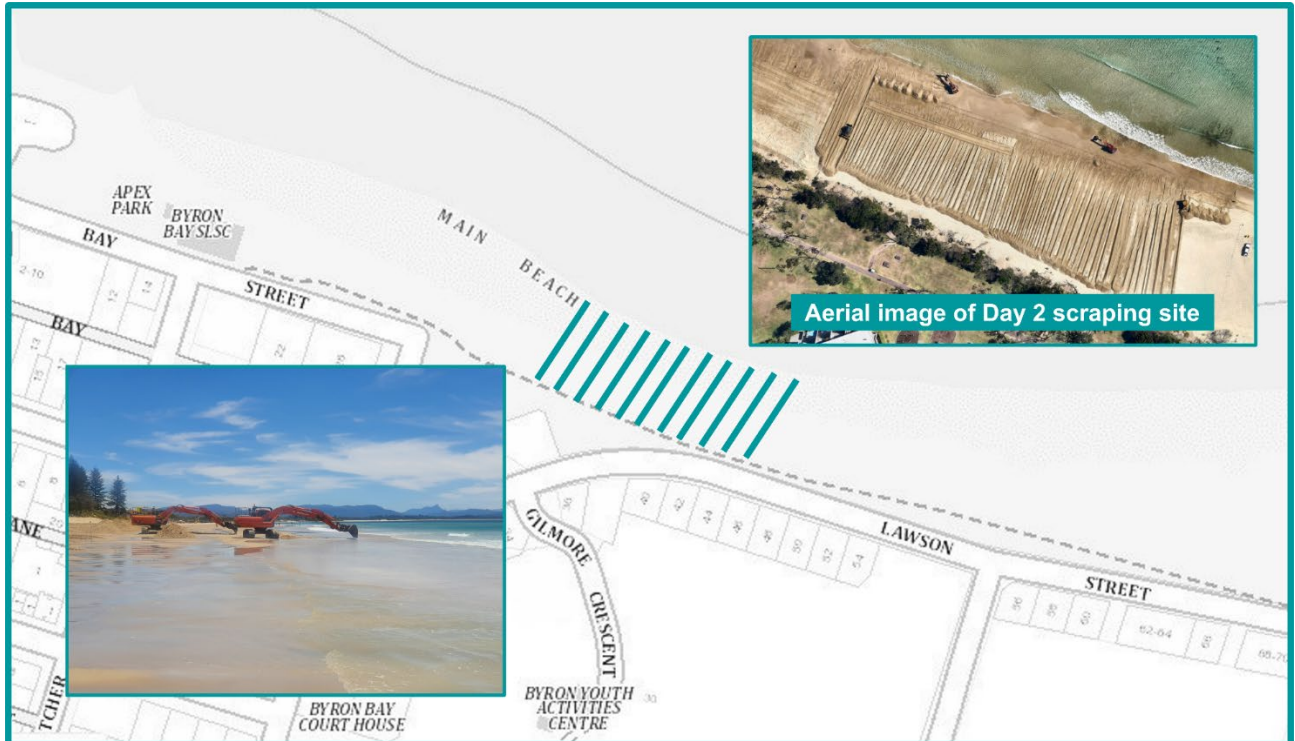
Figure 15: Day 2 (22/11/22) beach scraping works, located opposite 43 Lawson St to opposite 44 Lawson St.

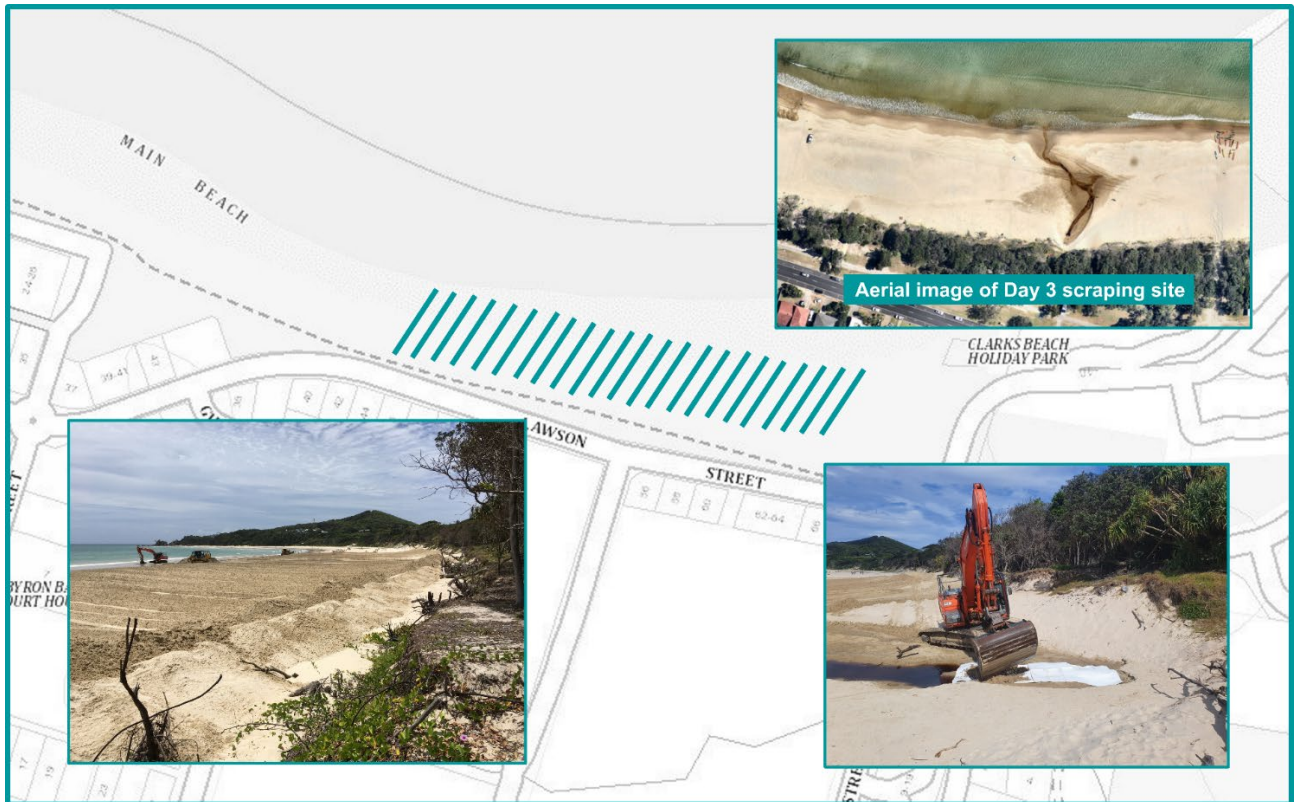
Figure 16: Day 3 (23/11/22) beach scraping works, located opposite 44 Lawson St to 62-64 Lawson St.

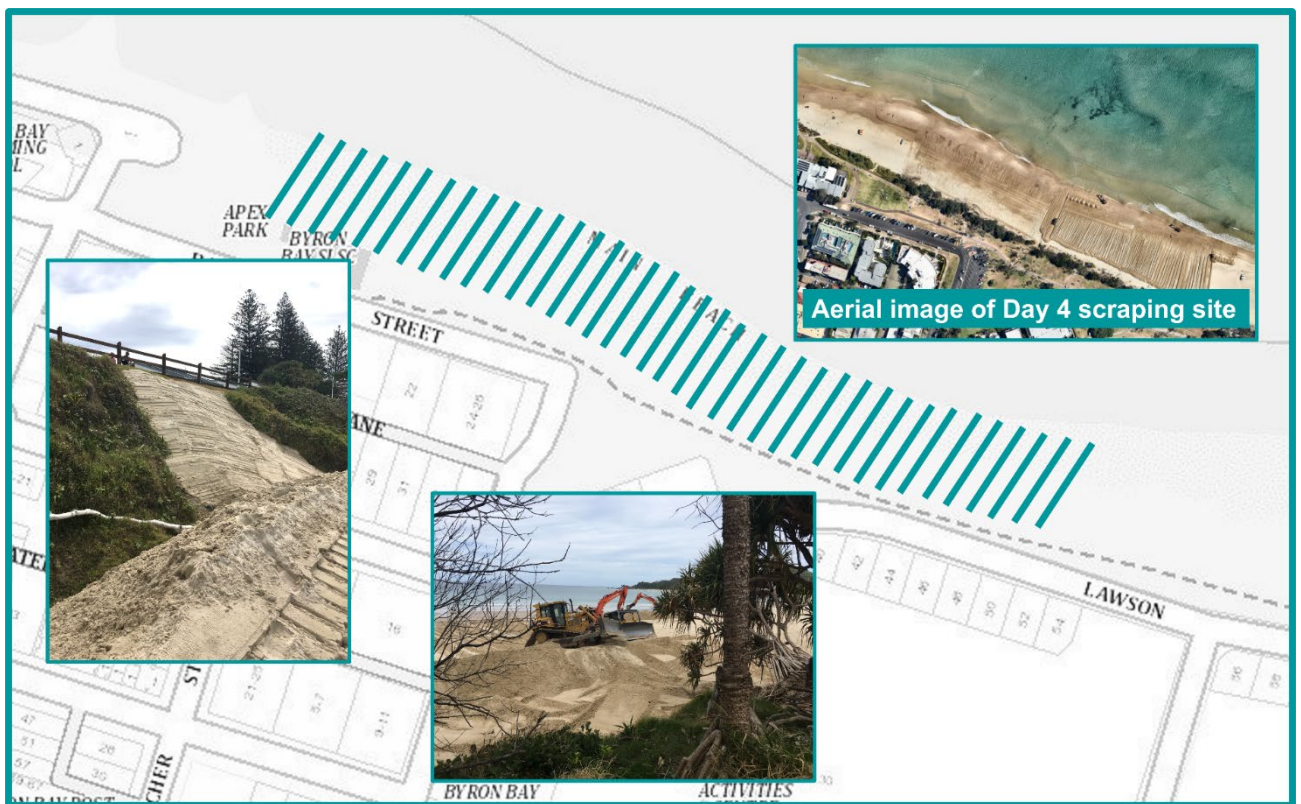
Figure 17: Day 4 (24/11/22) beach scraping works, opposite Byron Bay Surf Life Saving Club to opposite 50 Lawson St.

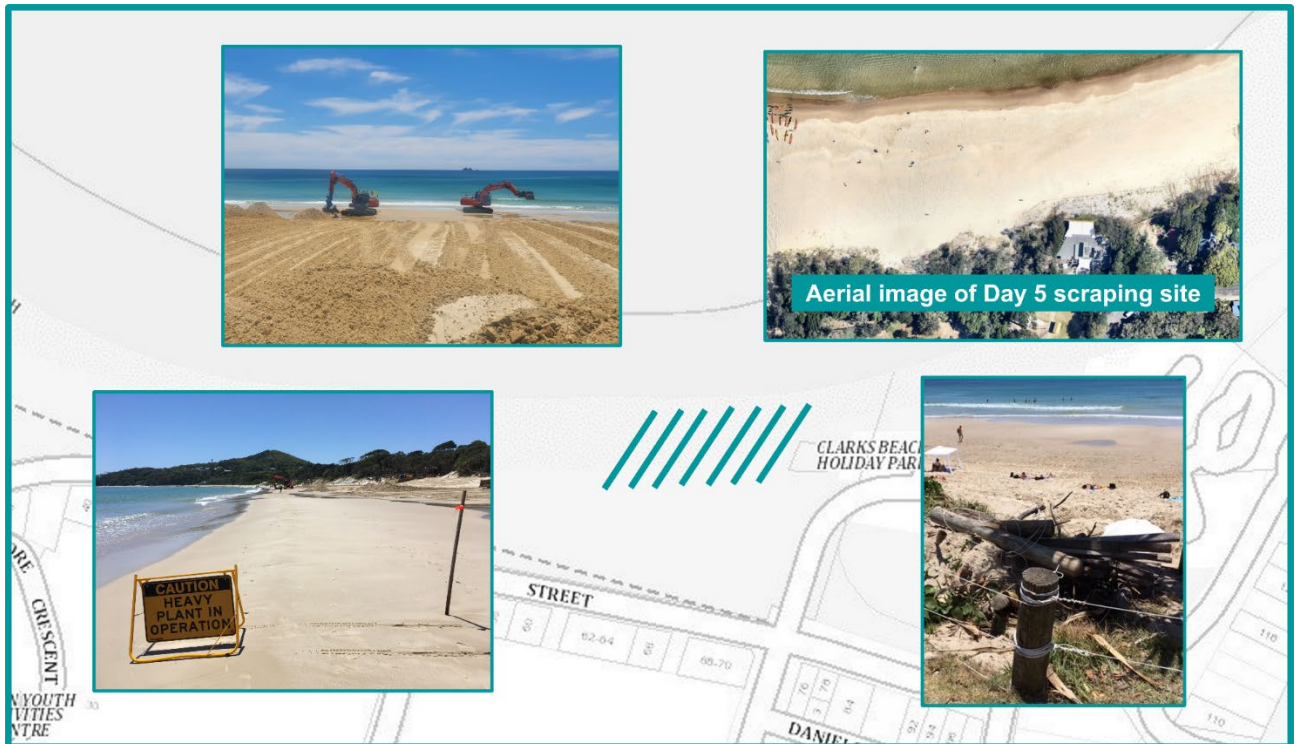
Figure 18: Day 5 (25/11/22) beach scraping works, located opposite 62-64 Lawson St to the Byron Beach Café.

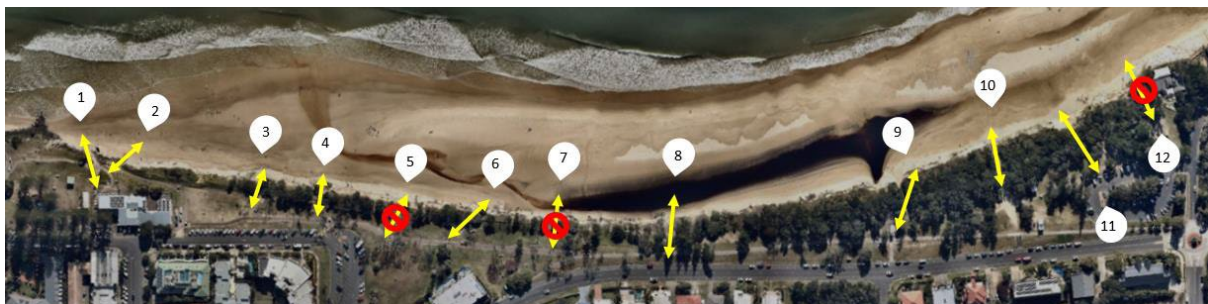
Figure 14: Map of Main and Clarkes Beach access pathways permanently decommissioned (red symbol)

During the 5 day works program 3 out of the 12 accessways were decommissioned and 7 out of the 12 accessways were restored (refer Figure 14 and Figure 15). 2 accessways at the Surf Club are concrete ramps and not included in the works scope. Restoration of accessways involved removal of debris/waste material and reprofiling sand around the access track to allow a safe gradient. Decommission involved removal of waste and fencing and reprofiling / pushing sand into eroded areas.

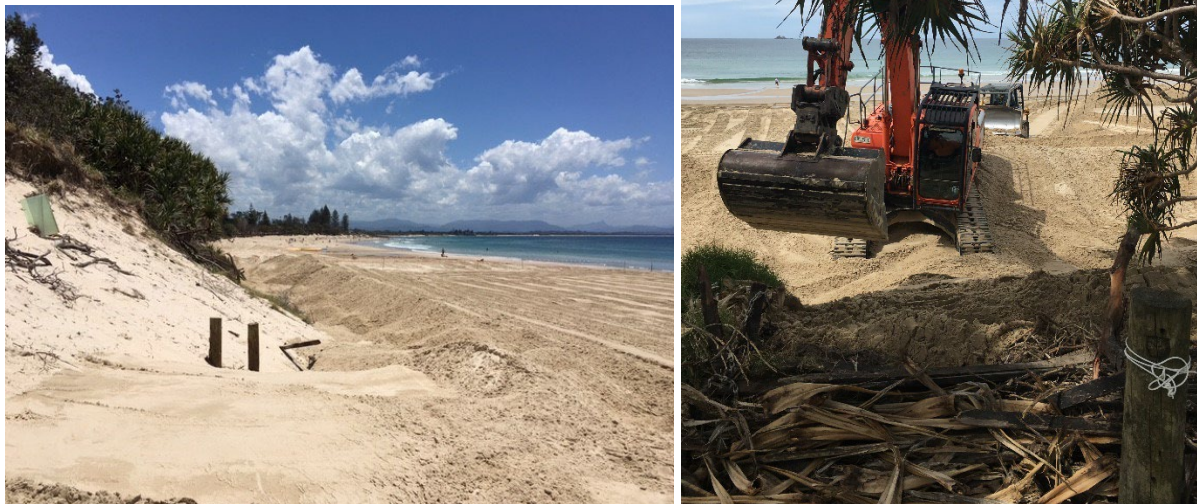
Figure 15: Restoration of Clarkes Beach Ex-Disabled Access (Access #11 from Figure 14) (left) and decommissioning of Dening Park West Access (Access #5 from Figure 14) (right)

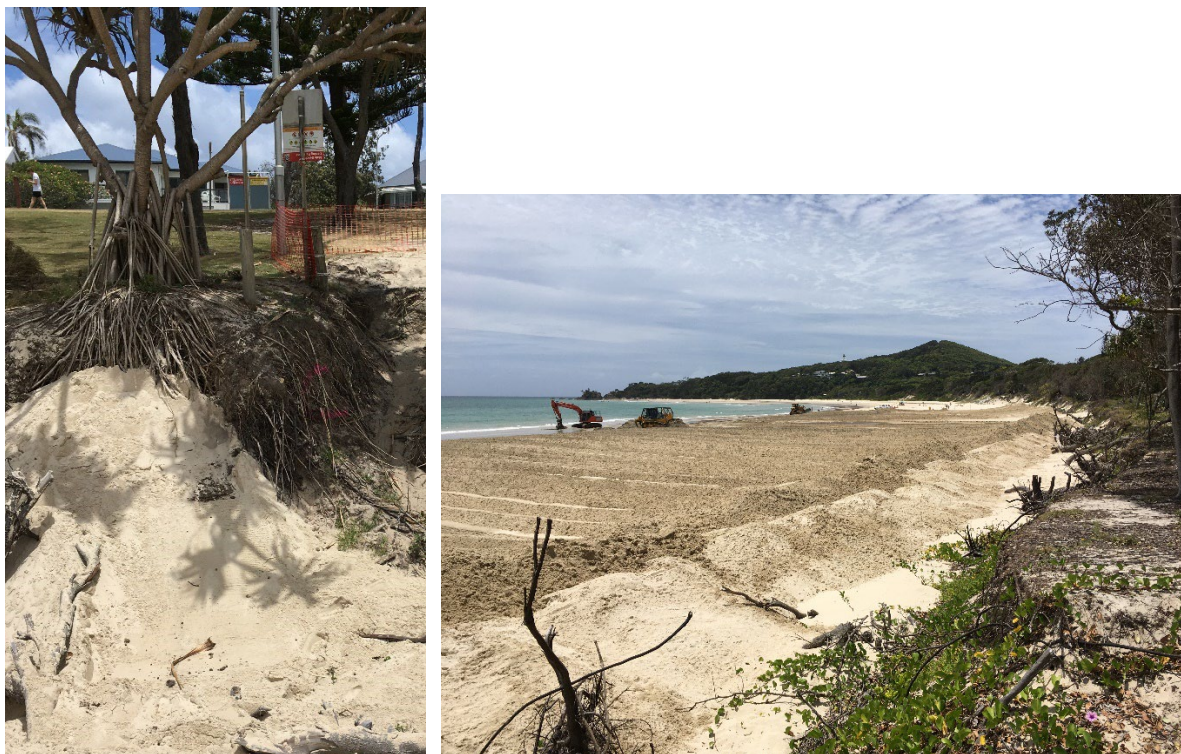
Figure 17: Sand pushed against the escarpment under exposed trees (left) and new incipient dune formation (right).

The incipient dune at Clarkes Beach is above the wave run-up area during average ocean conditions and should remain in place for some time (depending on storm events), slowly growing with sand being fed from littoral drift, aeolian transport and captured by vegetation growth (ground covers). Due to the limited extent/width of the western area of Main Beach, the incipient dune is closer to the upper limit of wave run-up and may be impacted during high tide / moderate wave conditions. However, should the present accretionary / beach building phase continue with calm conditions over the summer, the beach will continue to widen and grow with time until the next period of erosion caused largely by storm events and a reduction of sand moving into the embayment as a result of reduced headland bypassing.

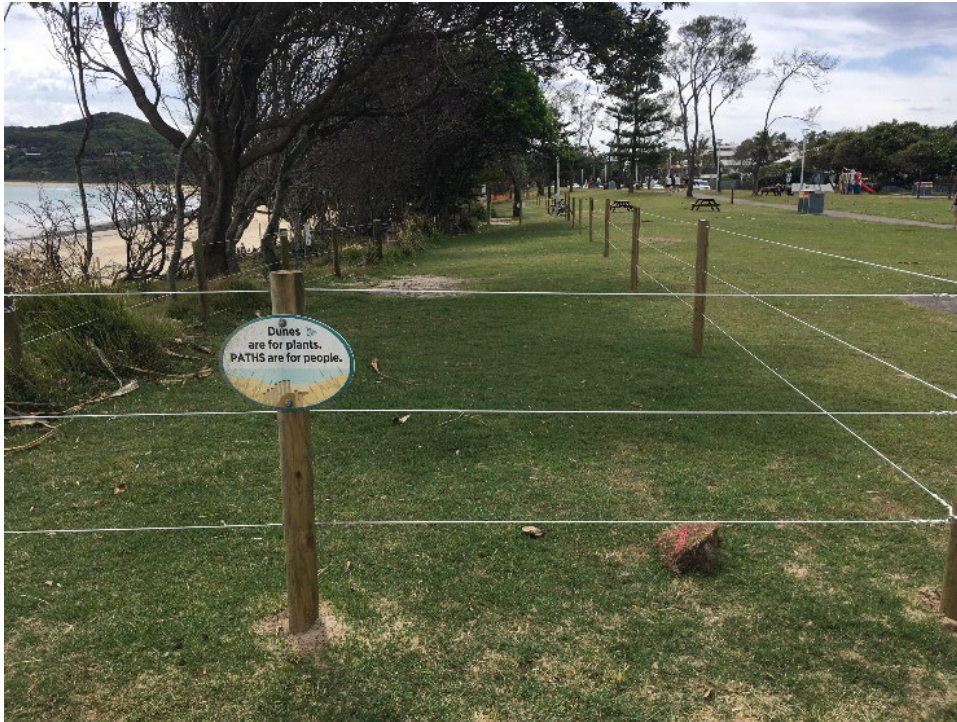
Figure 18: Landward vegetated buffer within the grassy reserve to expand the hind dune area (yet to be planted out).

An area up to 5m within the grassy reserve has been expanded through fencing and revegetation, planted out with larger plants concentrating on species appropriate for the hind dune vegetation zone. This allows space for the dune to retreat landward instead of being squeezed between the ocean and the reserve (Figure 18).

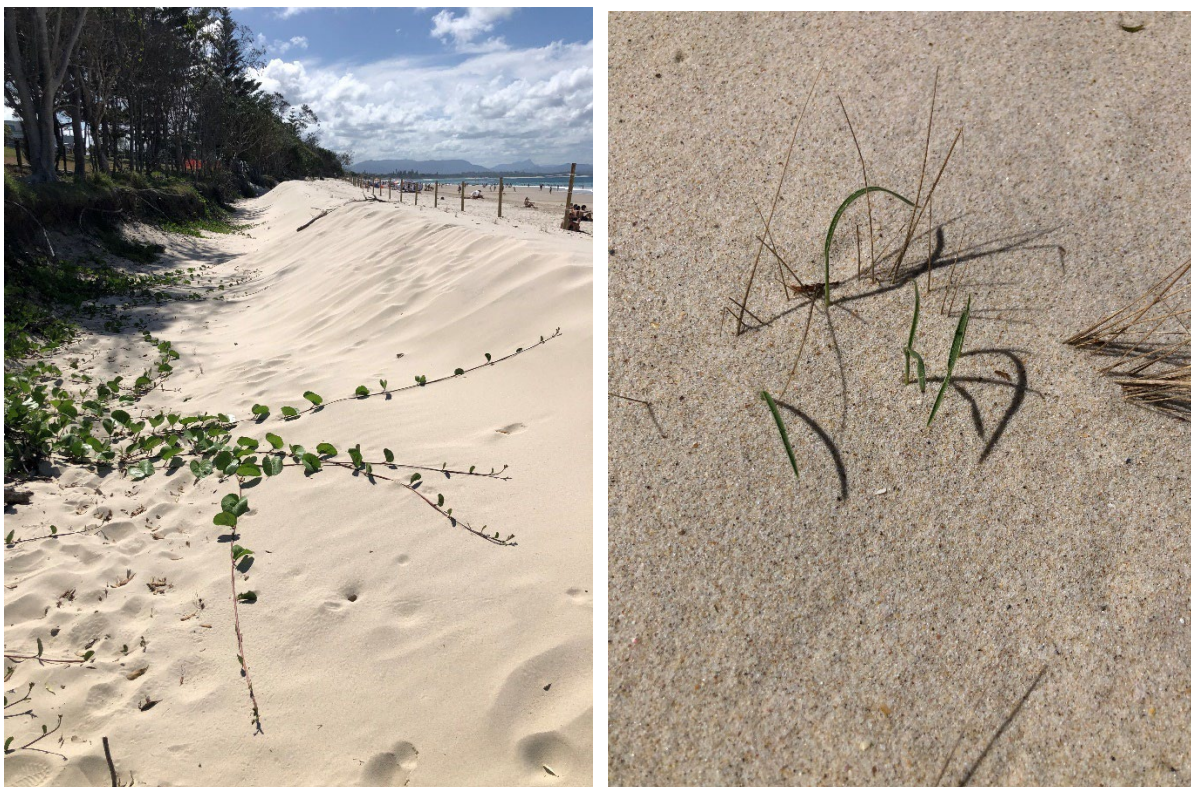
Figure 19: Goats Foot ground cover slowly moving towards the ocean (left) and newly planted Spinifex starting to germinate (right), photos taken 11 December 2022.

Monitoring of vegetation growth one month after planting shows rapid expansion of Goats Foot from the dune escarpment seaward into the swale area and germination of newly planted Spinifex (Figure 19).

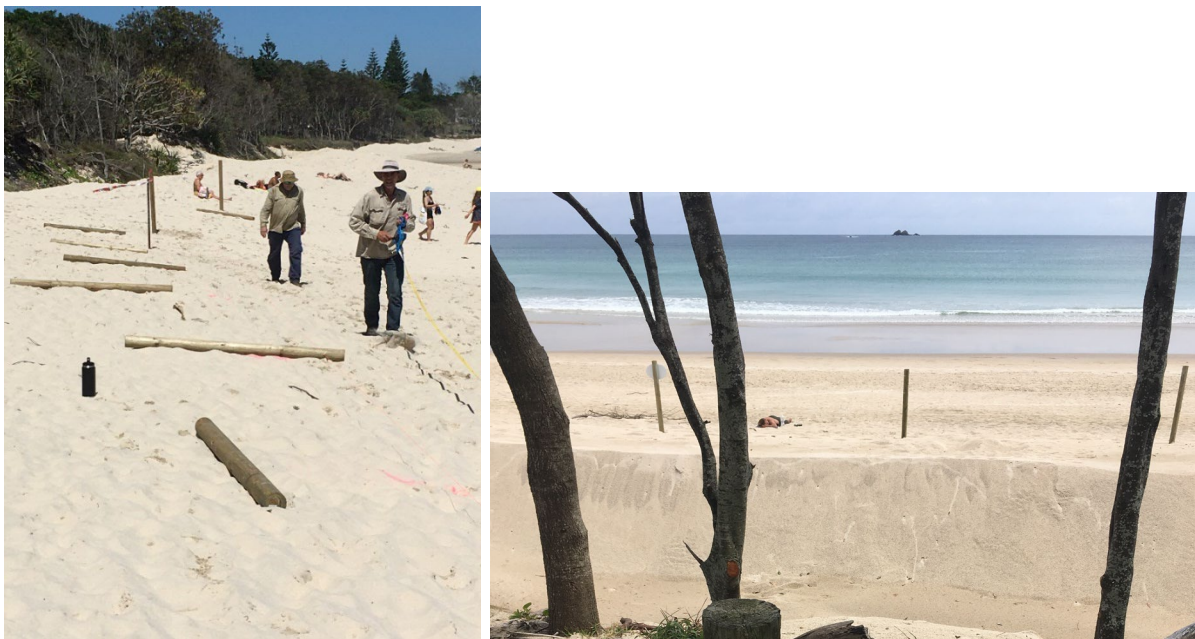
Figure 20: Fencing contractor - Clarkes Beach Café accessways (Access #11 from Figure 14) (left) and beachside fencing of Main Beach area (timber and 3-line wire) (right)

After the scraping works program was completed the dune fencing alongside the beach access ways was reinstated. Where existing fence posts could be retained or reused, this was done. Fencing consists of timber posts and 3-line Bayco® wire, similar to other beach fencing in the Shire. The alignment and location of fencing of the beach access ways focusses on streamlining pedestrian access straight to the beach, rather than allowing people to cut left or right onto the newly established incipient dune. New fencing was also installed along the beachside face of the newly formed incipient dune area for the entire project area between the Surf Club & the Beach Café. The beachside dune fencing ties-in to the beach access ways and the eastern and western extents in a smooth alignment. The fencing was positioned slightly up the front face of the incipient dune, above the potential wave run-up zone (Figure 20).

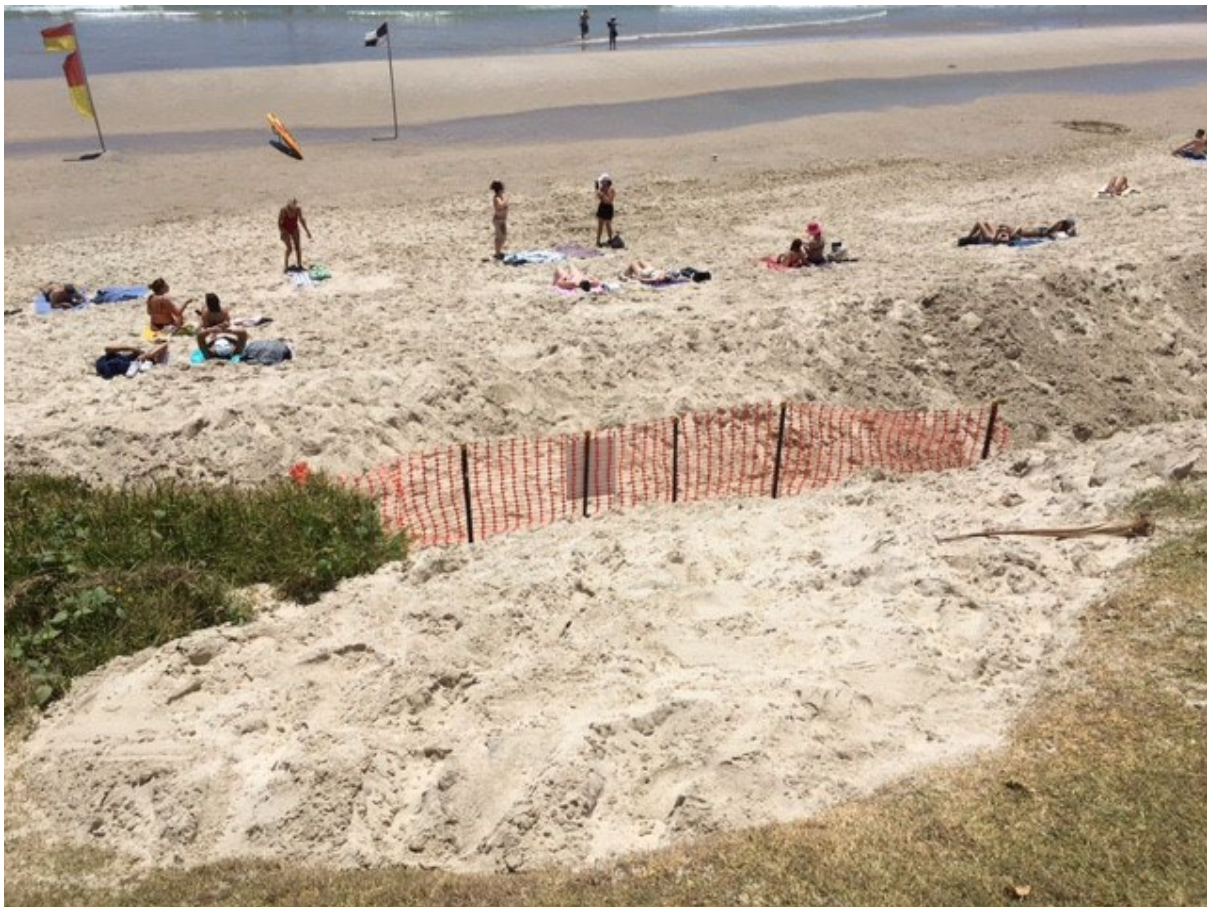
Figure 30: Photo of filled in eroded area in front of the Surf Club.

- Sand fill concentrated on forming the new incipient dune and swale formation and filling in areas below exposed trees where roots were visible (and the tree was assessed for possible successful re-establishment and stabilisation).
- In some areas sand was pushed directly up against the existing back-beach escarpment or within eroded areas of the dune as shown by the small fill area illustrated by the green line at a 45deg angle against the foredune as shown in Figure 29. This location is directly in front of the Surf Club where there was a large scallop eroded that was filled in (Figure 30).

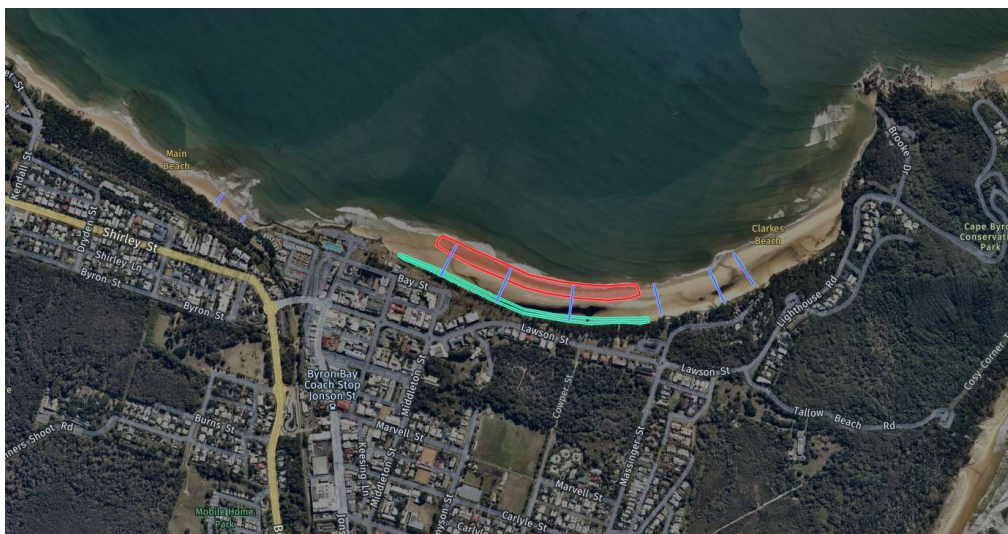
Figure 1. Map showing the position of transects (blue lines) sampled for this preliminary study of beach infauna. Transect numbers run sequentially from east (right) to west (left). Note - the green (deposition) and red (borrow) areas is indicative of position of beach scraping/dune rebuilding works (Figure supplied by NSW DP&E).

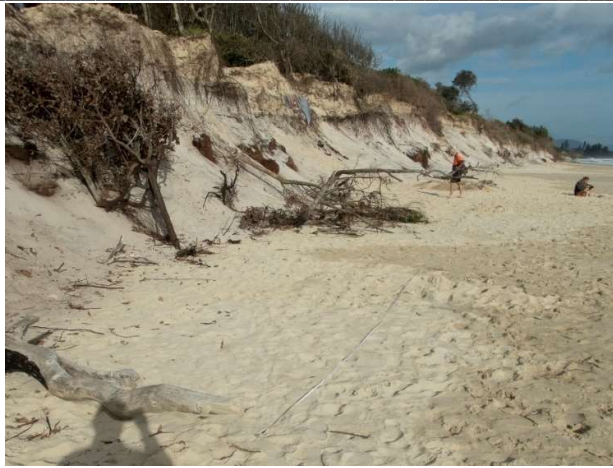
Figure 2. Assessing the density of active ghost crab burrows in the upper beach, Transect 7.

Ghost crabs (Family Ocypodidae) live within sand burrows in the upper beach and scavenge across the beach face, mostly during the early morning and late afternoon. For this reason, they are likely to be affected by any substantial change to the beach-face environment and have been recommended as suitable indicators of a range of impacts in the upper beach (Barros, 2001; Moss and McPhee, 2004; Hobbs et al., 2008; Lucrezi et al., 2009; Noriega et al., 2012; Smith et al., 2019). Following the methods used for similar assessments at Woolli, NSW, active crab holes were assessed in the upper beach for each of the eight transects. Three transects measuring 5m along the beach and 4m up the beach were established within a 25m strip at the top of each transect. The upper limit of the transects was placed at, or just into, the vegetation line where this was present (Figure 2). On transects with highly eroded upper sections, the upper limit of the transect was delineated by the base of the steeply eroded area. Crab holes can readily be obscured by trampling by beach goers. For this reason, all assessments were conducted in the early morning (from 07:00) when active burrows are most obvious (Barros, 2001). Active burrows with a diameter ≥ 10 mm were recorded in each transect.

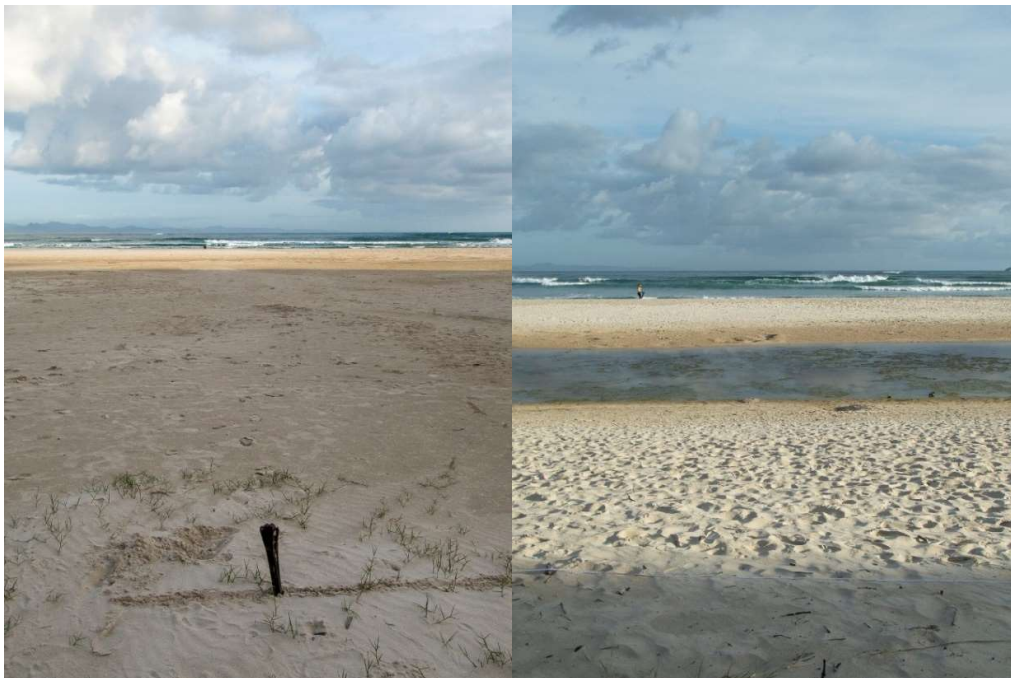
Transect 1 (Figure 4) – (length ~23m). This transect was placed between sections of the high-tide lagoon at the eastern end of the survey area. A strong berm was present with a vertical face measuring approximately 0.5m. The most recent strandline was above the berm and so the transect commenced just above the berm and ran down the moderately steep beach face. A low-tide moat was present at low tide with an emerged sand-bank to seaward. The Level 5 sample was taken on the sand-bank. The mid-section of the sample area was dominated by sand balls resulting from activity of sand-bubbler crabs, *Scopimera inflata*. A reduced layer (the Redox Potential Discontinuity Layer – RPDL), characterised by a transition from pale, oxygenated sand to grey/black, reduced sand was evident at Level 3 at a depth of 8cm. A moderate amount of coarse shell grit was retained in the sieve at Levels 3 and 4.

Figure 4. Transect 1 (left), Transect 2 (right).

Transect 2 (Figure 4) - (length ~23m). Transect 2 commenced at the bottom of the berm. As for Transect 1, the Level 5 sample was taken on a sand bank beyond the low-tide moat. The near-vertical berm measured approx. 0.7m with a moderately steep beach-face below. The mid-section

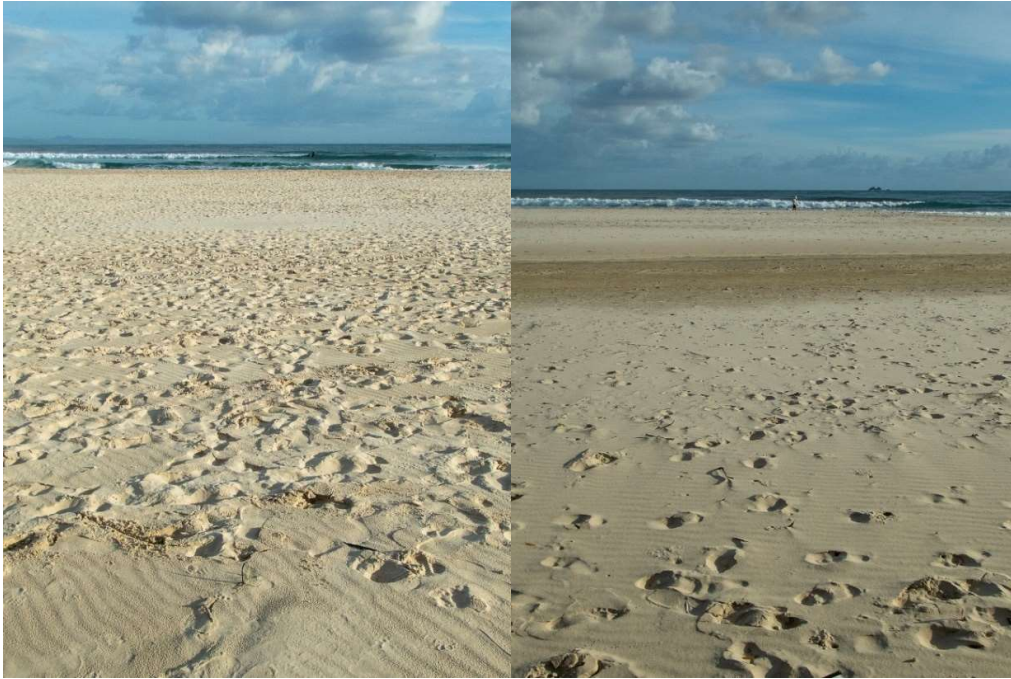
Figure 5. Transect 3 (left), Transect 4 (right).

Transect 3 (Figure 5) – (length ~19m). Transect 3 had a similar profile to Transect 2 with a prominent berm on the lower beach and a moderately steep profile. Sampling occurred just above the berm (Level 1) and ran down to the low tide level.

Transect 4 (Figure 5) – (length ~34m). Transect 4 was located immediately to the west of a semi-permanent water flow from a stormwater drain at the top of the beach. A strong berm with a near-vertical face measuring approx. 0.5m was present. Level 1 was established on top of the berm with the other levels equally spaced to the low tide level.

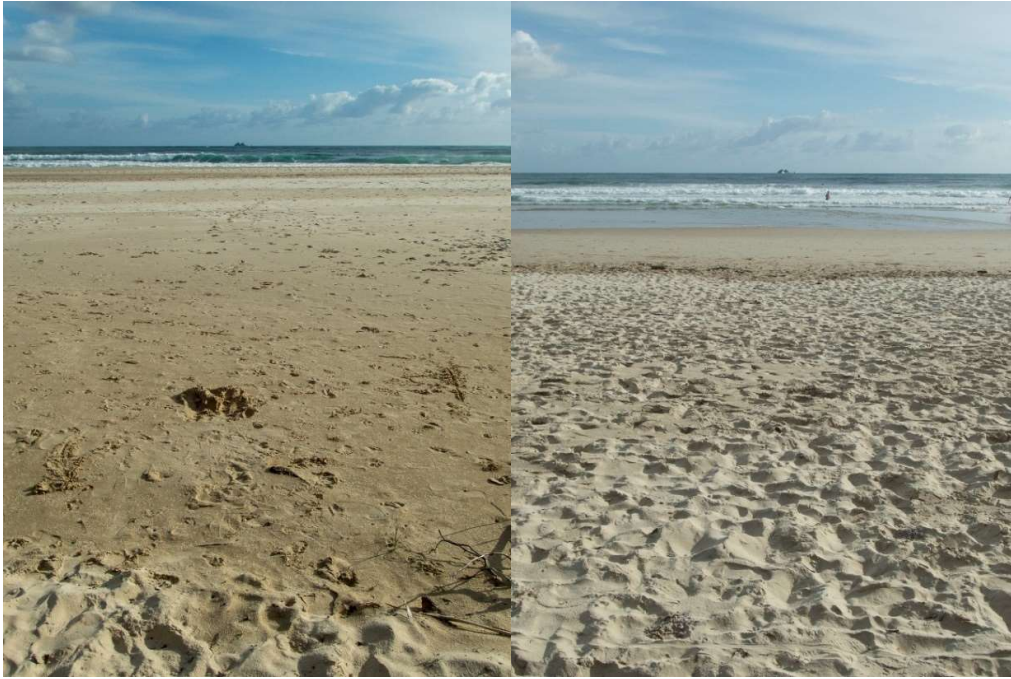
Figure 6. Transect 5 (left), Transect 6 (right).

Transect 5 (Figure 6)– (length ~60m). The strong beach berm evident in Transects 1-4 was lacking on Transect 5 although there was evidence of a slight elevation in profile (<30cm) corresponding to the start of the stronger berm to the east. With the lack of a berm barrier, seawater flooded further up the beach at high tide with the consequence that the transect was longer than those to the east.

Transect 6 (Figure 6) – (length approx. 86m). The beach profile at Transect 6 comprised a shallow, monotonic slope with the recent strandline occurring approximately 80% of the distance from the

low water level to the base of the dune. Thus, this was the longest of any of the transects evaluated.

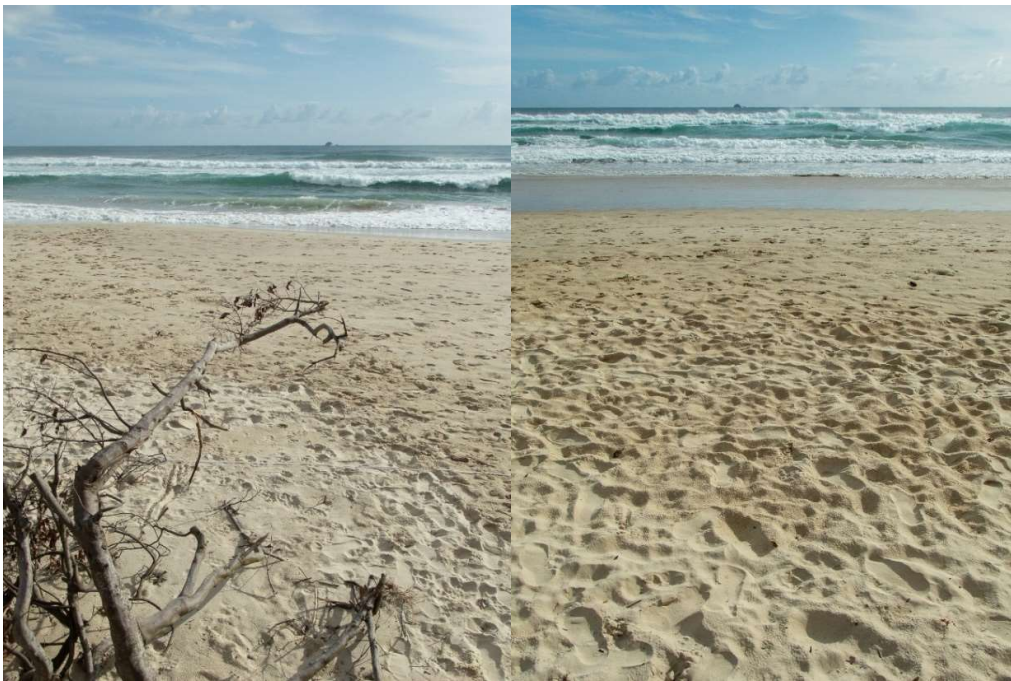
Figure 7. Transect 7 (left), Transect 8 (right)

Transect 7 (Figure 7) – (length ~41m). This transect was placed approximately 20m east west of the rock-wall structure at the end of the Jonson Street breakwall. The upper beach was highly eroded with a steep dune face (see Figure 2). The beach had a monotonic slope that was steeper than Transect 6 to the east.

Transect 8 (Figure 7) – (length ~38m). As for Transect 7, the upper beach was highly eroded with a steep dune face and a monotonic slope that was steeper than Transect 6.

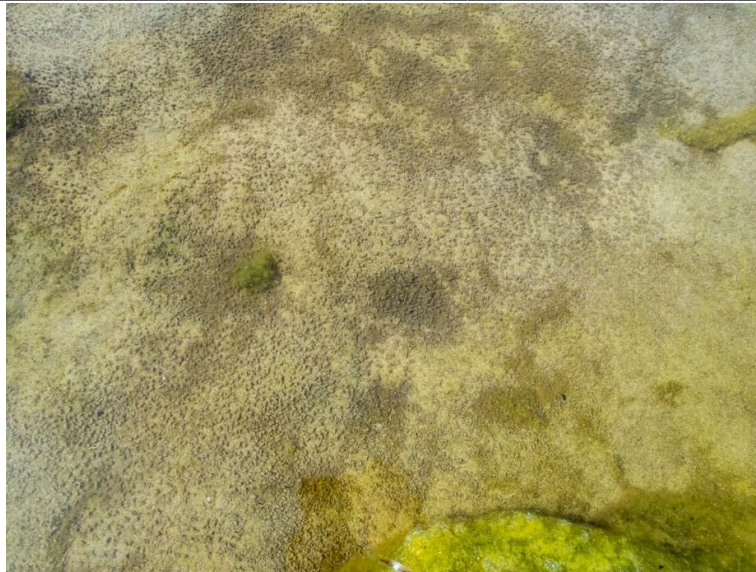
The edges of the lagoon contained obvious signs of the presence of tubicolous animals. These biogenic structures were slightly elevated above the substratum and occurred in high densities (Figure 12). Field examination indicated a large abundance of small, red “worms” along the edges of the lagoon, but biogenic structures could also be seen towards the central sections of the lagoon. By far the majority of animals examined were the same, larvae of non-biting midges in the Family Chironomidae (sometimes referred to as “blood worms”). Chironomid larval abundance in the five core samples ranged from 88-289 with a mean of 152 (SE = 36.09). Sixty percent of the chironomids passed through the 1mm sieve and were retained on the 0.5mm sieve. Further examination indicated that individuals also passed through the 0.5mm sieve though this fraction was not evaluated. The different sizes of individuals suggest the presence of the full range of instar stages (chironomids have four larval instar stages – Zerguine, 2021). This very high density equates to 57,523 chironomid larvae per square metre. If densities are the same in other sections of the lagoon, and using the dimension of the lagoon from the most recent Google Earth images, standing stock is likely to exceed 500 million. Images of the larvae found in the core samples are shown in Appendix 1.

Figure 12. Tubes of chironomid larvae occurred in high densities along the edges of the lagoon and were sampled with a small core (5.8cm internal diameter).

The samples of shallow lagoon sediments were completely dominated by chironomid larvae which likely proliferated in this habitat due to their wide tolerance of environmental conditions and their use of haemoglobin to enhance oxygen acquisition under conditions of low oxygen tension (Nath, 2018; Zerguine, 2021). This feature gives them a characteristic red appearance, and the common epithet of “blood worms”, and facilitates their ability to occupy a huge diversity of aquatic habitats (e.g. Nath, 2018; Zerguine, 2021). The extremely high densities of individuals in sediment samples suggests they might form an important food source for foraging animals such as birds. Indeed, we noted a substantial number of bird species visiting the lagoon over the two days of field sampling; in particular, silver gulls, white-faced herons, Pacific reef herons, little black cormorants, pied oystercatchers, and welcome swallows. Some birds appeared to be feeding in the margins of the lagoon, while others (e.g. pied oystercatchers) appeared to be feeding on sand-bubbler crabs adjacent to the lagoon, or possibly on emerging insects (welcome swallows - although we made no
