Main and Clarkes Beach Dune Recovery Project

Summary Report

January 2023

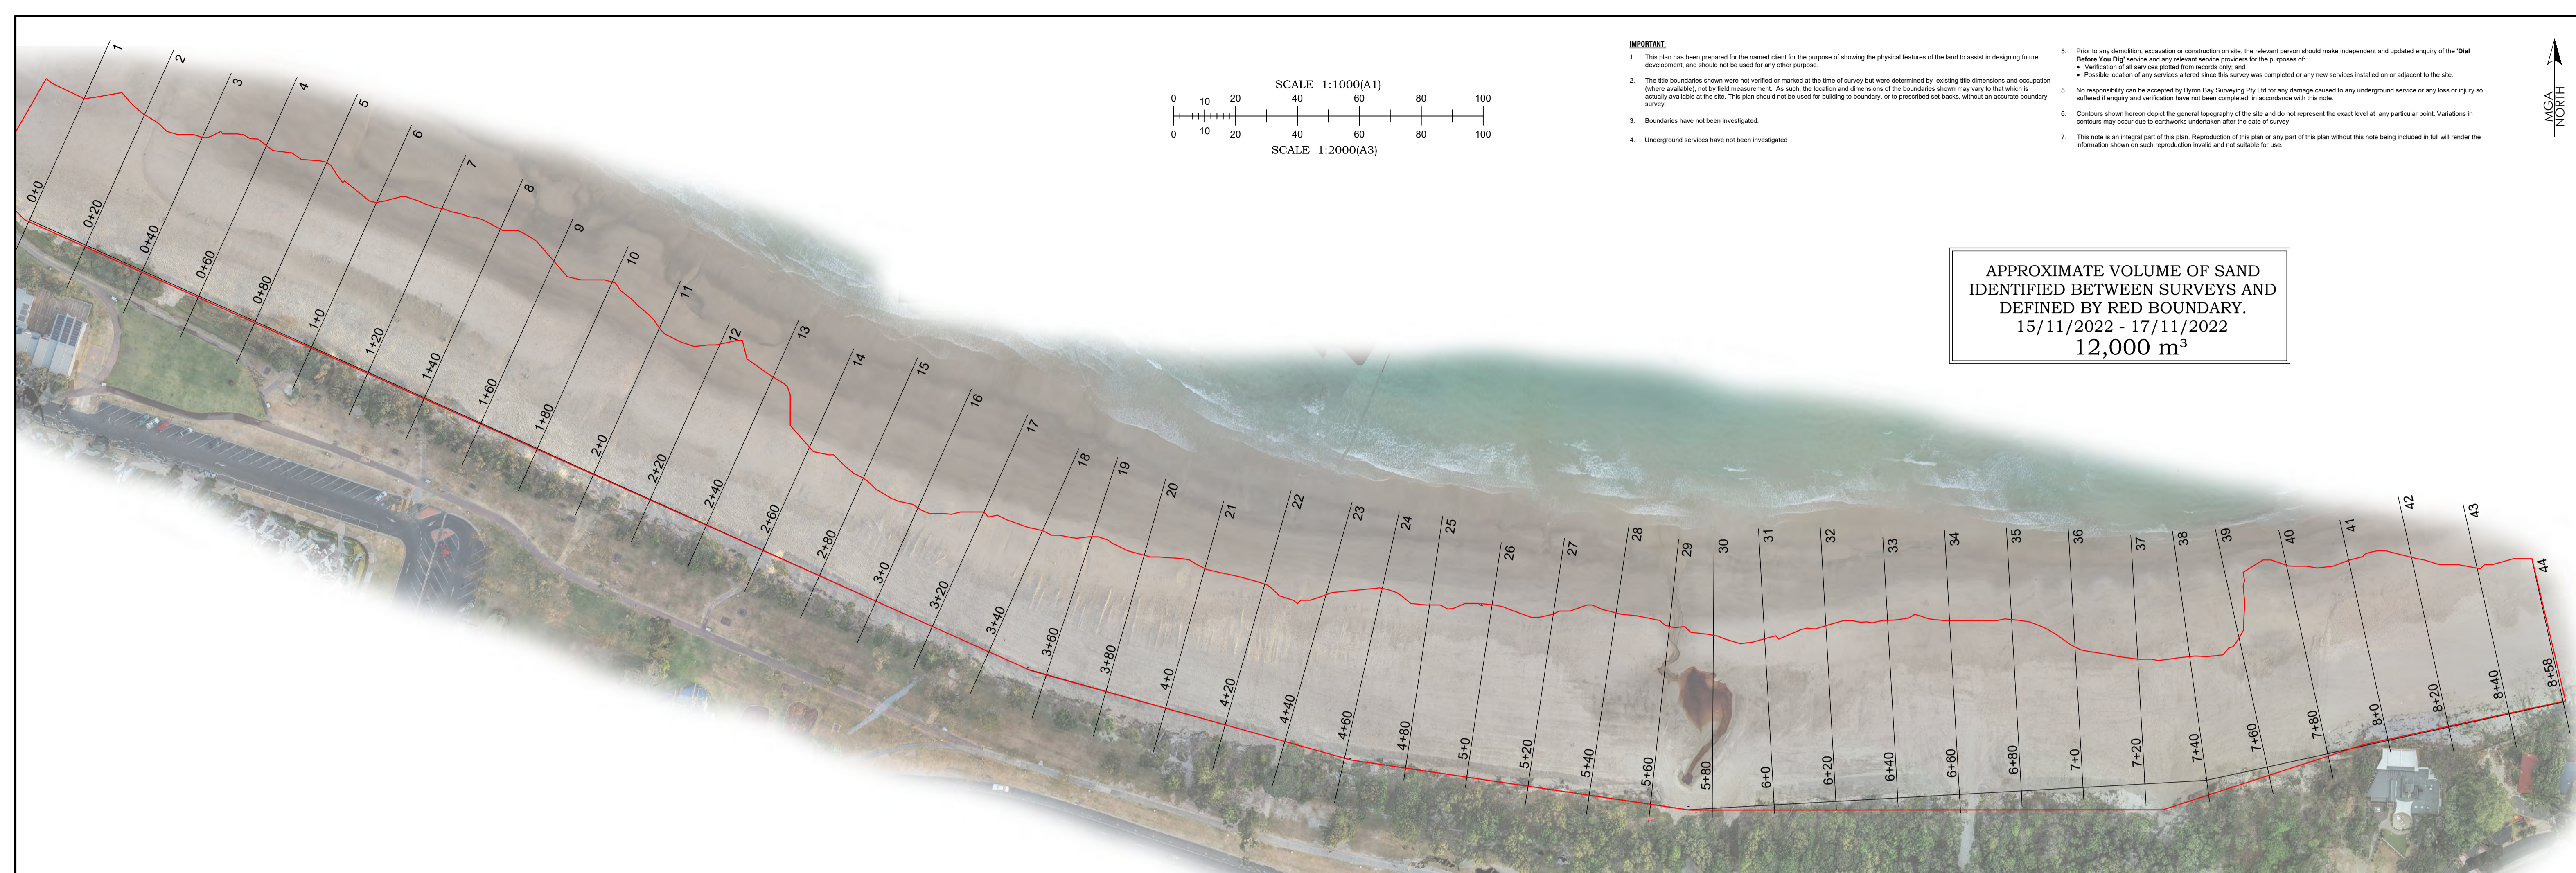
APPROXIMATE VOLUME OF SAND IDENTIFIED BETWEEN SURVEYS AND DEFINED BY RED BOUNDARY.
15/11/2022 - 17/11/2022
12,000 m³
