Item name: Pair of Cottages**Location:** 40-42 Cowper Street Byron Bay 2481

Statement of significance: This pair of Victorian style timber workers cottage of vertical board and batten construction demonstrates historical and aesthetic significance and rarity at a local level. Socially they were associated with railway fettlers who worked on the railway lines. This pair of historic cottages, positioned close to the road frontage which are rare examples of C. late 19th century era dwellings in Byron Bay. The cottages retain a reasonably high level of intactness to original roof form and scale, with original joinery and windows and are worthy of careful conservation.

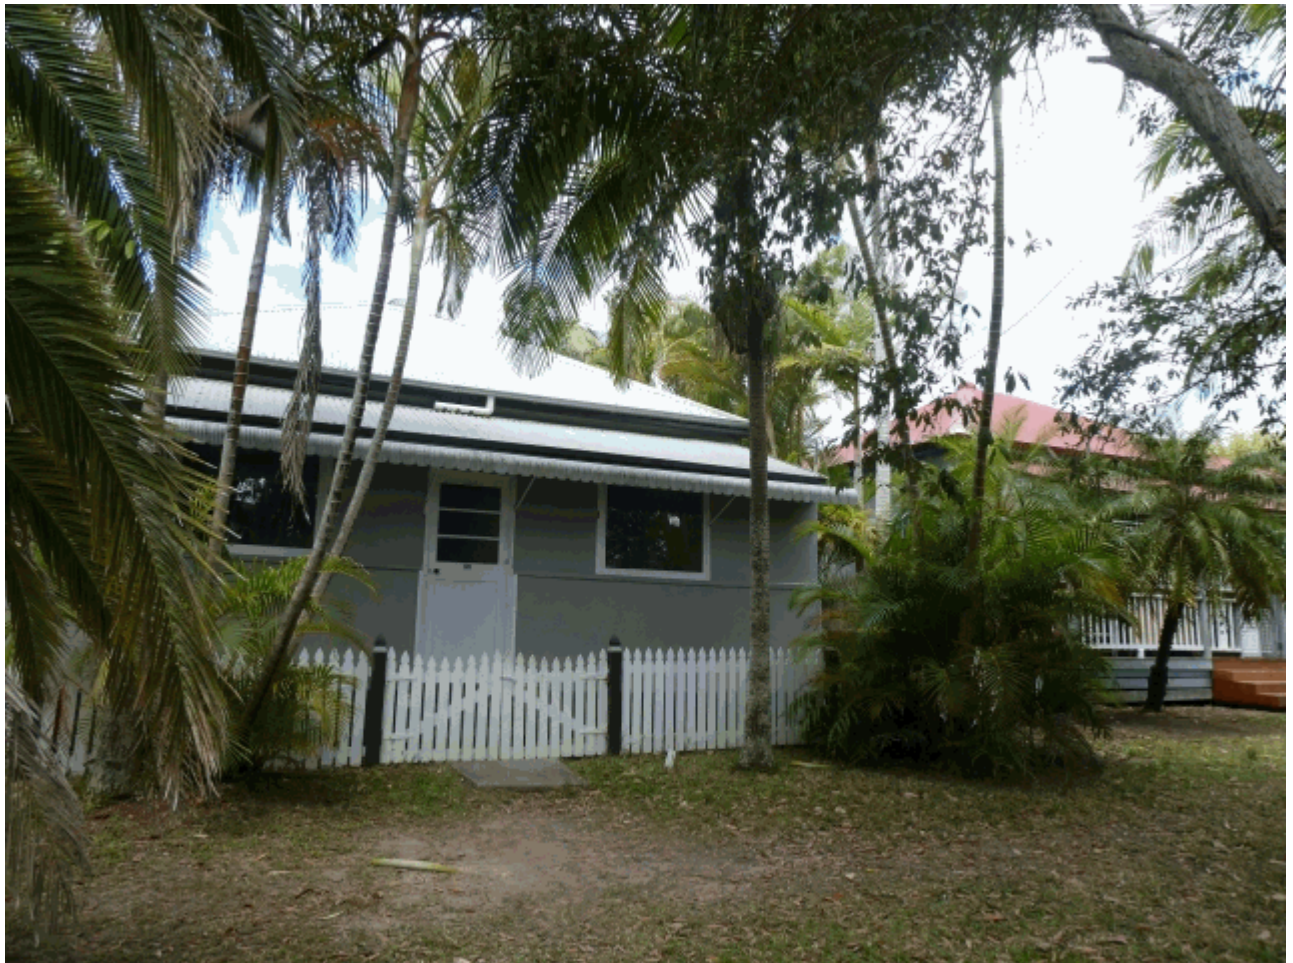
Physical description: This pair of early vertical board and batten construction workers cottages are located within the Kingsley Street Heritage Conservation Area. Each end of this section of the street is marked by a heritage listed item; 'Palm Court' to the north and Arcadia Guesthouse to the south. This pair of historic workers timber cottages have a pyramidal shaped hipped roof, symmetrical form, with front verandahs which are notable for their position aligned close to the road frontage on narrow allotments.

Caption: 40 and 42 Cowper Street

Recommended management: Carefully conserve all original elements and details. Consider removal of fibre cement wall cladding to reveal original timber walls. Ensure any future additions or alterations are located at the rear are sympathetic in form and scale and do not impact on the collective value of the pair and their streetscape setting.

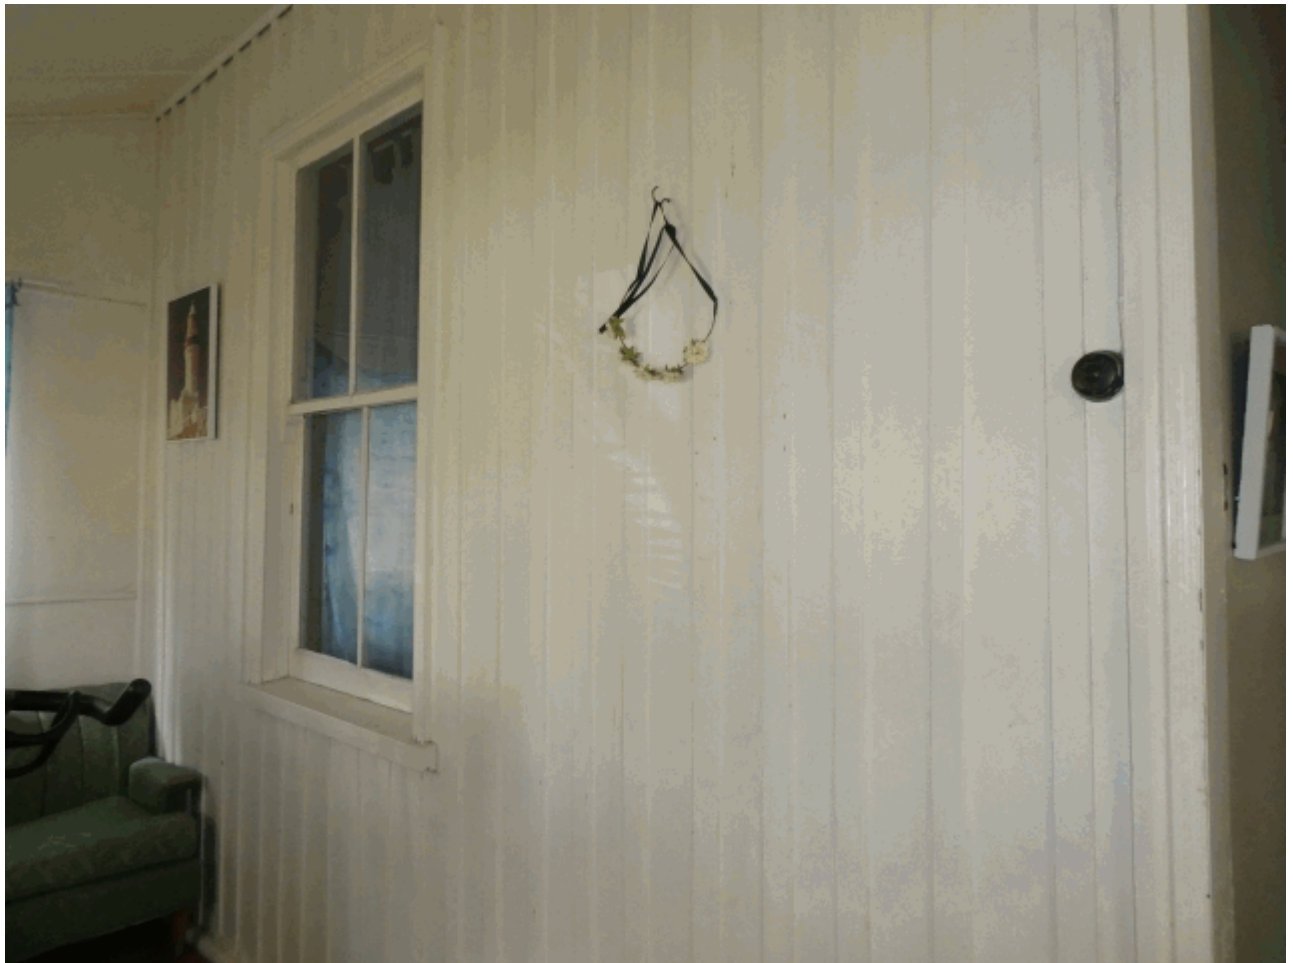
Within the enclosed verandah, the original vertical board and batten timber construction walls are evident with double hung timber sash windows on either side of a central entry door. A central entry and hallway are typical of the traditional form.

Caption: 40 Cowper Street original exterior wall within enclosed verandah

Further comments: Enclosure of verandah at 40 and later balustrade and lattice to 42. Fibre cement cladding over boards which could be removed.

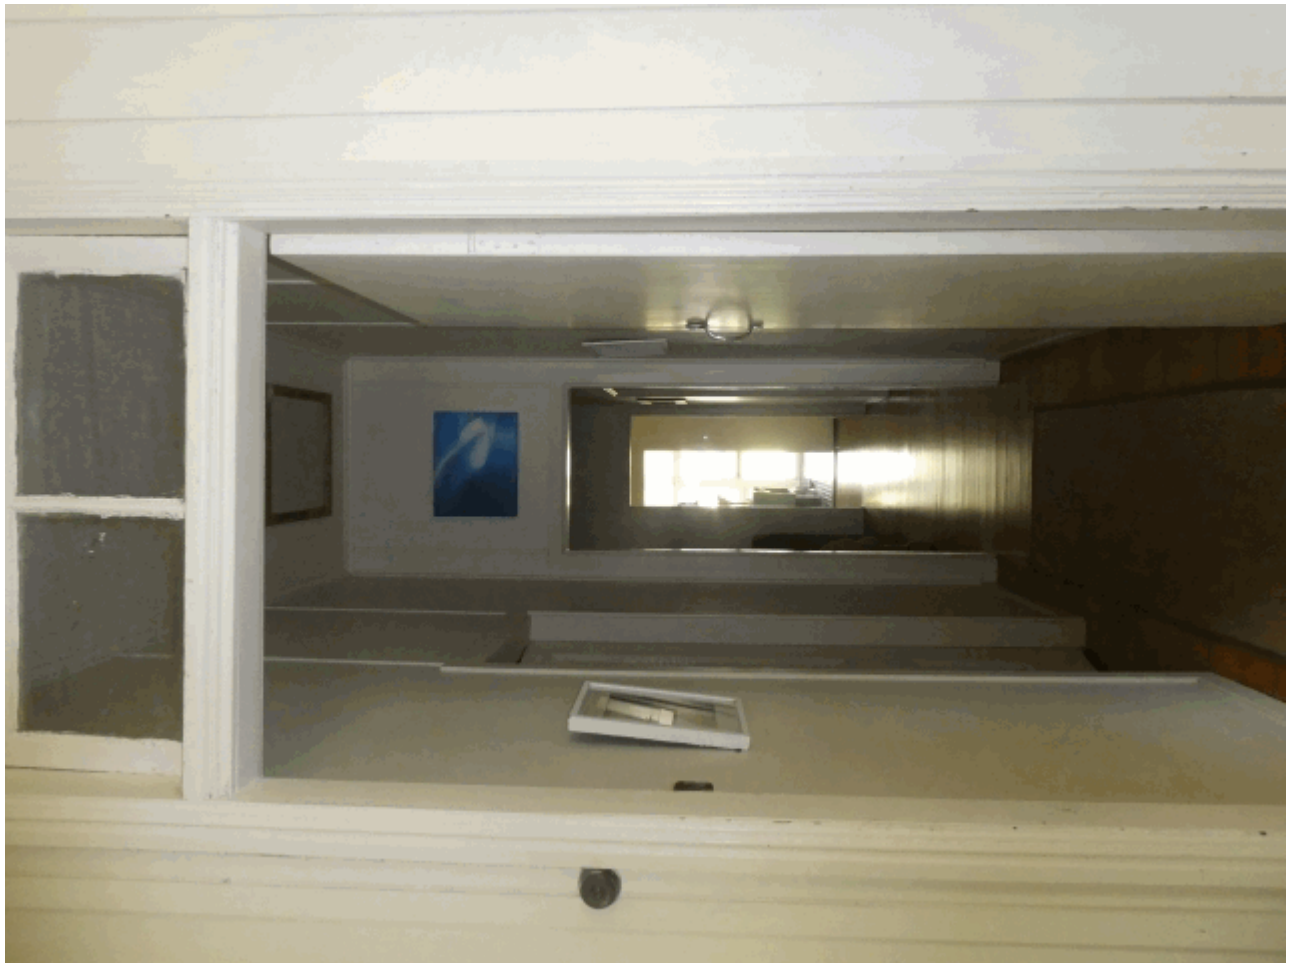
A transom light sits above a non original flush panel entry door. The interior has Four panel original doors to interior rooms and original milled brass door hardware. Original floorboards extend through the cottage and appear to be Teak or a light timber. Timber lined ceilings remain. The rooms have some fibre cement linings applied. The rear kitchen living area is a later lean to addition. Timber boundary fences.

Caption: 40 Cowper Street hallway

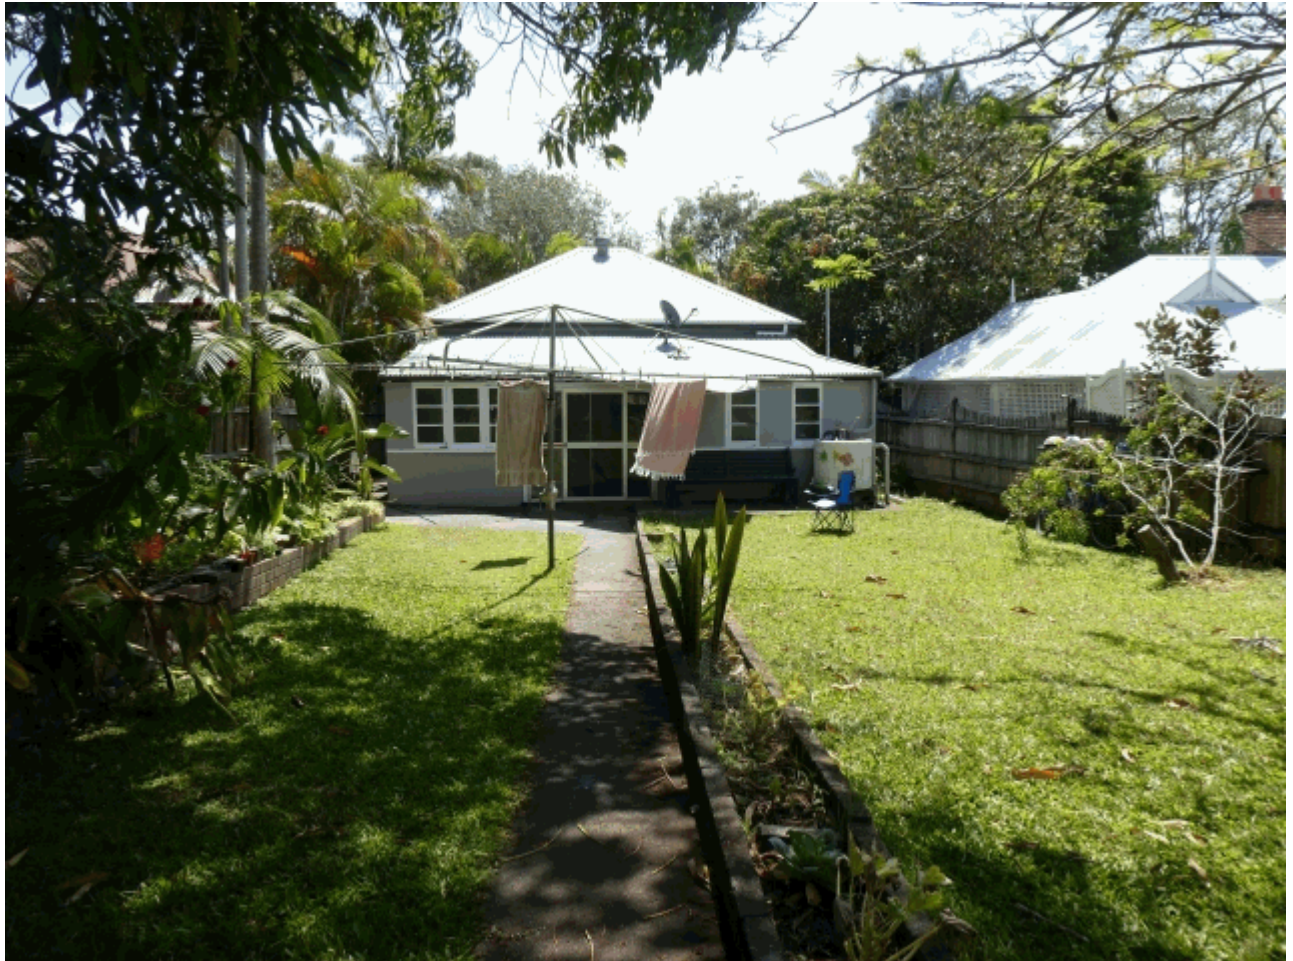
Caption: 40 Cowper Street rear elevation and garden

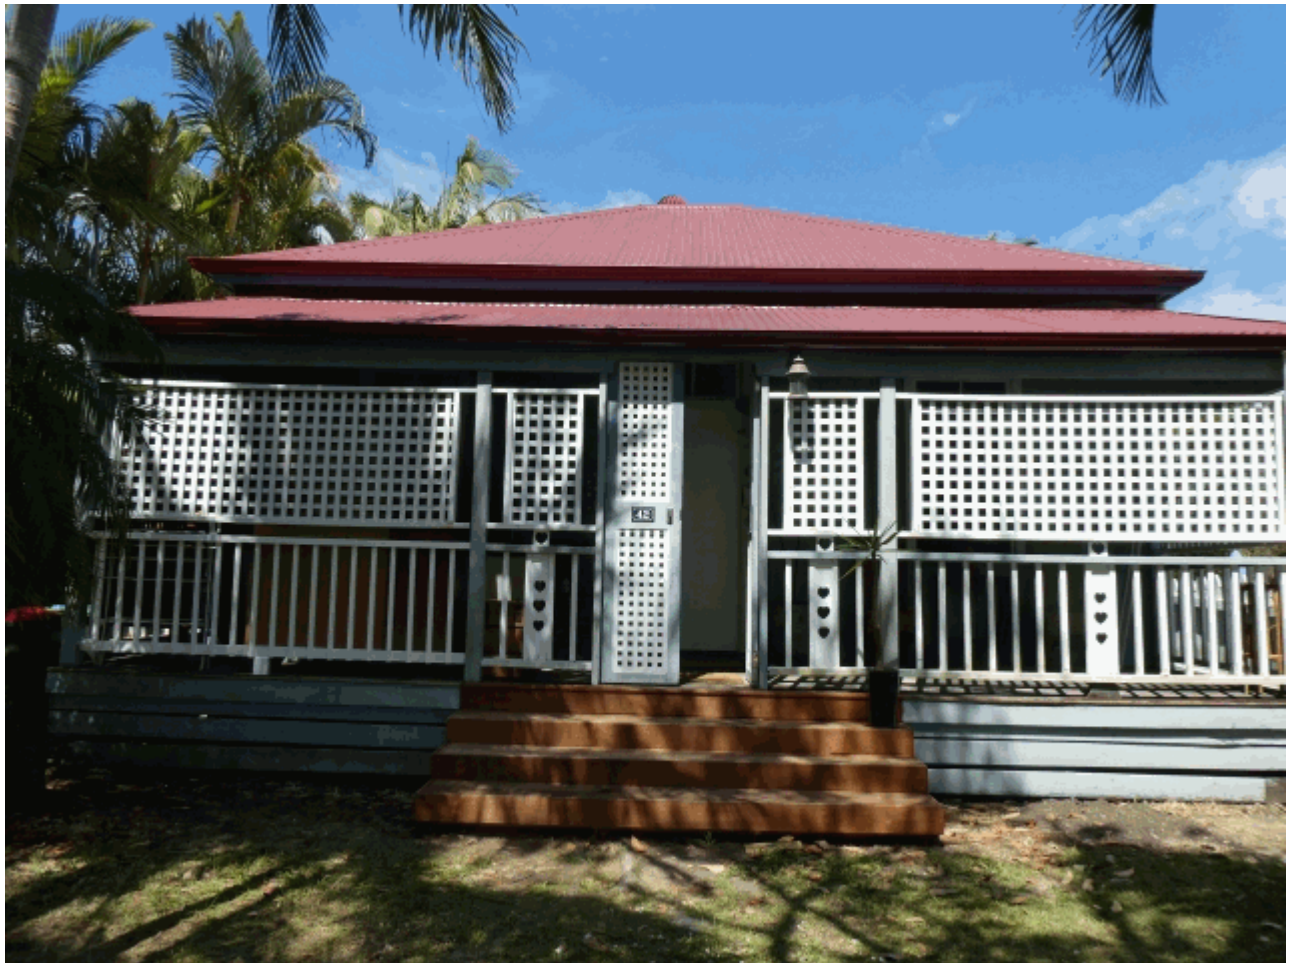
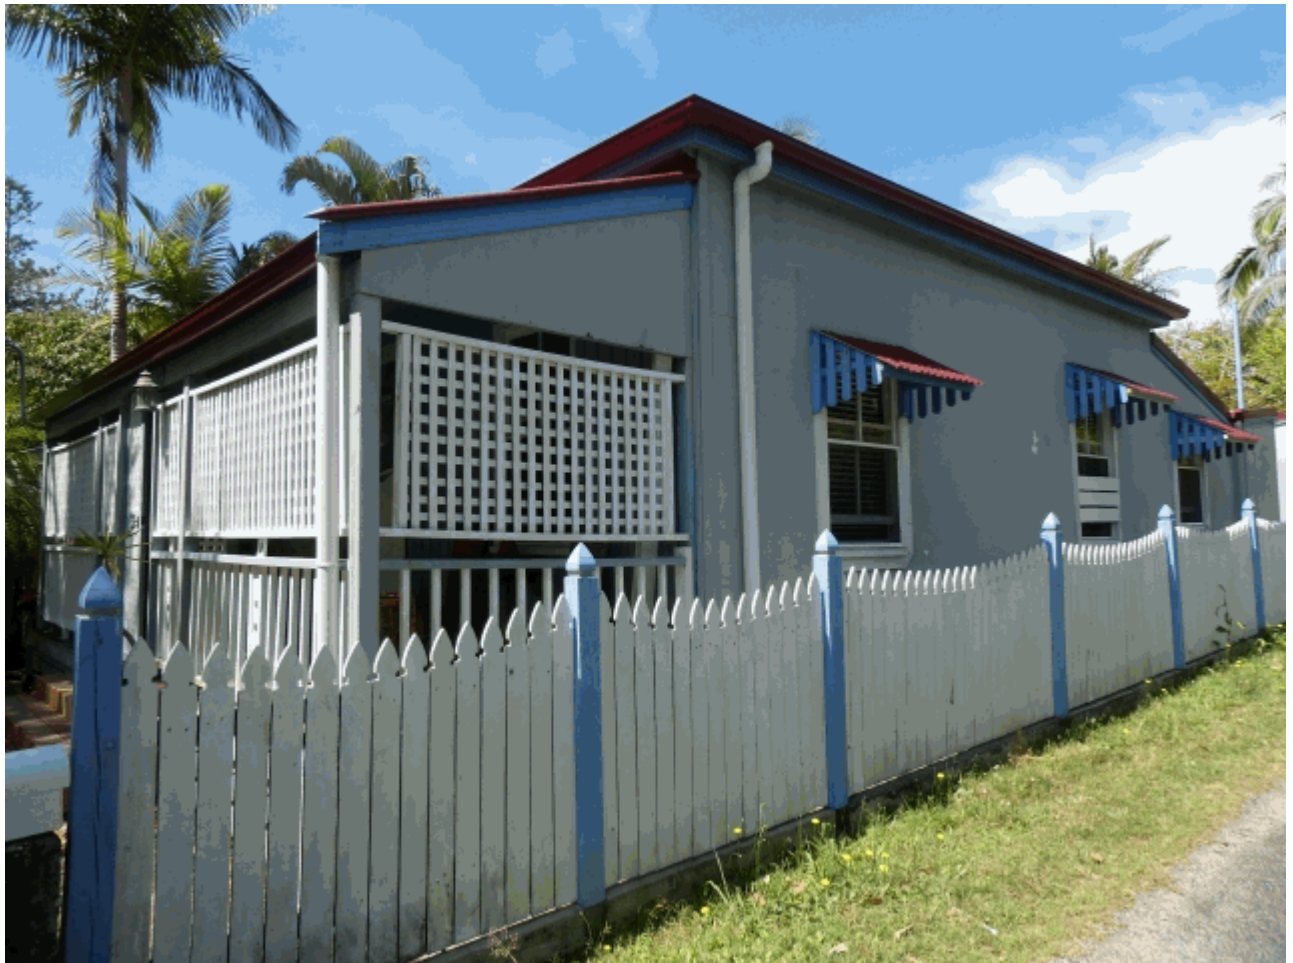
No 42 has the same form and proportions with a separate skillion verandah roof below the hipped roof. The verandah is not fully enclosed but has some non original timber balustrade and lattice above for privacy. This dwelling exterior has also been clad over in fibre cement but retains original timber double hung sash windows with small hoods. Timber picket fence on side with laneway. The interior of this cottage was not inspected.

Caption: 42 Cowper Street

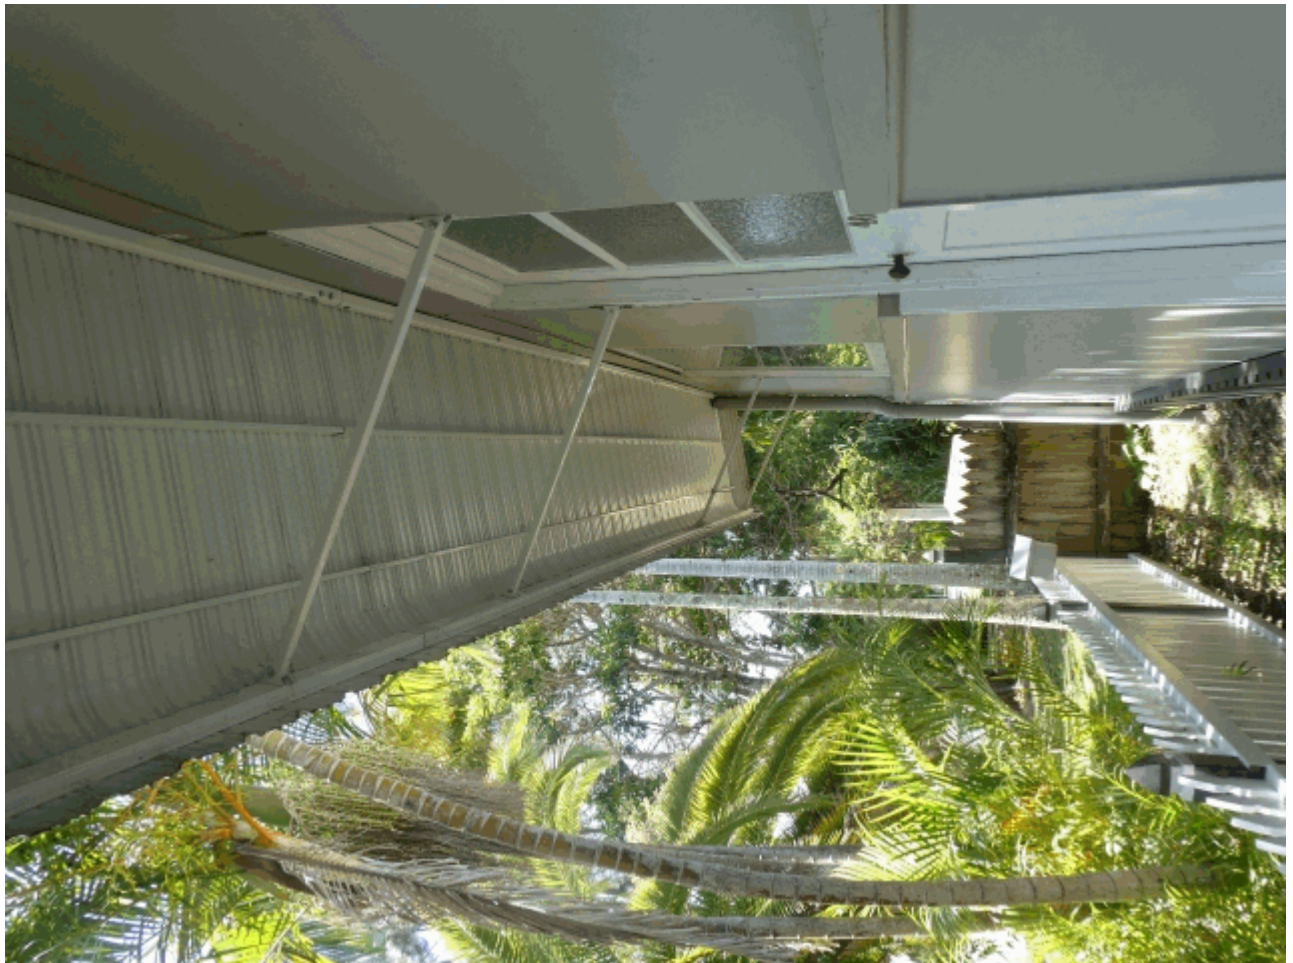
No 40 Cowper Street maintains its original hipped roof form with a rear skillion roof addition. and its presentation is reduced by an enclosed verandah with fibre cement cladding which is a removable alteration. An aluminium awning projects beyond the original verandah line.

Caption: 40 Cowper Street
