HERITAGE PARK

LANDSCAPE MASTER PLAN

Prepared by Plummer & Smith Pty Ltd for Byron Shire Council

This document is a Landscape Master Plan report outlining landscape treatments and design strategies for Heritage Park, Mullumbimby. The plan seeks to promote environmental, cultural, and open space outcomes in a space that is a celebration of the diverse local community.

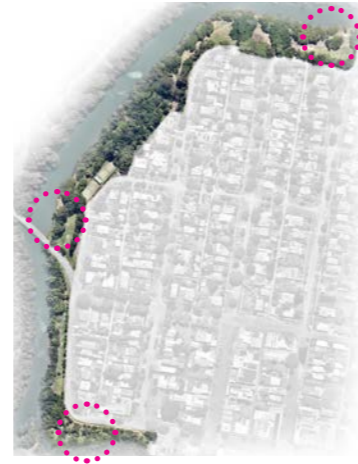
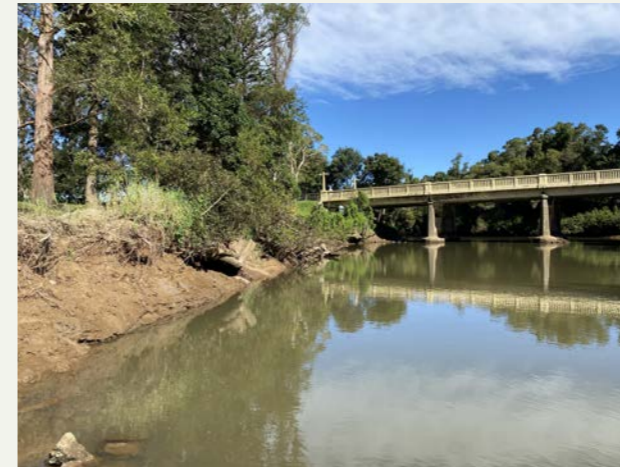
There is significant stress on a number of environmental and ecological areas of the park. This is particularly the case in the riparian zones where river erosion is undermining the banks and damaging riparian vegetation areas and therefore damaging the long term viability of adjacent public open space areas. There are also significant ecological and environmental assets including the Arboretum and native riparian vegetation areas.

Riparian erosion stress

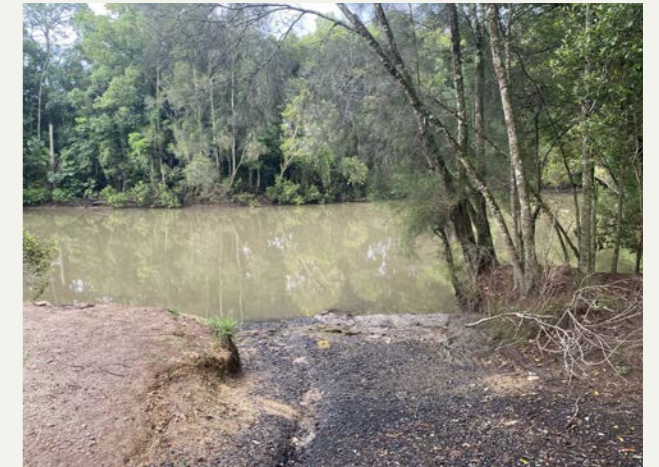
Riparian erosion stress

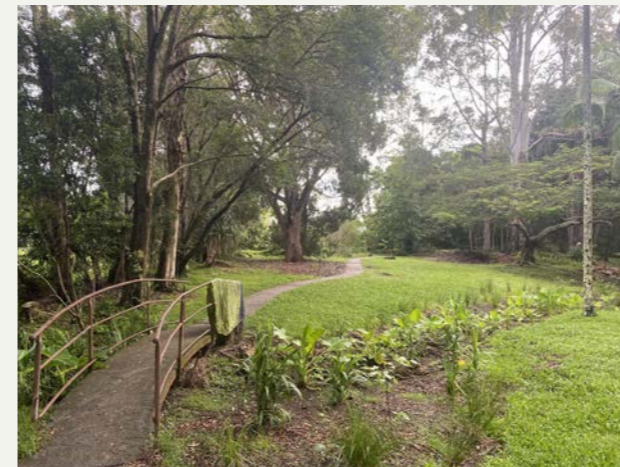
Much of the park- particularly Heritage Park and Heritage Park West, are characterised by a lack of constructed paths and poor accessibility. In many areas existing paths are also no longer fit for purpose. This significantly reduces the accessibility of the park and the potential benefits and amenity that this linear park space offers the community. Palm Park and the associated sculpture walk area are the only park areas with existing viable circulation paths.

Existing path requiring upgrade

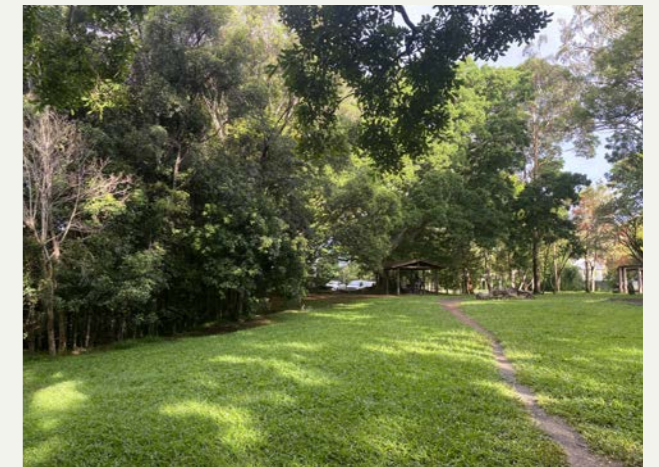
Example of park areas without formal paths

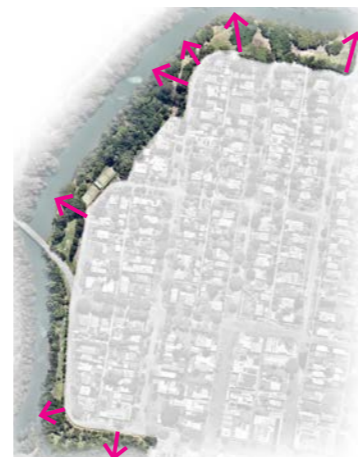
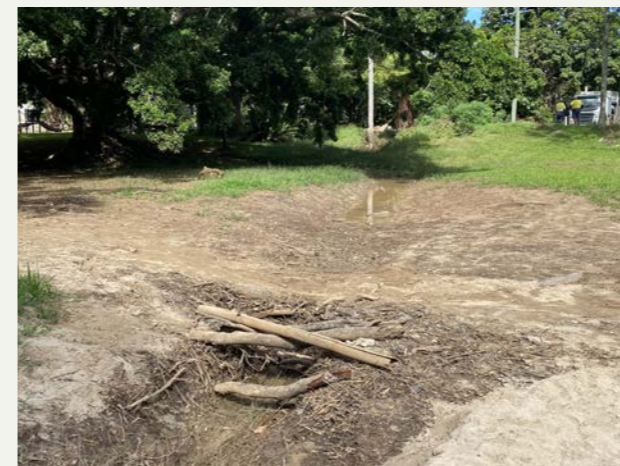
Existing drainage lines crossing the park areas. Image also shows silt deposit from the 2022 flood

The park areas come under significant stress from existing hydrology. Much of the park is in flood flow zones- all of it is in potential inundation areas. The park is also the location of much of the town centre's 'end of line' drainage- being the discharge point for much of the street network's drainage. This causes significant erosion and maintenance stress as well as linear connectivity disruptions within the park.

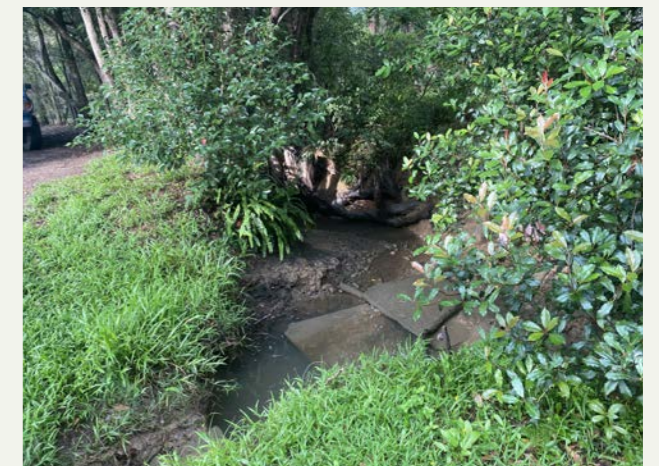
Heavily eroded and degraded drainage line

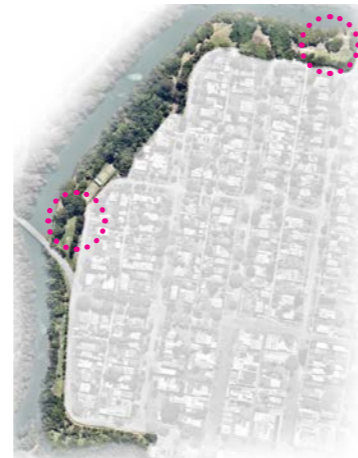
The two current on site car parks are at the north eastern river access and the western boat ramp area. Both areas are unsealed and are heavily degraded. The on site car parking and vehicular access consumes large expanses of the park in valuable positions (particularly Heritage Park areas), meaning these areas cannot be used as public open recreational space. The majority of people utilising the park accessed the park via walking. On street car parking is also present at the tennis courts and along the edges of the park.

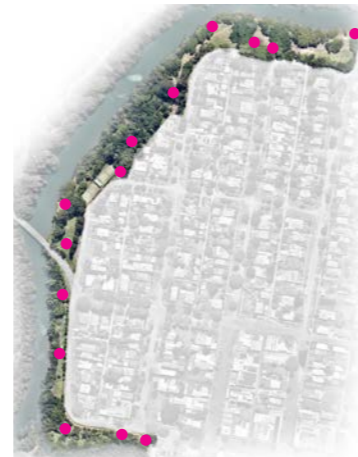
The site currently has a range of facilities of varying ages. Existing infrastructure includes shelters, benches, picnic tables, pathways, bridges, drainage systems, parking management bollards, boat launch ramps, and bins. In a number of cases these facilities are inaccessible.

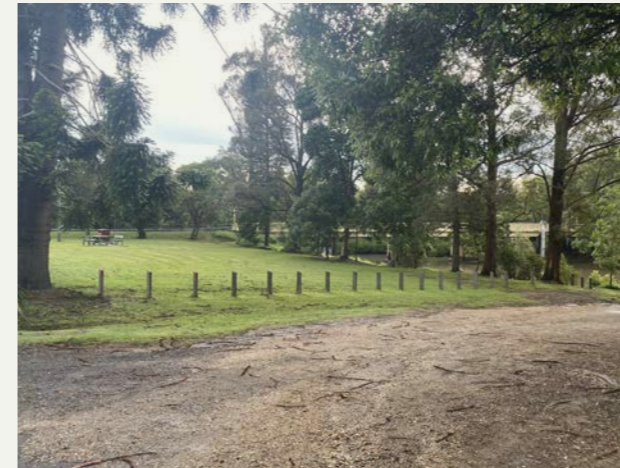
Heritage Park West informal vehicular access

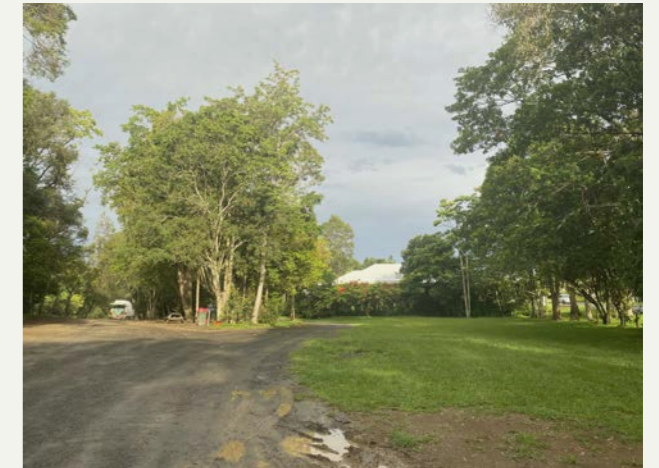
Heritage Park open space areas dominated by vehicular access

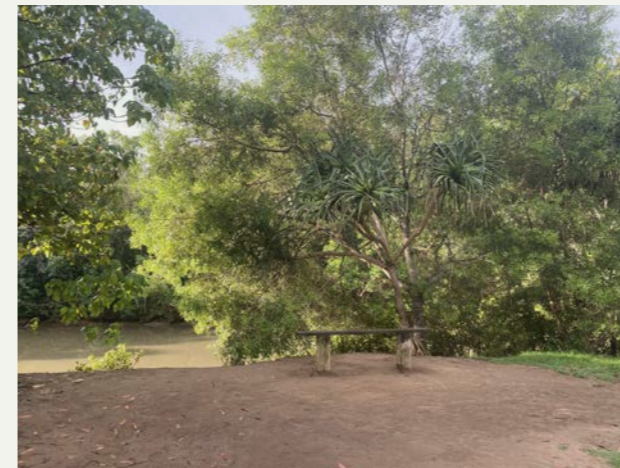
Existing informal and inaccessible furniture

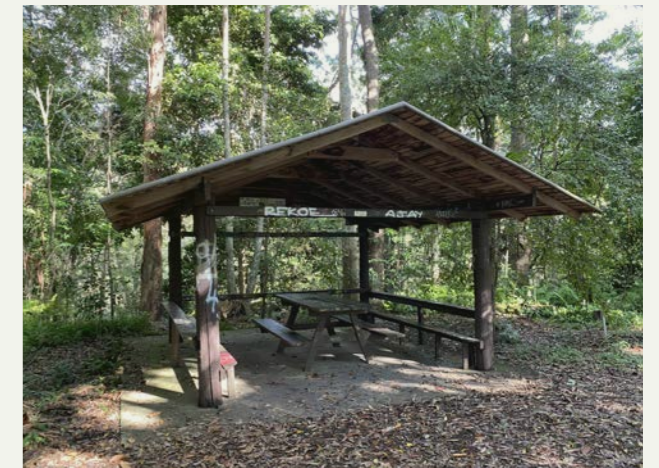
Existing arboretum shelter

8. Existing shelter upgraded (refurbished or replaced- to be assessed) with surrounding areas made usable for small community gatherings
9. Secondary path along river connecting to arboretum path- increasing activation of river edge areas

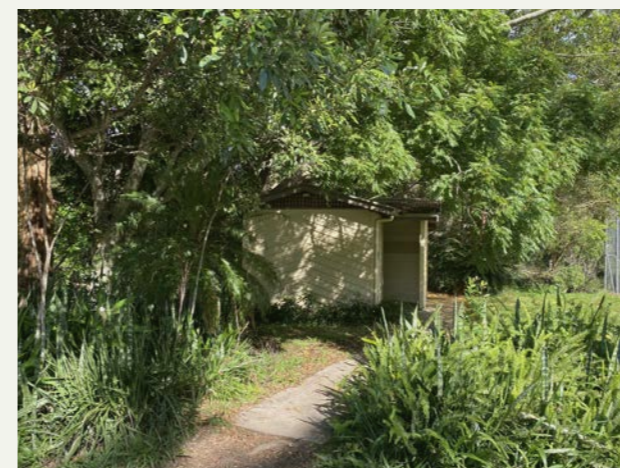
Existing amenities block with poor passive surveillance

Visibility and sight lines into the existing toilet block will be increased to improve passive surveillance and safety. This will be achieved by redesigning the entry area and with the removal of existing under-storey plants blocking views to and from the amenities. This under-storey can be replaced with low growing species.

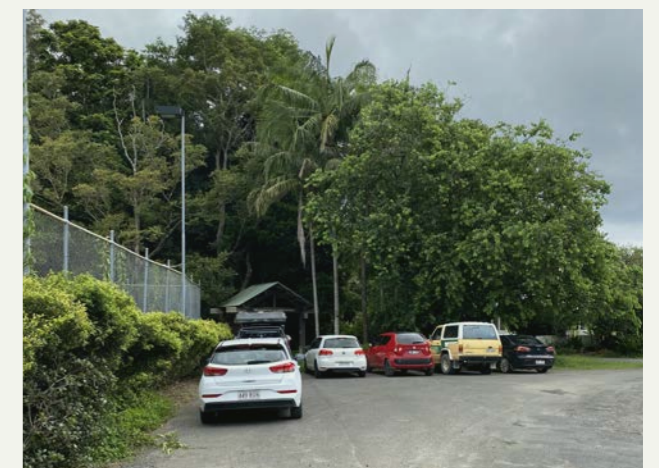
Maslen Arboretum entry- no formalised pedestrian access

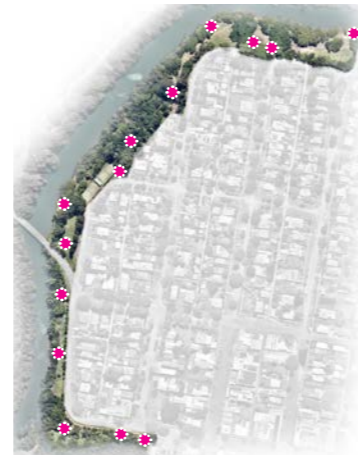
Upgrades and refurbishments to existing infrastructure as well as additional facilities will be incorporated into the park. Upgrades to the shelters, playground, benches, picnic tables, pathways, bridges, drainage systems, car parking, and river access will be included. This will create a more usable, appealing and welcoming space for a wide range of community members. Existing infrastructure should be retained where possible.

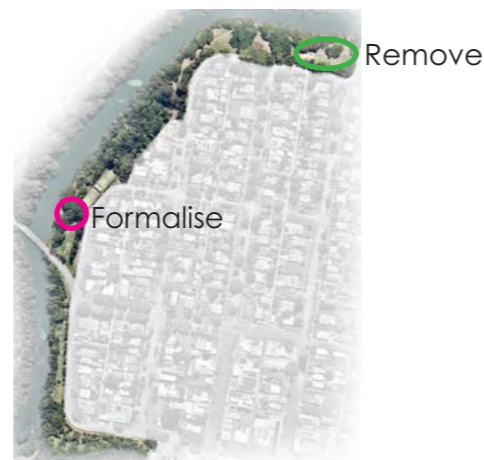
Pedestrian access will be prioritised as the main access strategy to the site. Prioritising people oriented open space and riparian health will mean the removal of informal car parking and vehicular access from the northern end of the park. Car parking to the western river access will be upgraded. On street car parking and existing car parking near the tennis court will be retained and upgraded. This will improve safety, ecological issues, and enhance usable public open space.

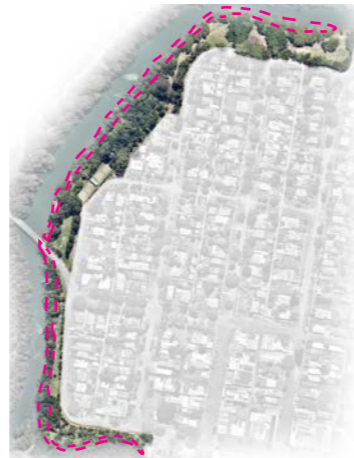
Reducing the destruction and loss of the riparian zones is imperative for the environmental and ecological health of the site. Riparian vegetation along the river banks is essential for bank stability and the protection of the park and wildlife habitat. Strengthening of the riparian zones will be undertaken by implementing planting strategies to reinforce the existing riparian corridors and removal of weed species. In areas where the riparian vegetation has been impacted, planting areas will be widened. Vehicle access to riparian areas will be managed and/or removed.

The staged removal of Camphor laurels from river bank areas is an important part of riparian management. These trees should be replaced with appropriate native species that will assist long term river bank stability rather than undermine it.

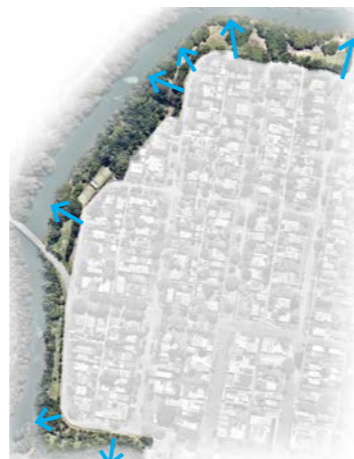
Existing key drainage locations will be upgraded to ensure positive drainage throughout the site. The main upgrades proposed will be planted drainage swales, rain gardens and regrading of some areas to limit pooling of water.

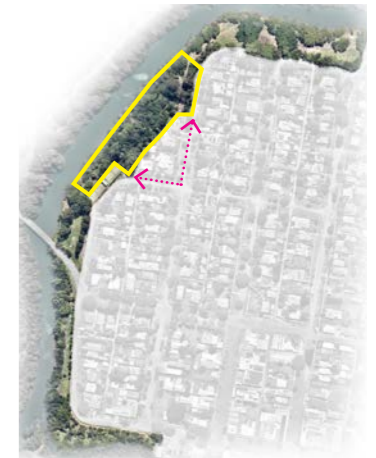
Thorough passive surveillance into the Arboretum is not achievable due to the dense existing vegetation. This section of the park is also bounded on both sides- the river and houses- i.e. there is no street frontage through the majority of this area. Management strategies within the arboretum can improve safety- such as management of foliage encroaching on the path with careful and selected pruning to ensure the pathway is kept clear. An 'arboretum bypass' path is proposed on Dalley and Gordon Streets, connecting the southern entry of the arboretum to the pathway network at the north of arboretum, providing an alternative route to walking and cycling through the Arboretum to improve circulation options.

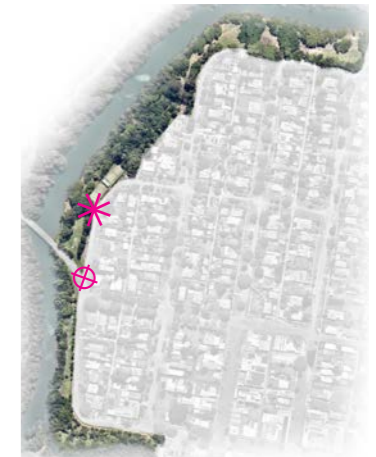
Providing for safe pedestrian movement across this intersection is critical for safety and accessibility.

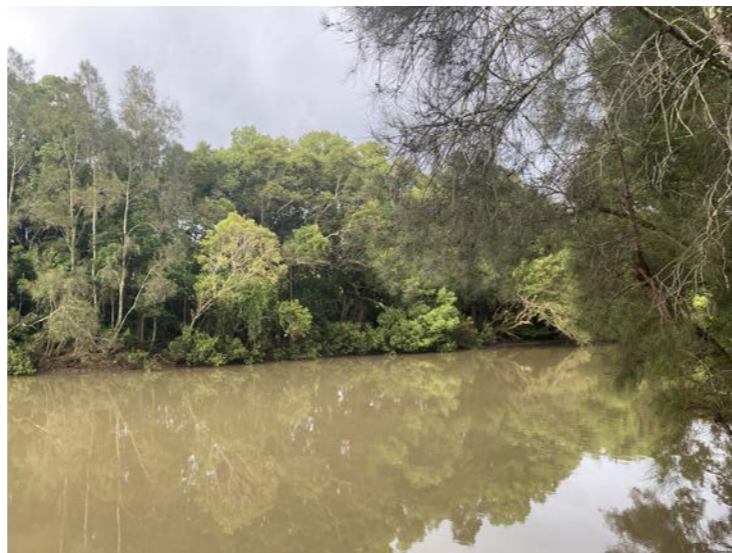
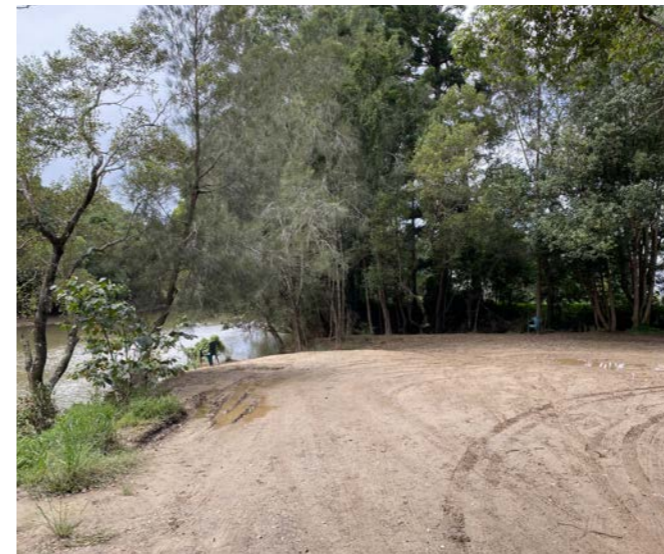
Riparian degradation associated with vehicular access and the boat ramp in Heritage Park

The informal boat ramp located in Heritage Park (northern boat ramp) is having significant negative impacts on riparian health. Maintaining and formalising boat access within Heritage Park will result in significant loss of public open space in the future- for required vehicle movements and associated parking. This runs counter to community desires for maximising usable open space in the Heritage Park sector. Beyond the park boundaries the small residential village streets are already under strain from increasing traffic movements and parking. Encouraging large vehicles and boat trailers into these streets long term does not represent a sound future strategy for promoting safe streets and viable public open space outcomes for the community. As a result the solution proposed in this masterplan is to provide 'soft' river access from within the Heritage Park area for kayaks and canoes.

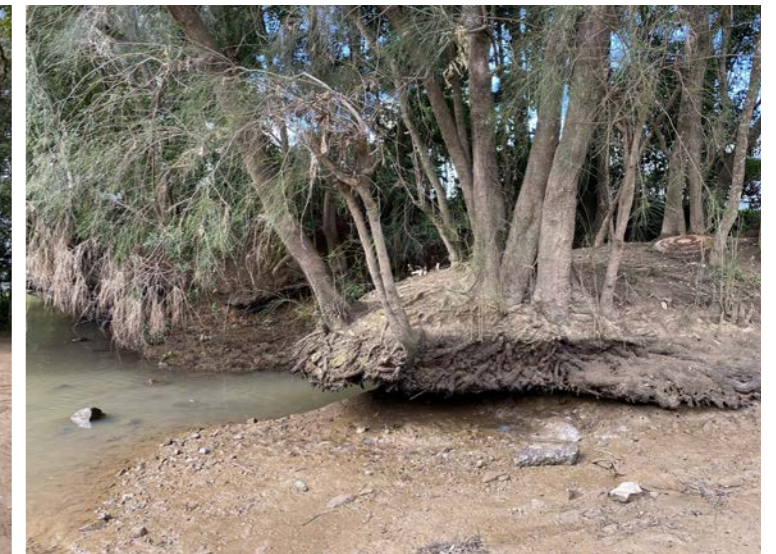
Existing significant erosion associated with the informal boat ramp in Heritage Park

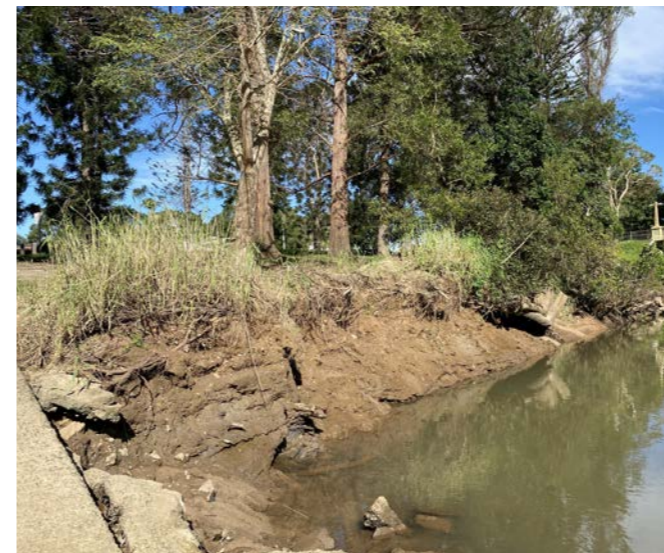
The Heritage Park West boat ramp is steep and under-utilised- adjacent riverbank areas are heavily eroded

The Heritage Park West boat ramp, located near Federation Bridge is proposed to be retained in this masterplan. The retention of this boat ramp will entail a formalised car park with the existing boat ramp retained in it's current condition with potential for renewal, subject to future funding. There is another option for this area to be a 'soft' river access (refer to 3.7).

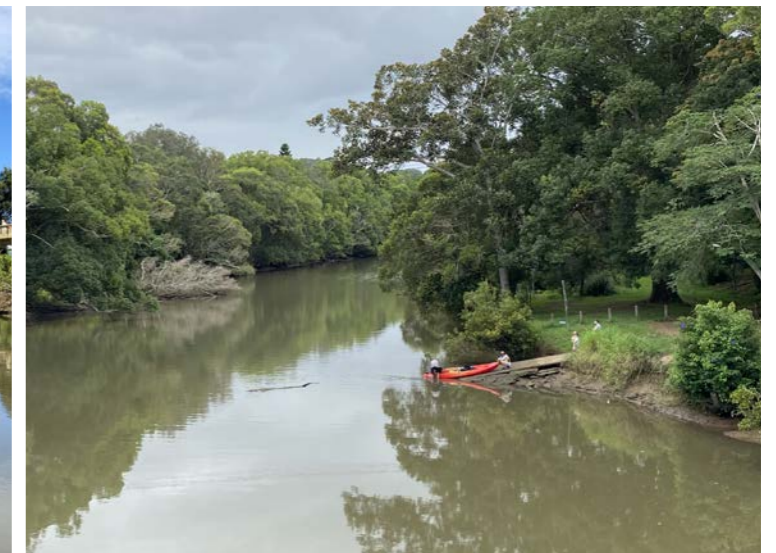
Example of kayak launching from Heritage Park West

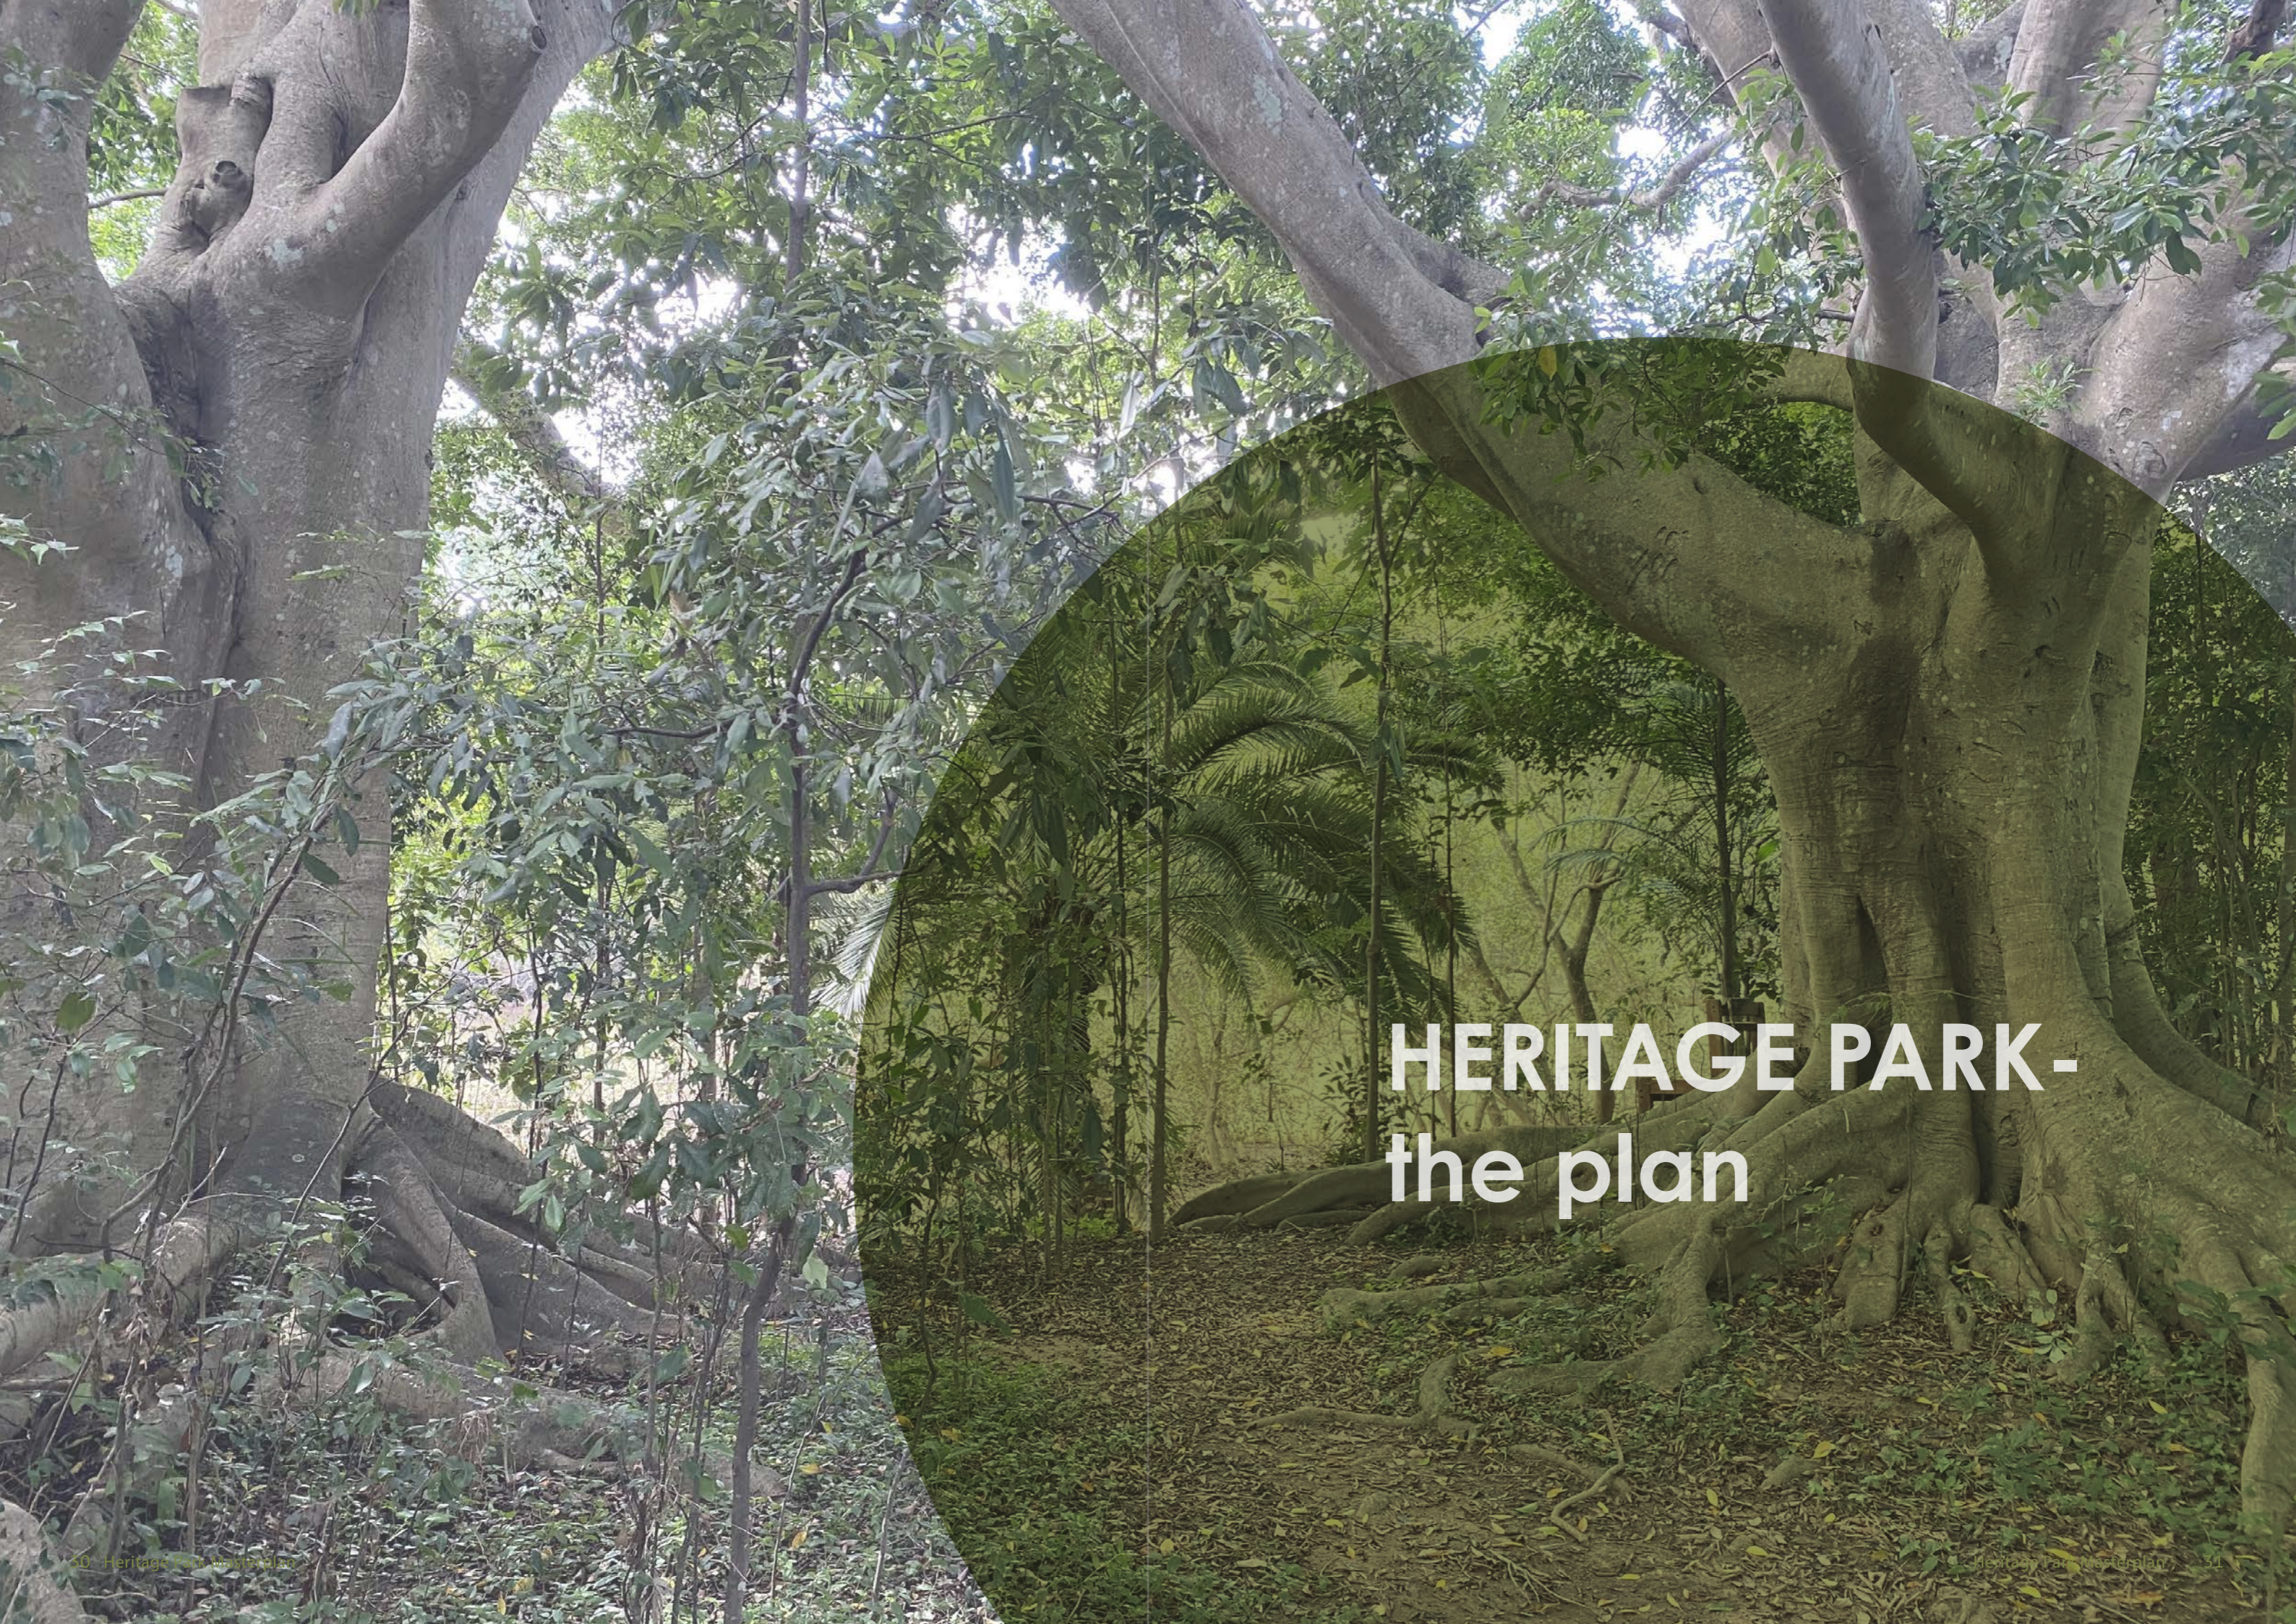
MASTERPLAN KEY PLAN

3.1 Proposal

Refer to detail plans for additional information

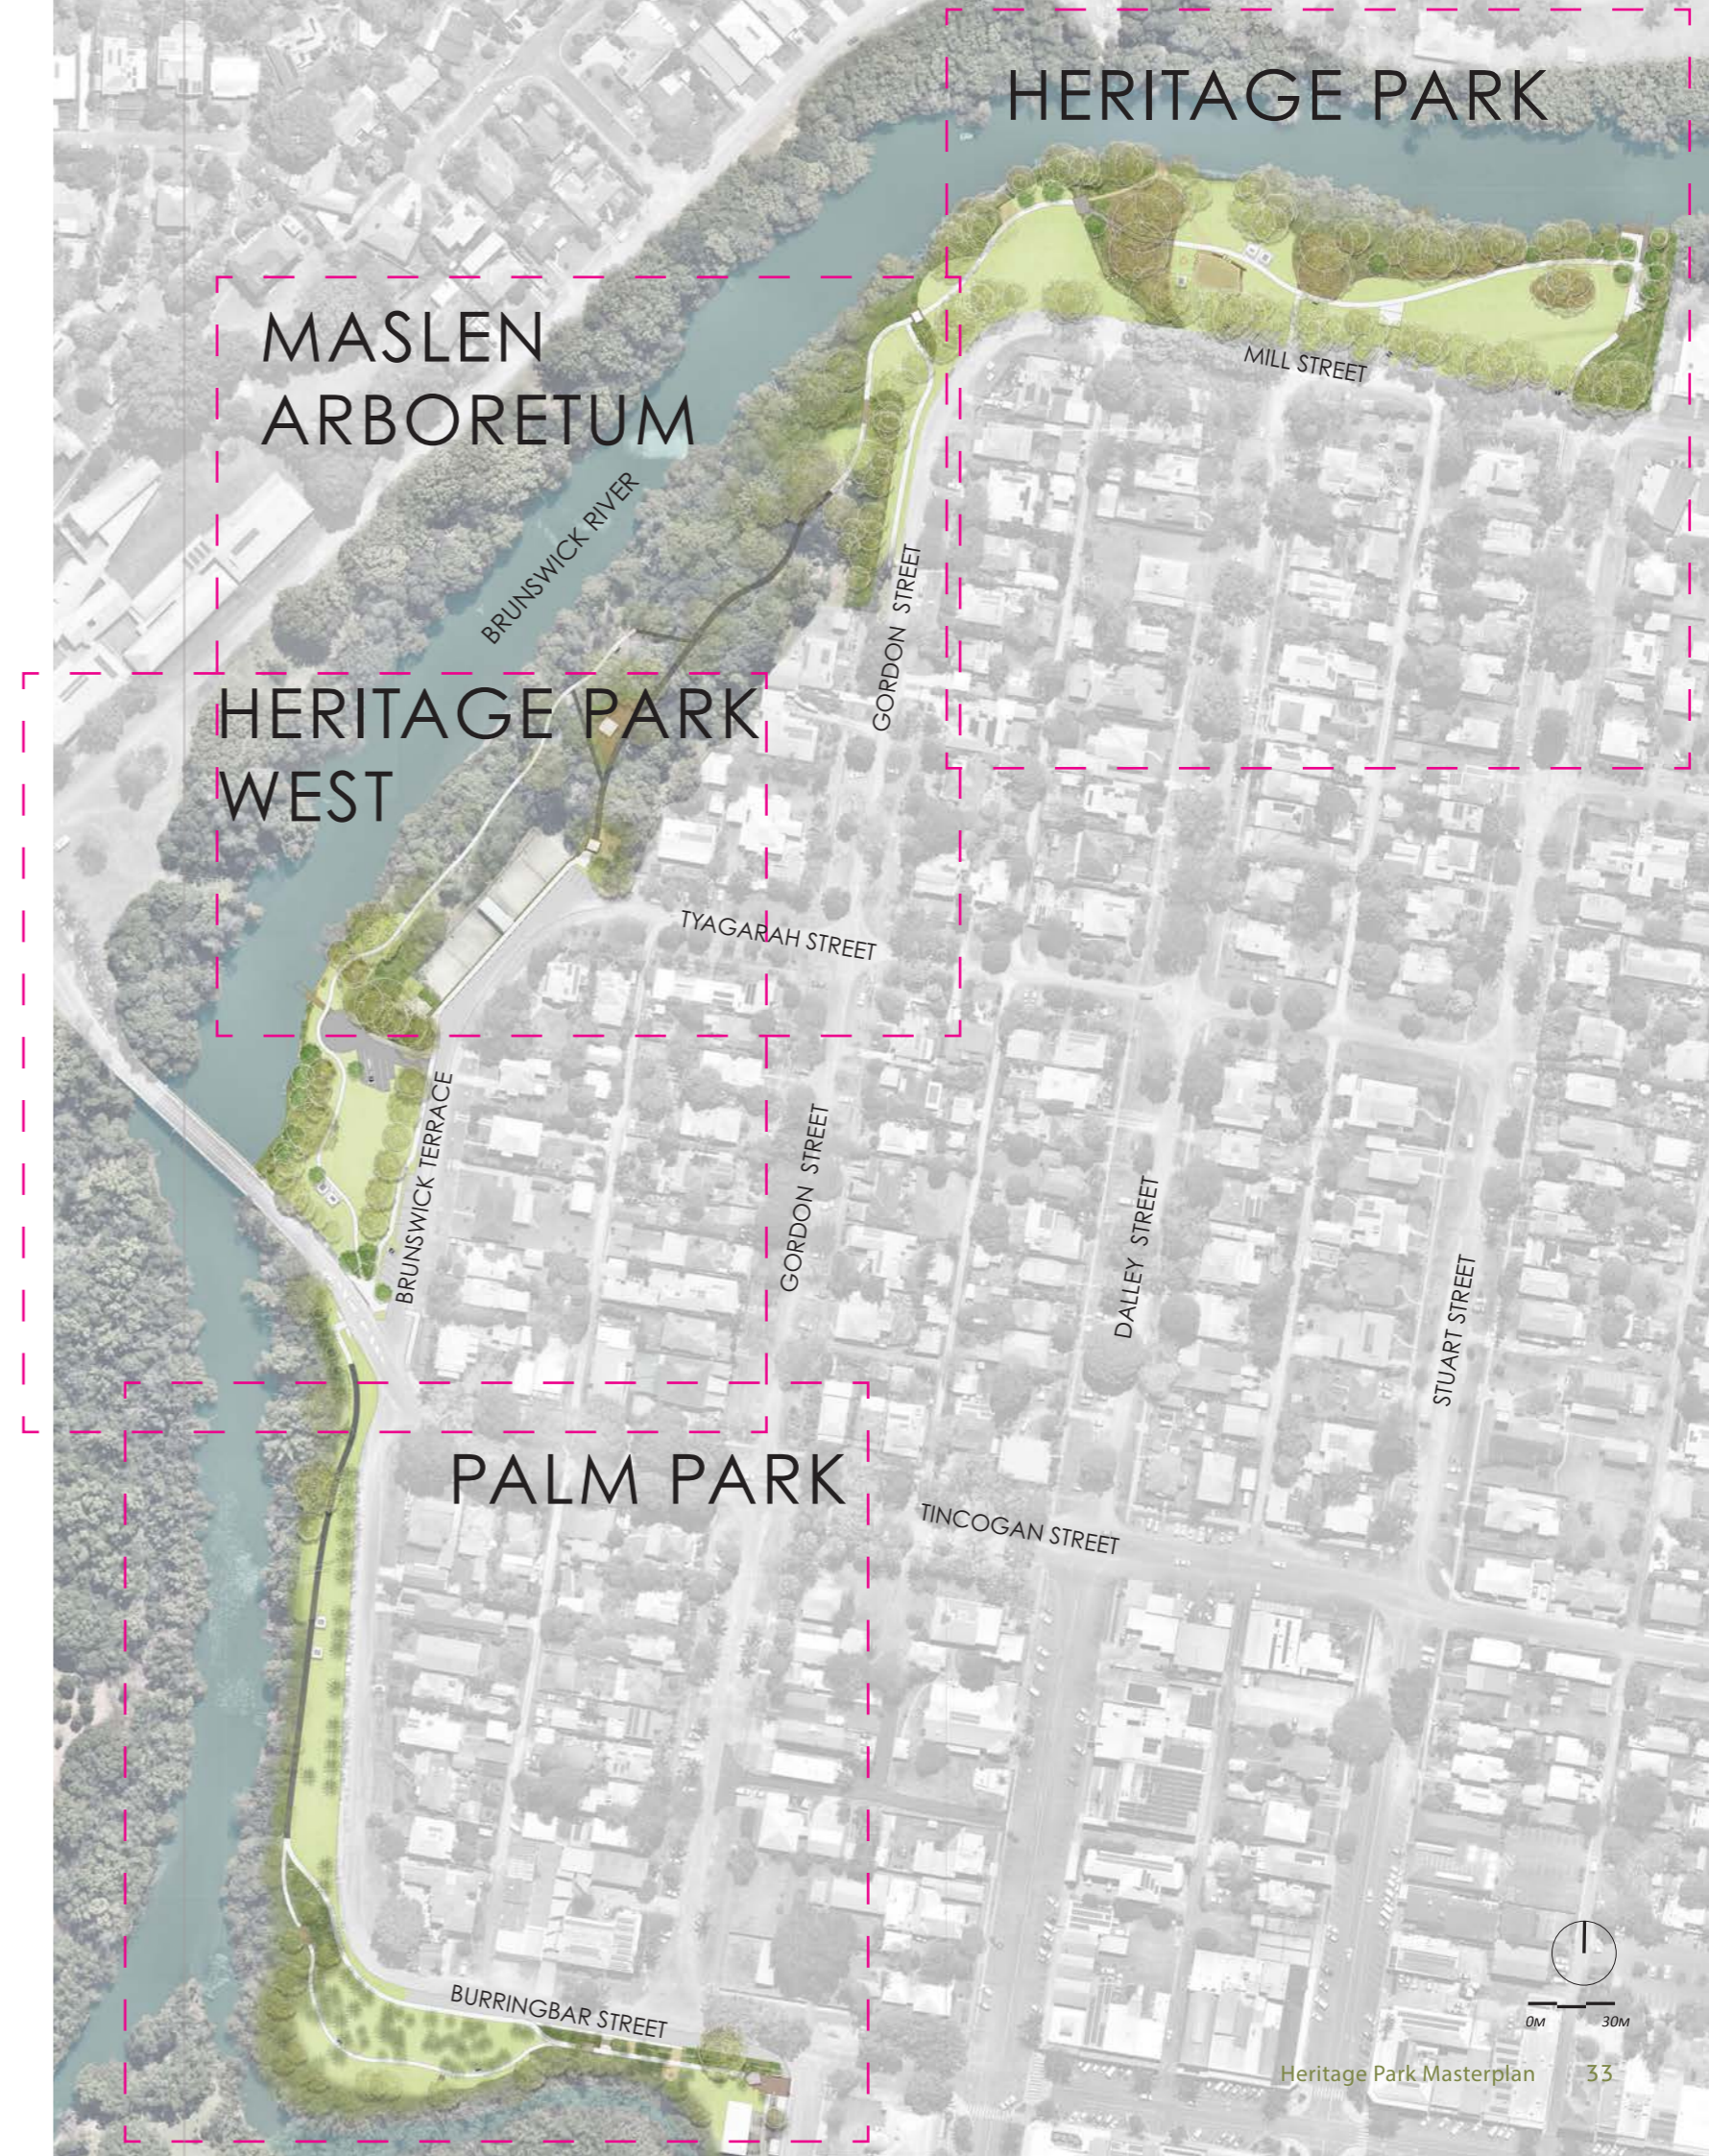
3.2 Heritage Park

1. Concrete pathway nominal 2m wide
2. River viewing pause point with seating, interpretive information and safety balustrade
3. New shade / riparian tree planting

4. Existing grass areas retained as flexible open space
5. Existing trees retained
6. Improved drainage swale including stabilisation measures and native planting to assist with the filtering of run-off prior to it entering the River system

7. Boardwalk providing access under fig trees and across the drainage swale
8. River viewing platform providing accessible river viewing destination and protection of sensitive riparian zones

9. Decomposed granite/gravel path
10. Nature play upgrades and additions to existing play space- viable play elements retained (such as rope climbing structure) and degraded elements upgraded

11. New shelter with picnic table
12. New shelter with BBQ
13. Amenities building with access from playground and on street car parking- positioned close to park entries and mid way between Heritage Park use nodes

16. Turf area for passive recreational use
17. Picnic bench
18. Brunswick River access node- kayak / canoe launch, river viewing terrace, erosion management, picnic tables, bike racks and riparian vegetation improvements

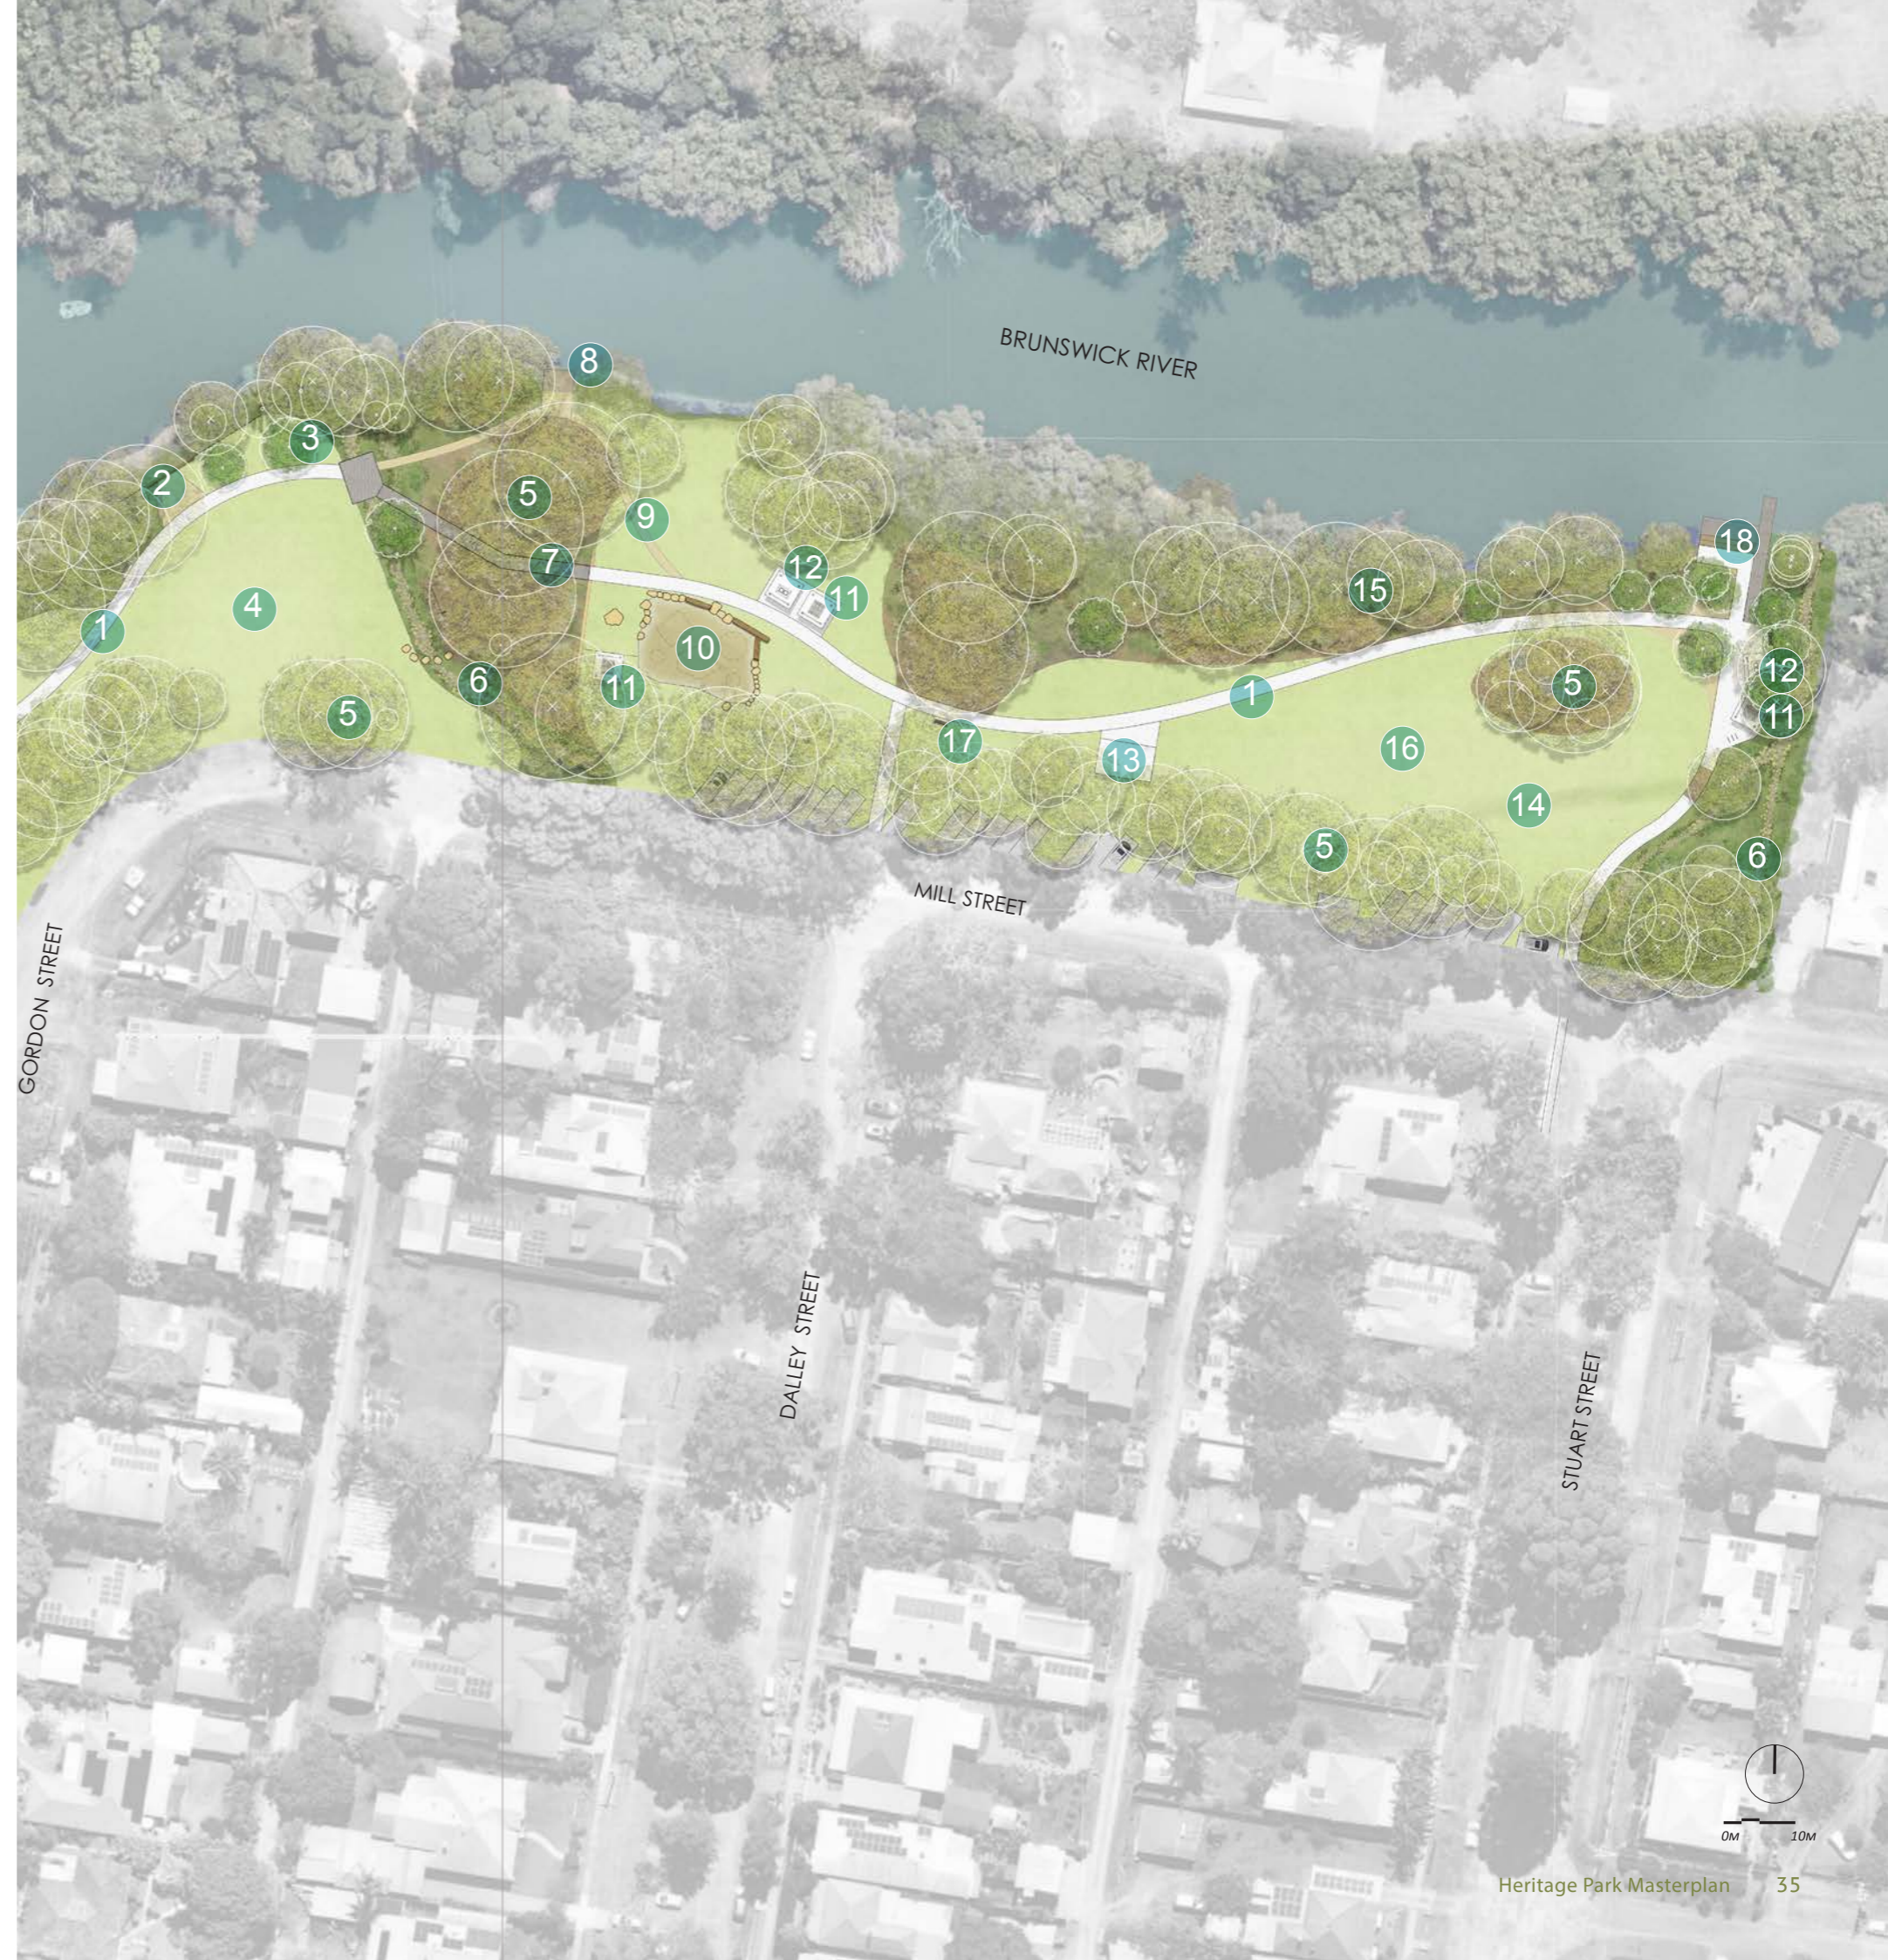
3.3 Maslen Arboretum

1. Concrete pathway nominal 2m wide
2. Existing arbour/ entry to arboretum upgraded
3. Connections to street footpath- new street footpath provides a cycling bypass of the Arboretum- also a bypass for those that feel safer staying on the street

4. Improved drainage swale including stabilisation measures and native planting to assist with the filtering of run-off prior to it entering the River system

Works to not negatively impact Arboretum vegetation.
