HERITAGE PARK

LANDSCAPE MASTER PLAN

Prepared by Plummer & Smith Pty Ltd for Byron Shire Council

This document is a Landscape Master Plan report outlining landscape treatments and design strategies for Heritage Park, Mullumbimby. The plan seeks to promote environmental, cultural, and open space outcomes in a space that is a celebration of the diverse local community.

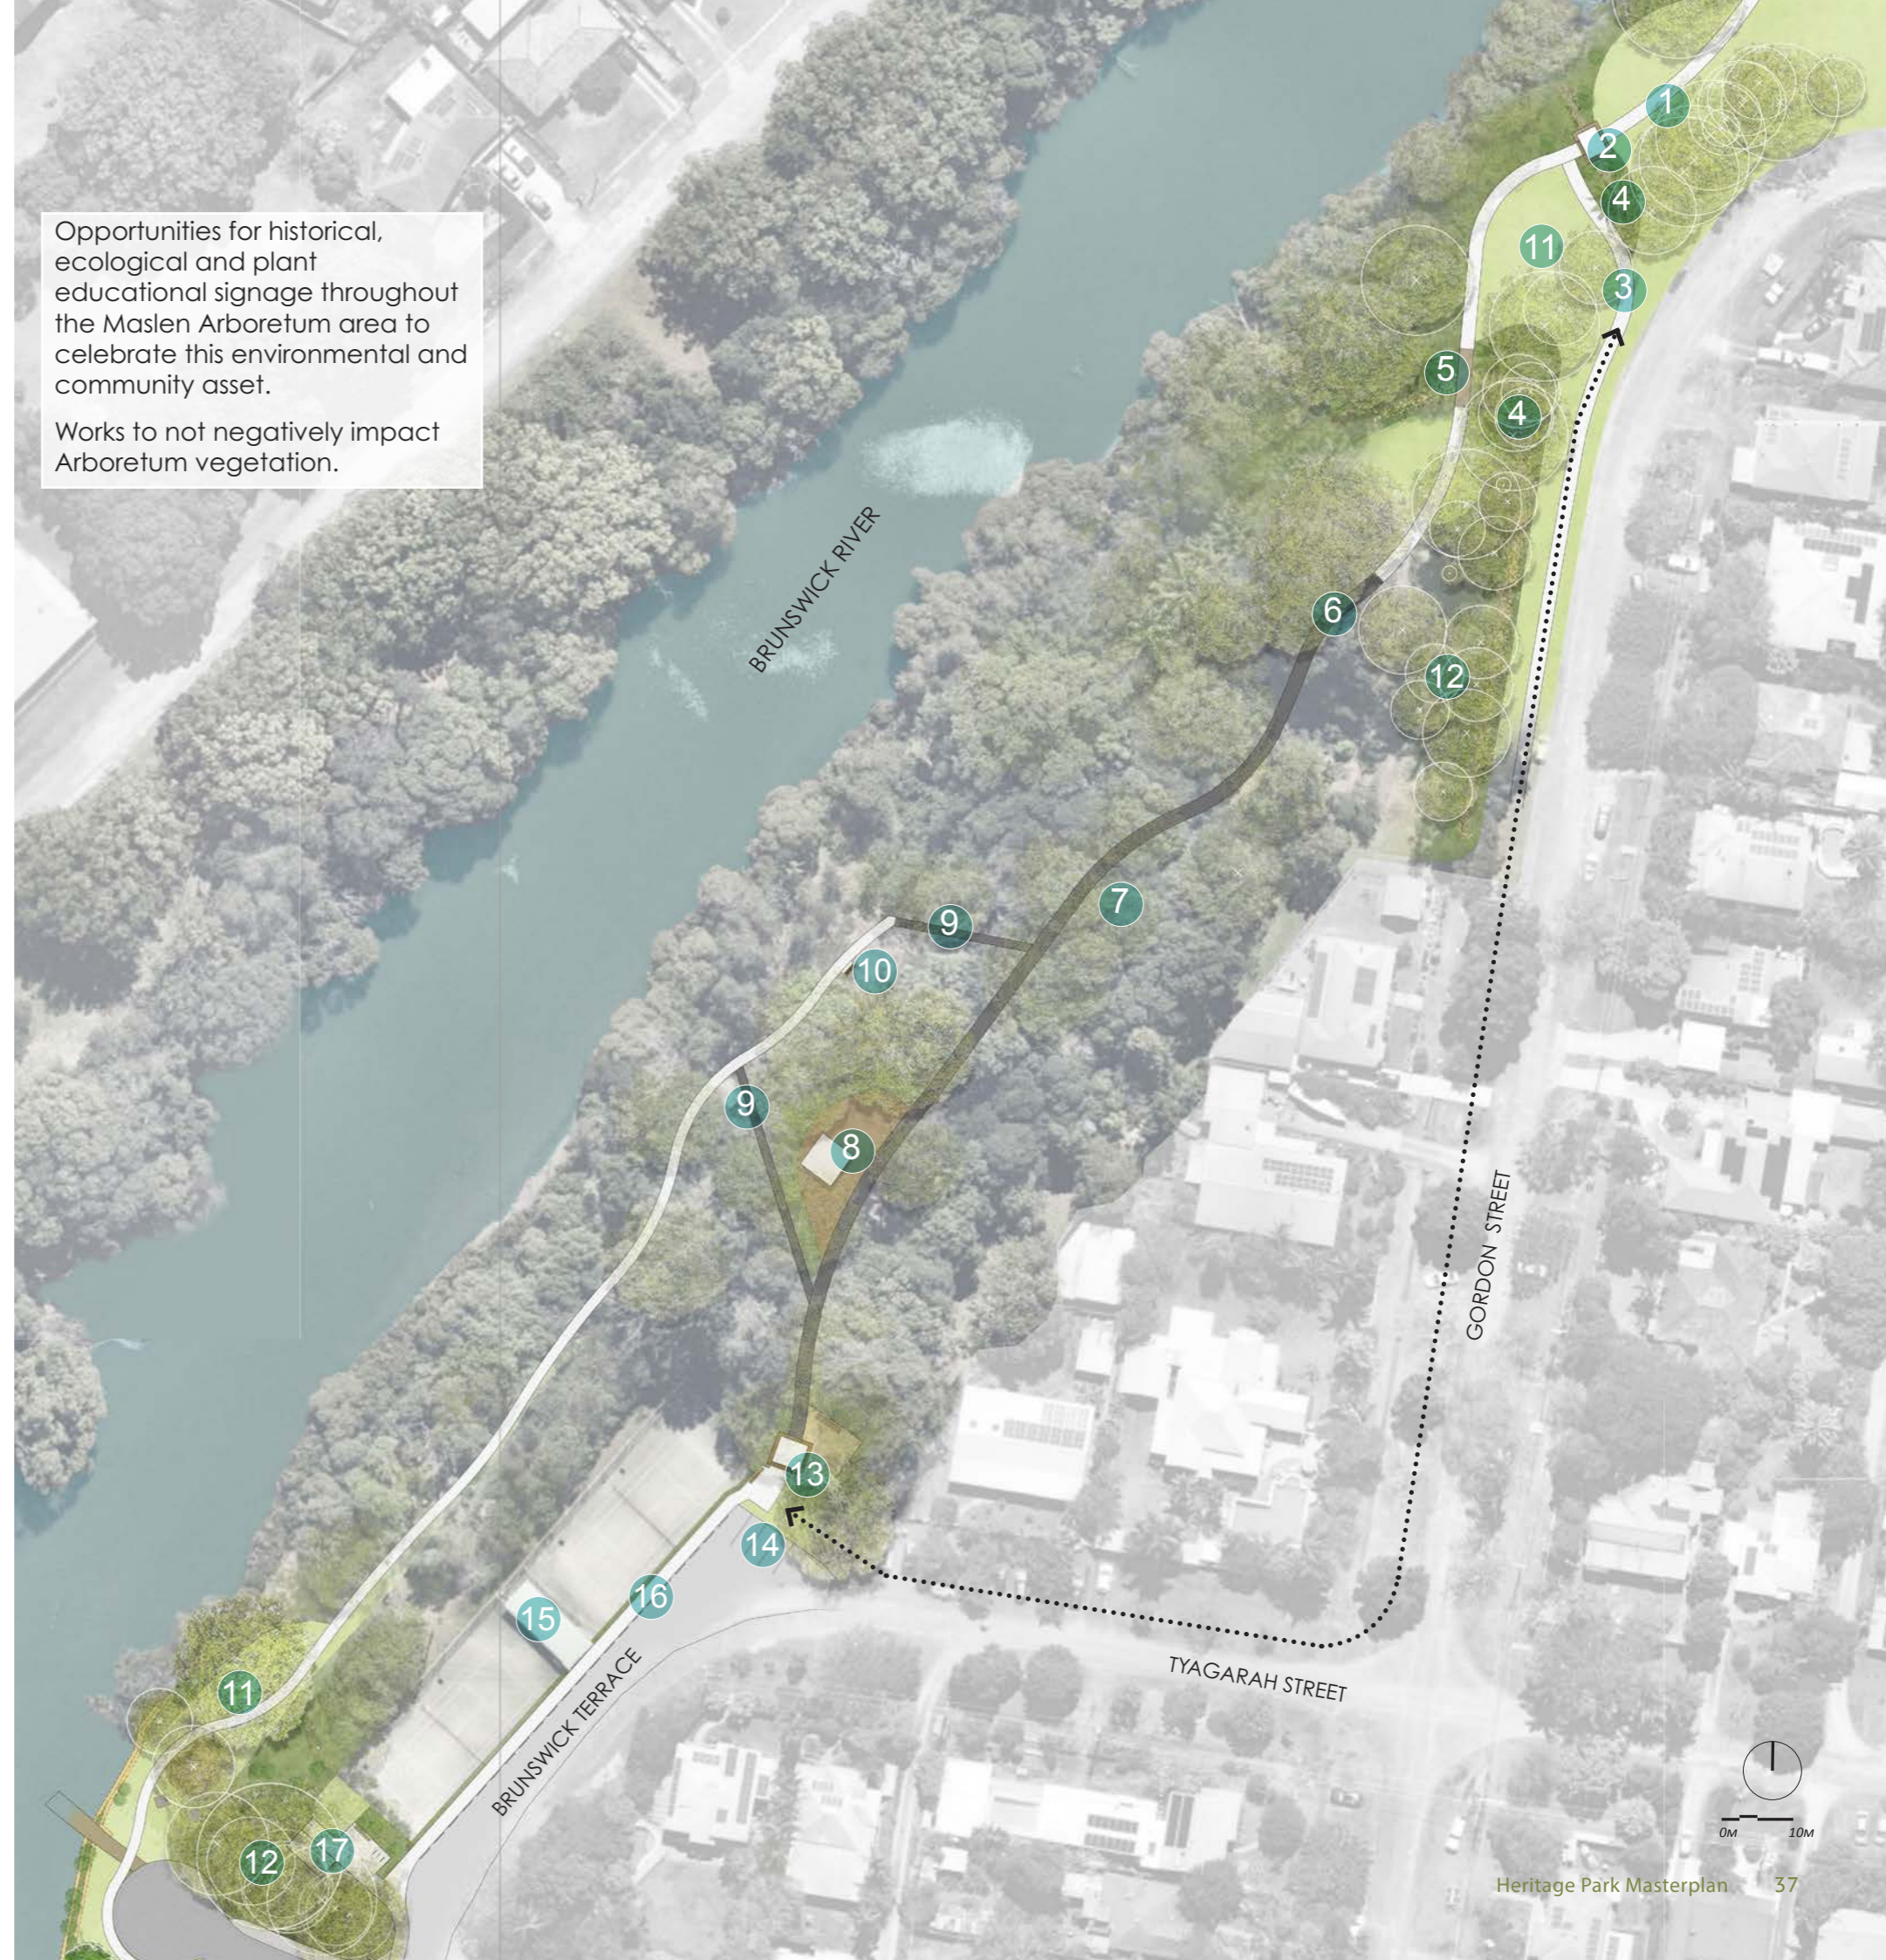
3.4 Heritage Park West

1. Existing boat ramp retained. River bank protection works and stabilisation terracing also required. Detailed investigations and design required. Potential for boat ramp to be renewed, subject to future funding.

15. New footpath to link to existing street path network
16. Existing asphalt path retained
17. New path extending along Brunswick Terrace to connect Heritage Park West to the Arboretum as part of accessibility and connectivity upgrades

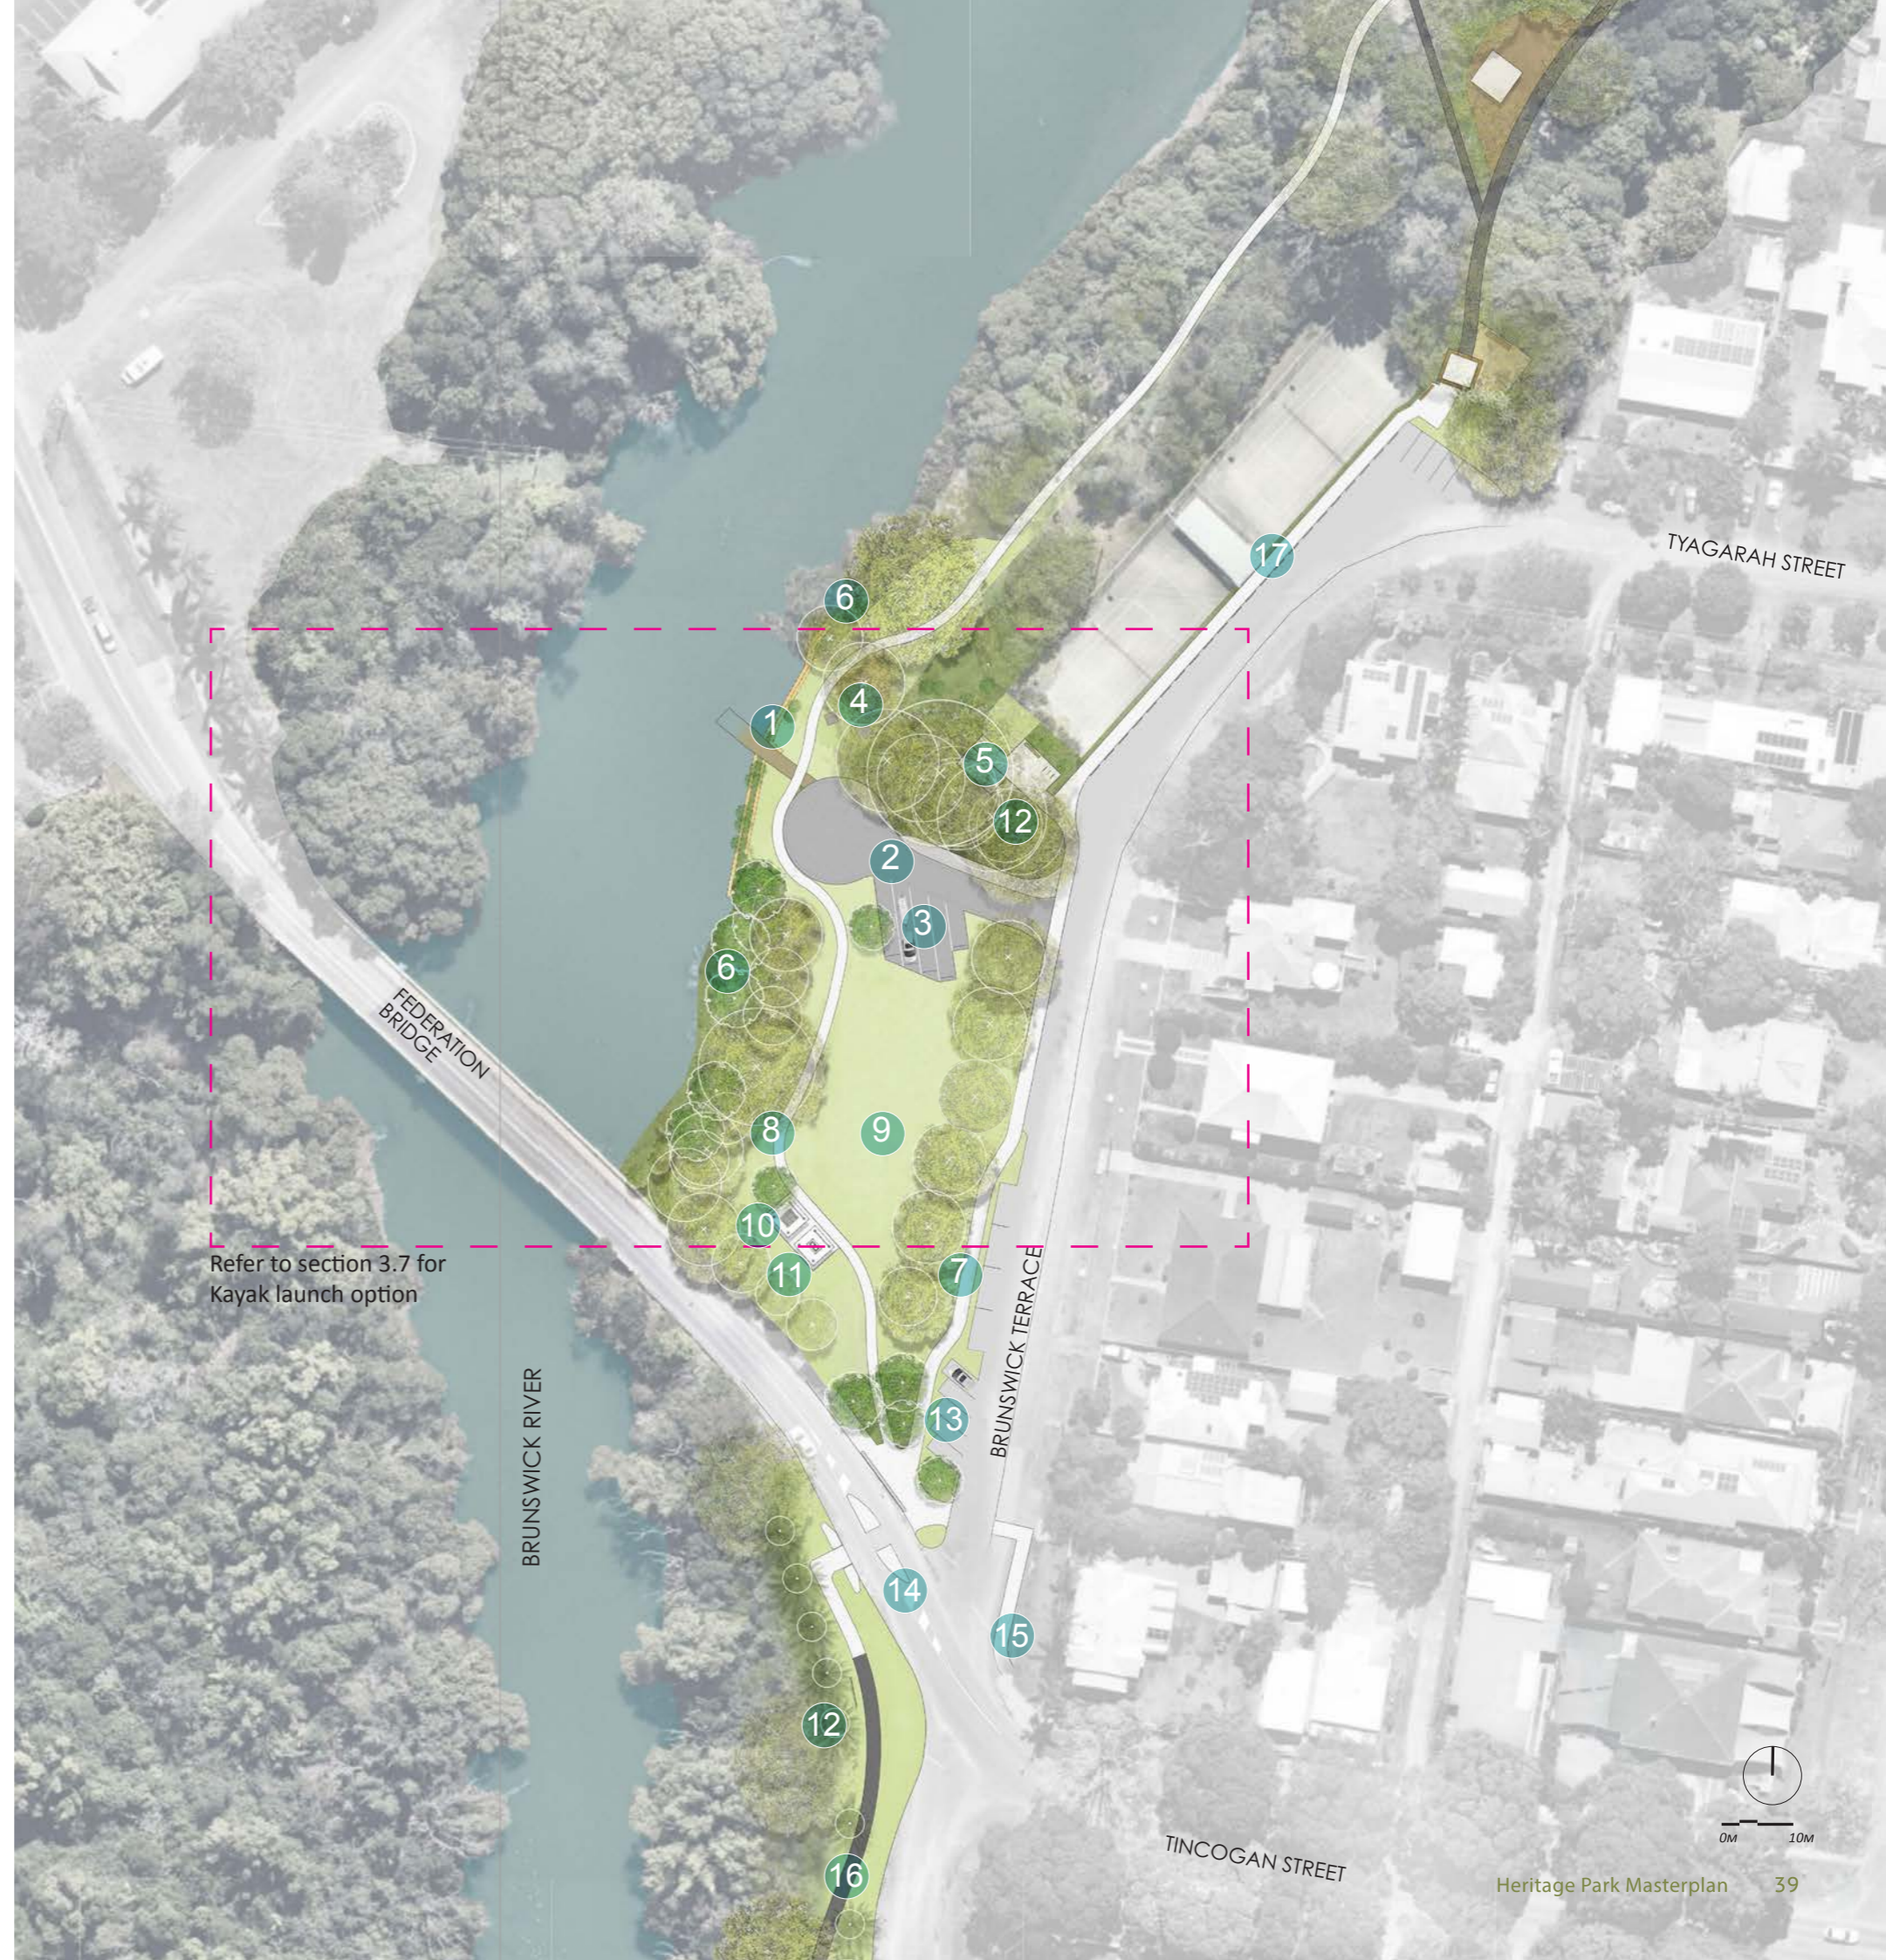
3.5 Palm Park

1. Existing asphalt path retained
2. Existing sculpture walk retained and celebrated
3. New shelter with picnic table to replace existing tables and associated concrete slabs

22. Existing bus shelter

Opportunities to add interpretive signage to celebrate the sculpture walk and Mullumbimby's creative community.

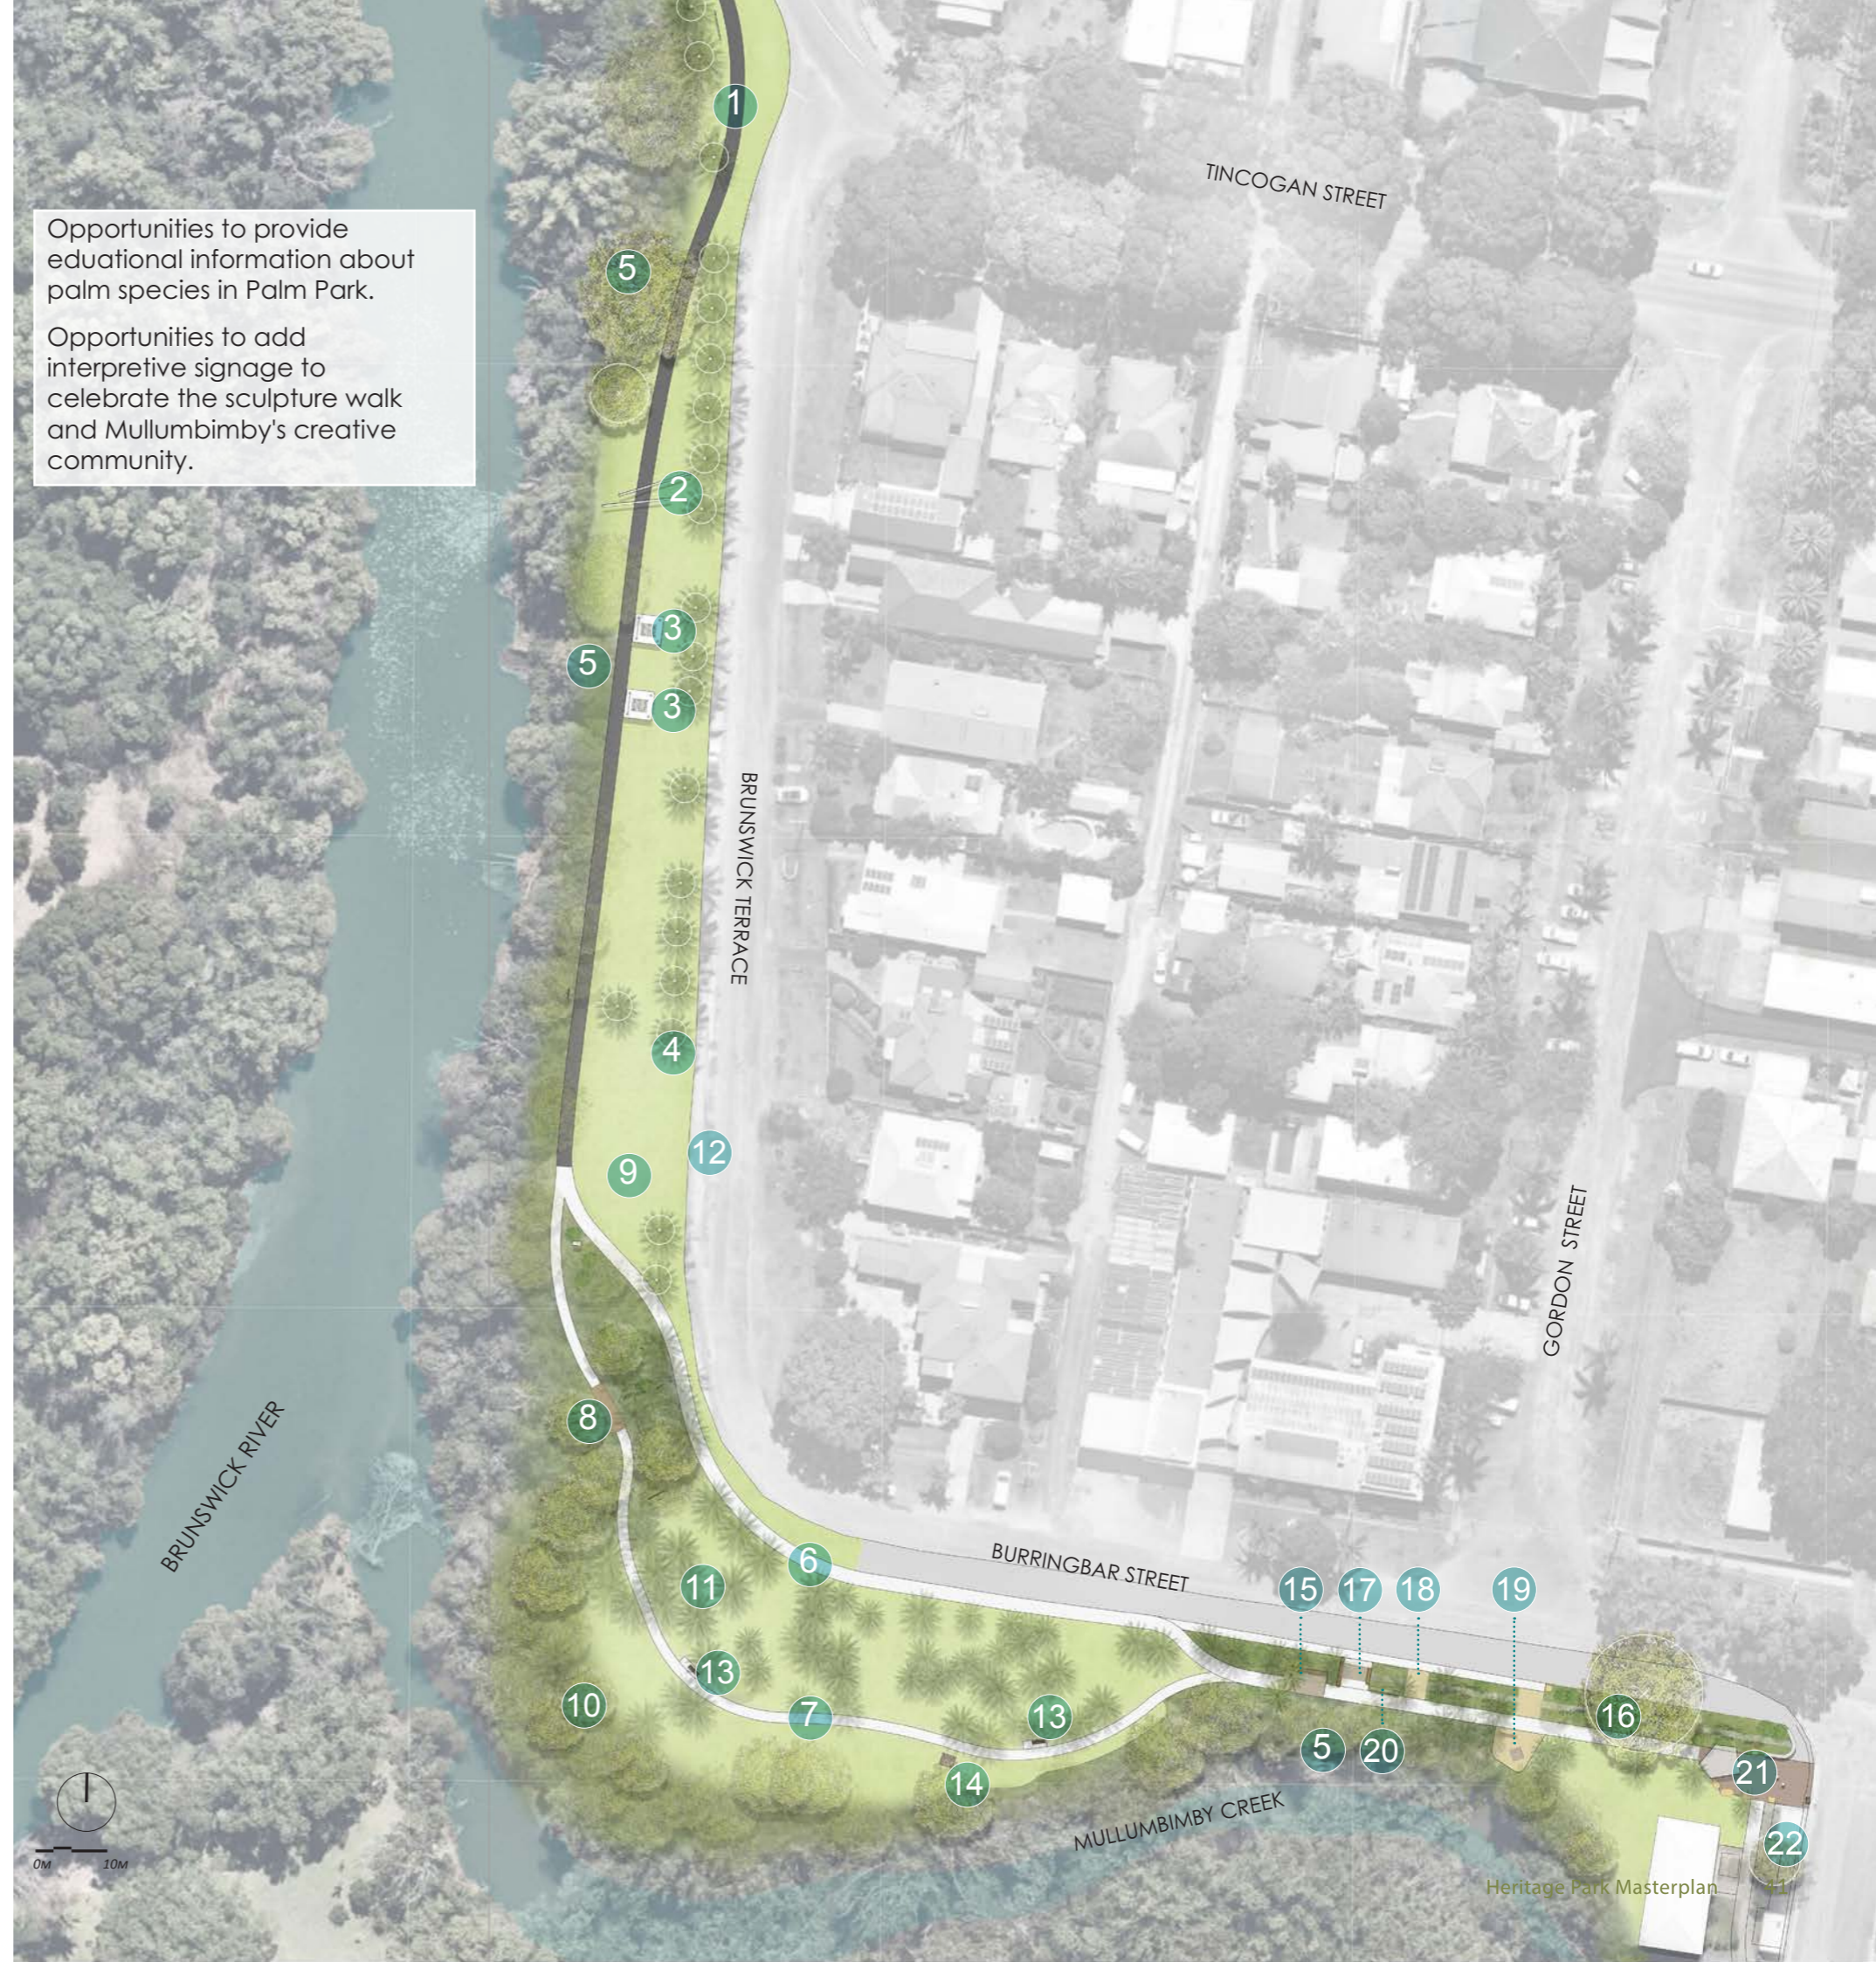
3.6 Northern Node and River Access

1. Concrete pathway nominal 2m wide providing accessible connections into and along the park
2. Widened concrete plaza facilitating group gatherings and adequate pathway circulation

15. Existing trees cluster and picnic tables to be retained- understorey to be mulched with minimal low groundcover planting
16. Amenities building located for convenience to both the play zone and river node zone of Heritage Park

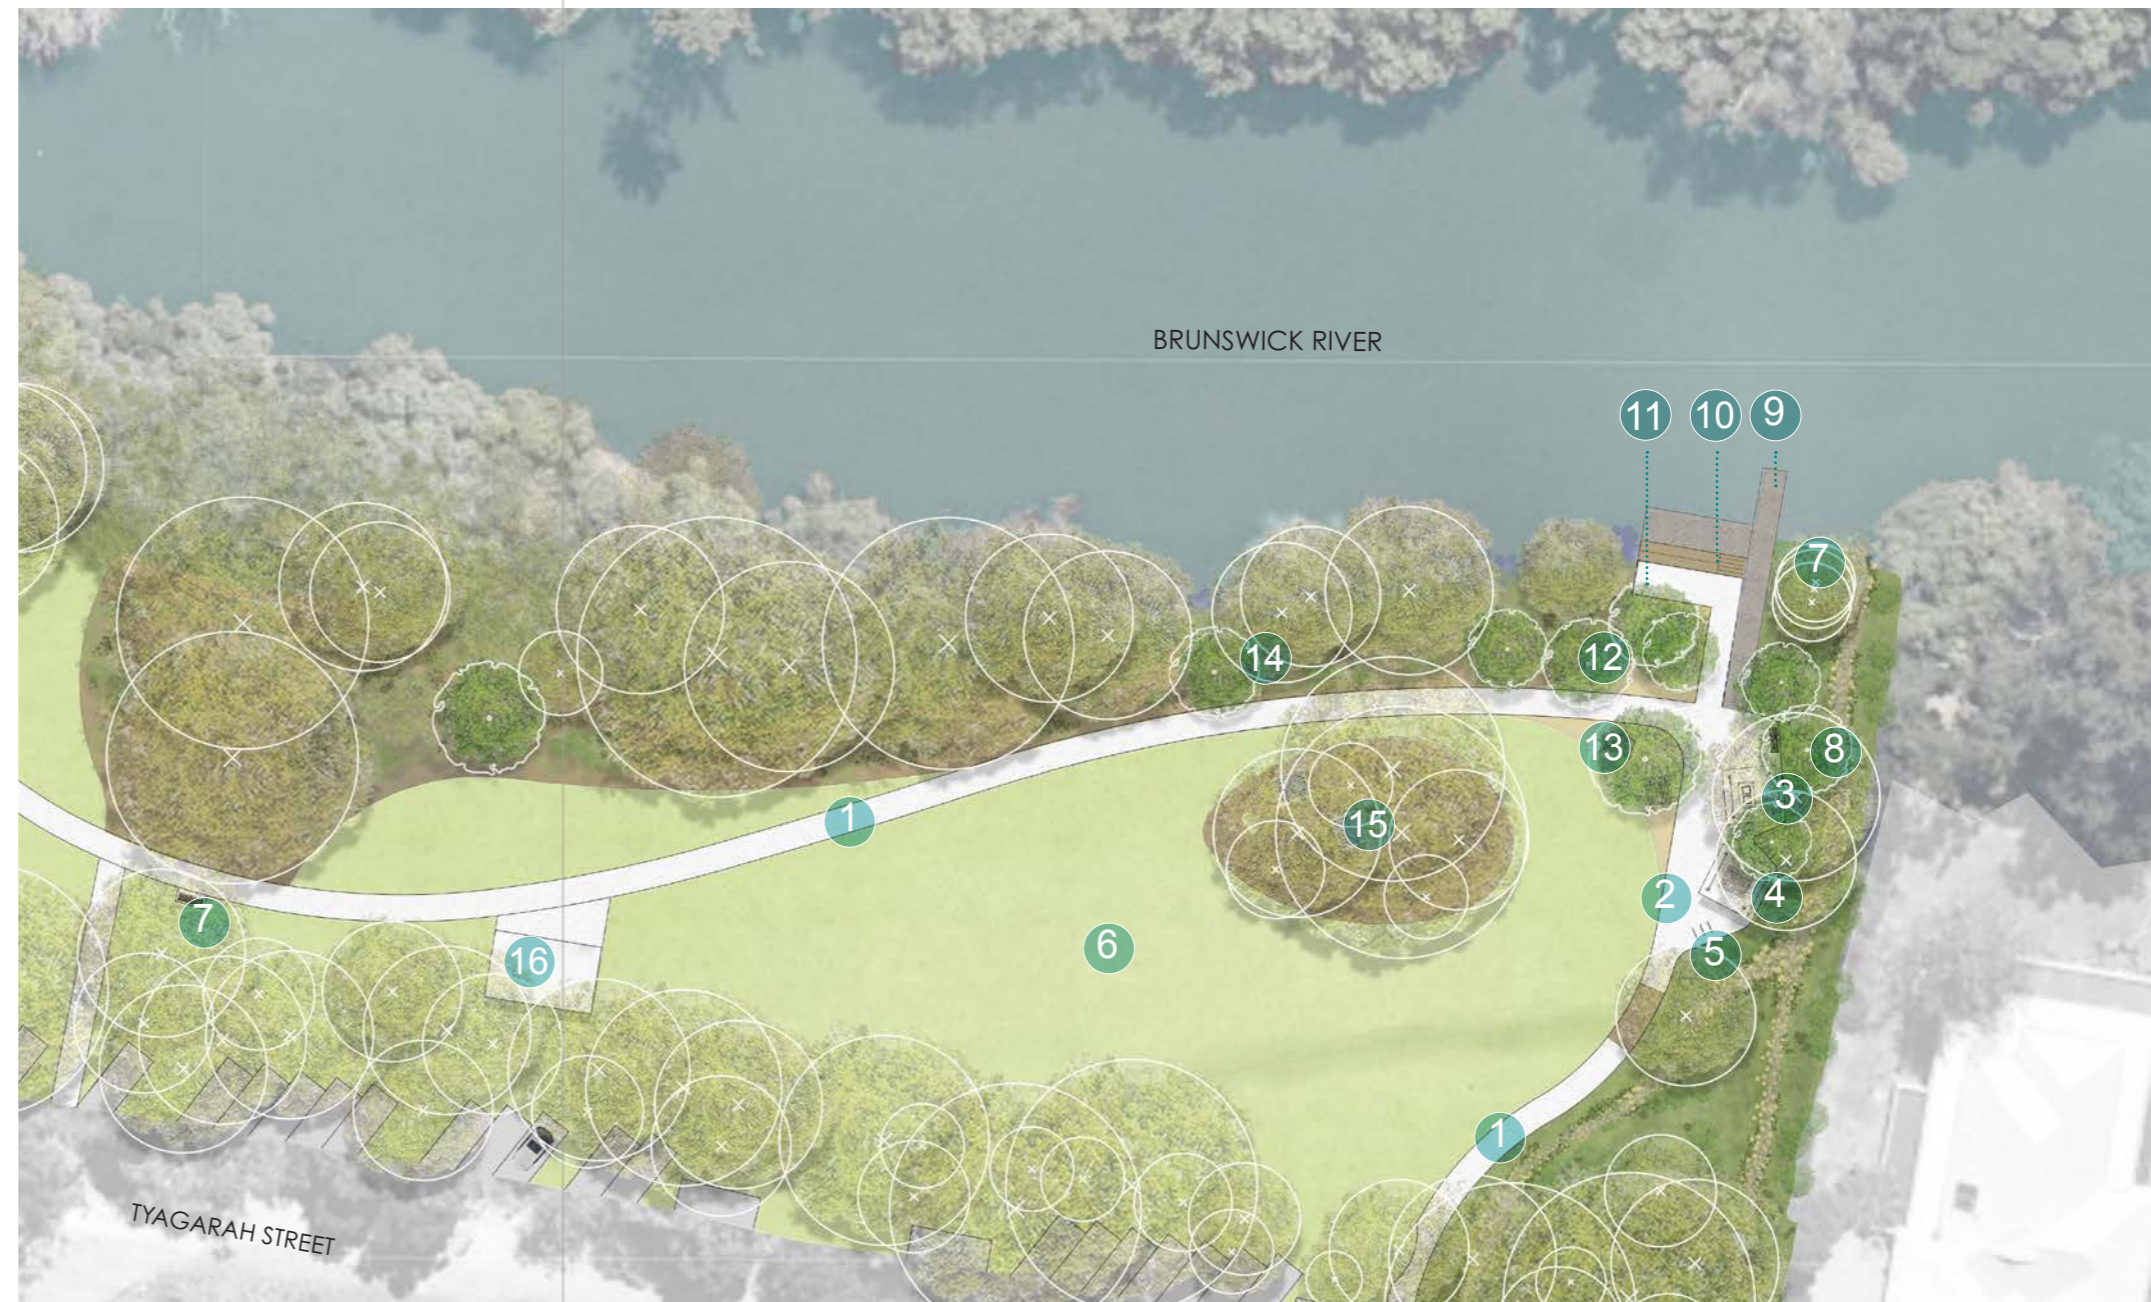
3.7 Heritage Park West- Kayak Launch Option

1. New accessible path along Brunswick Tce. Path located for park and street path network improvements. Path alignment to avoid passing directly under existing Bunya Pines to avoid seed drop zone

19. Path connecting to Arboretum with wheel stops
- X** Existing Bunya Pine in poor condition to be removed

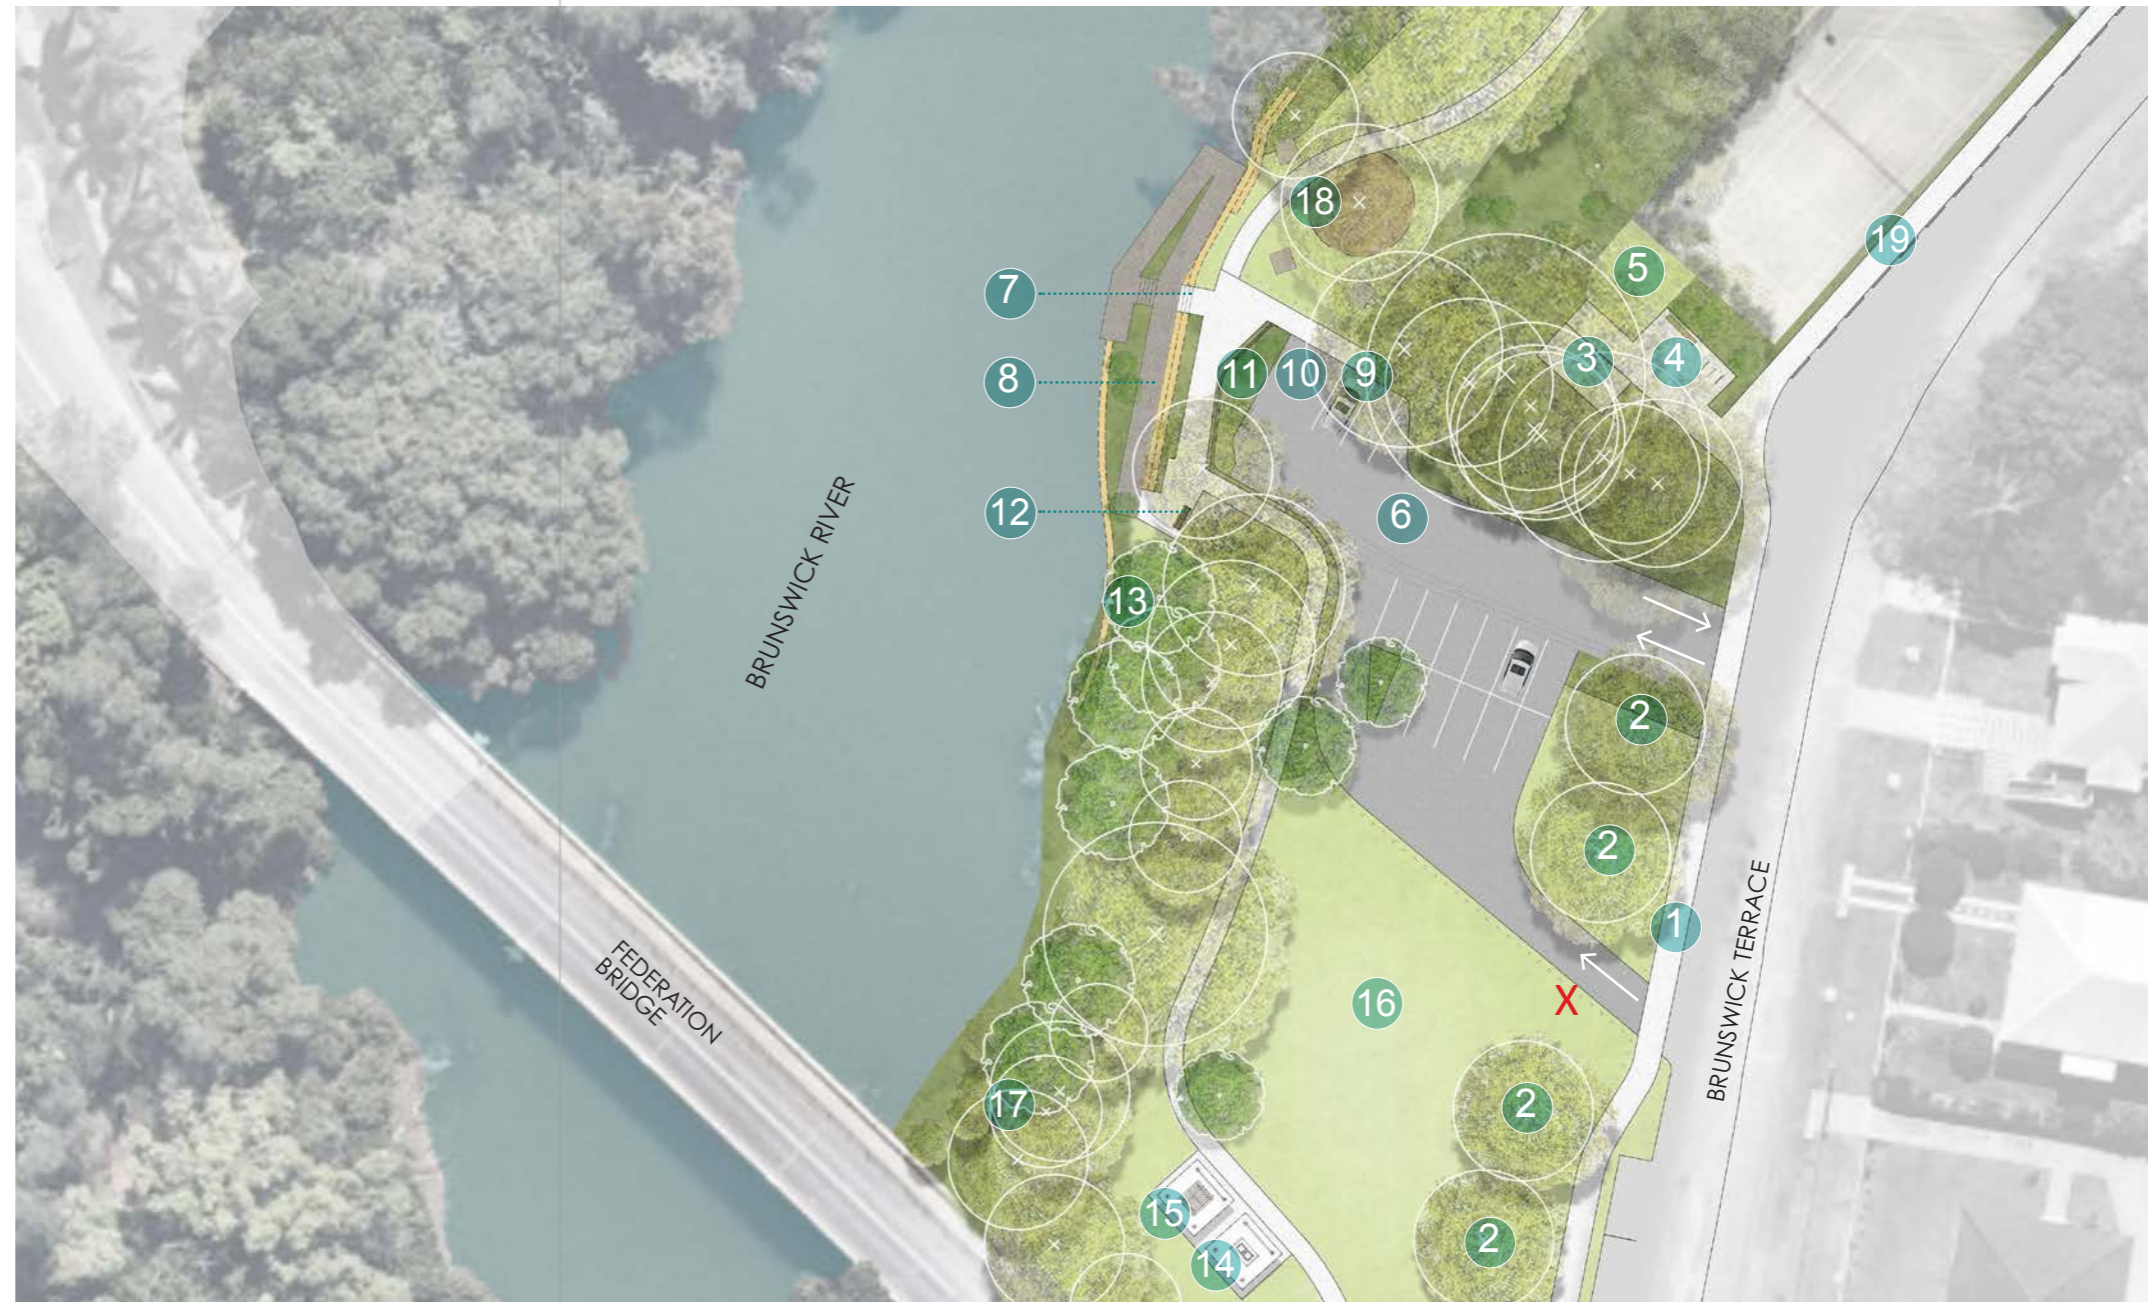
3.8 Tincogan Street Intersection

Improving the safety of the Tincogan Street / Brunswick Terrace intersection was a key outcome of the site analysis and community consultation. Changes are required to the intersection to improve pedestrian and vehicular safety. The following adjustments are proposed:

*Design coordinated with Byron Shire Council Engineers. Refer to appendix C.

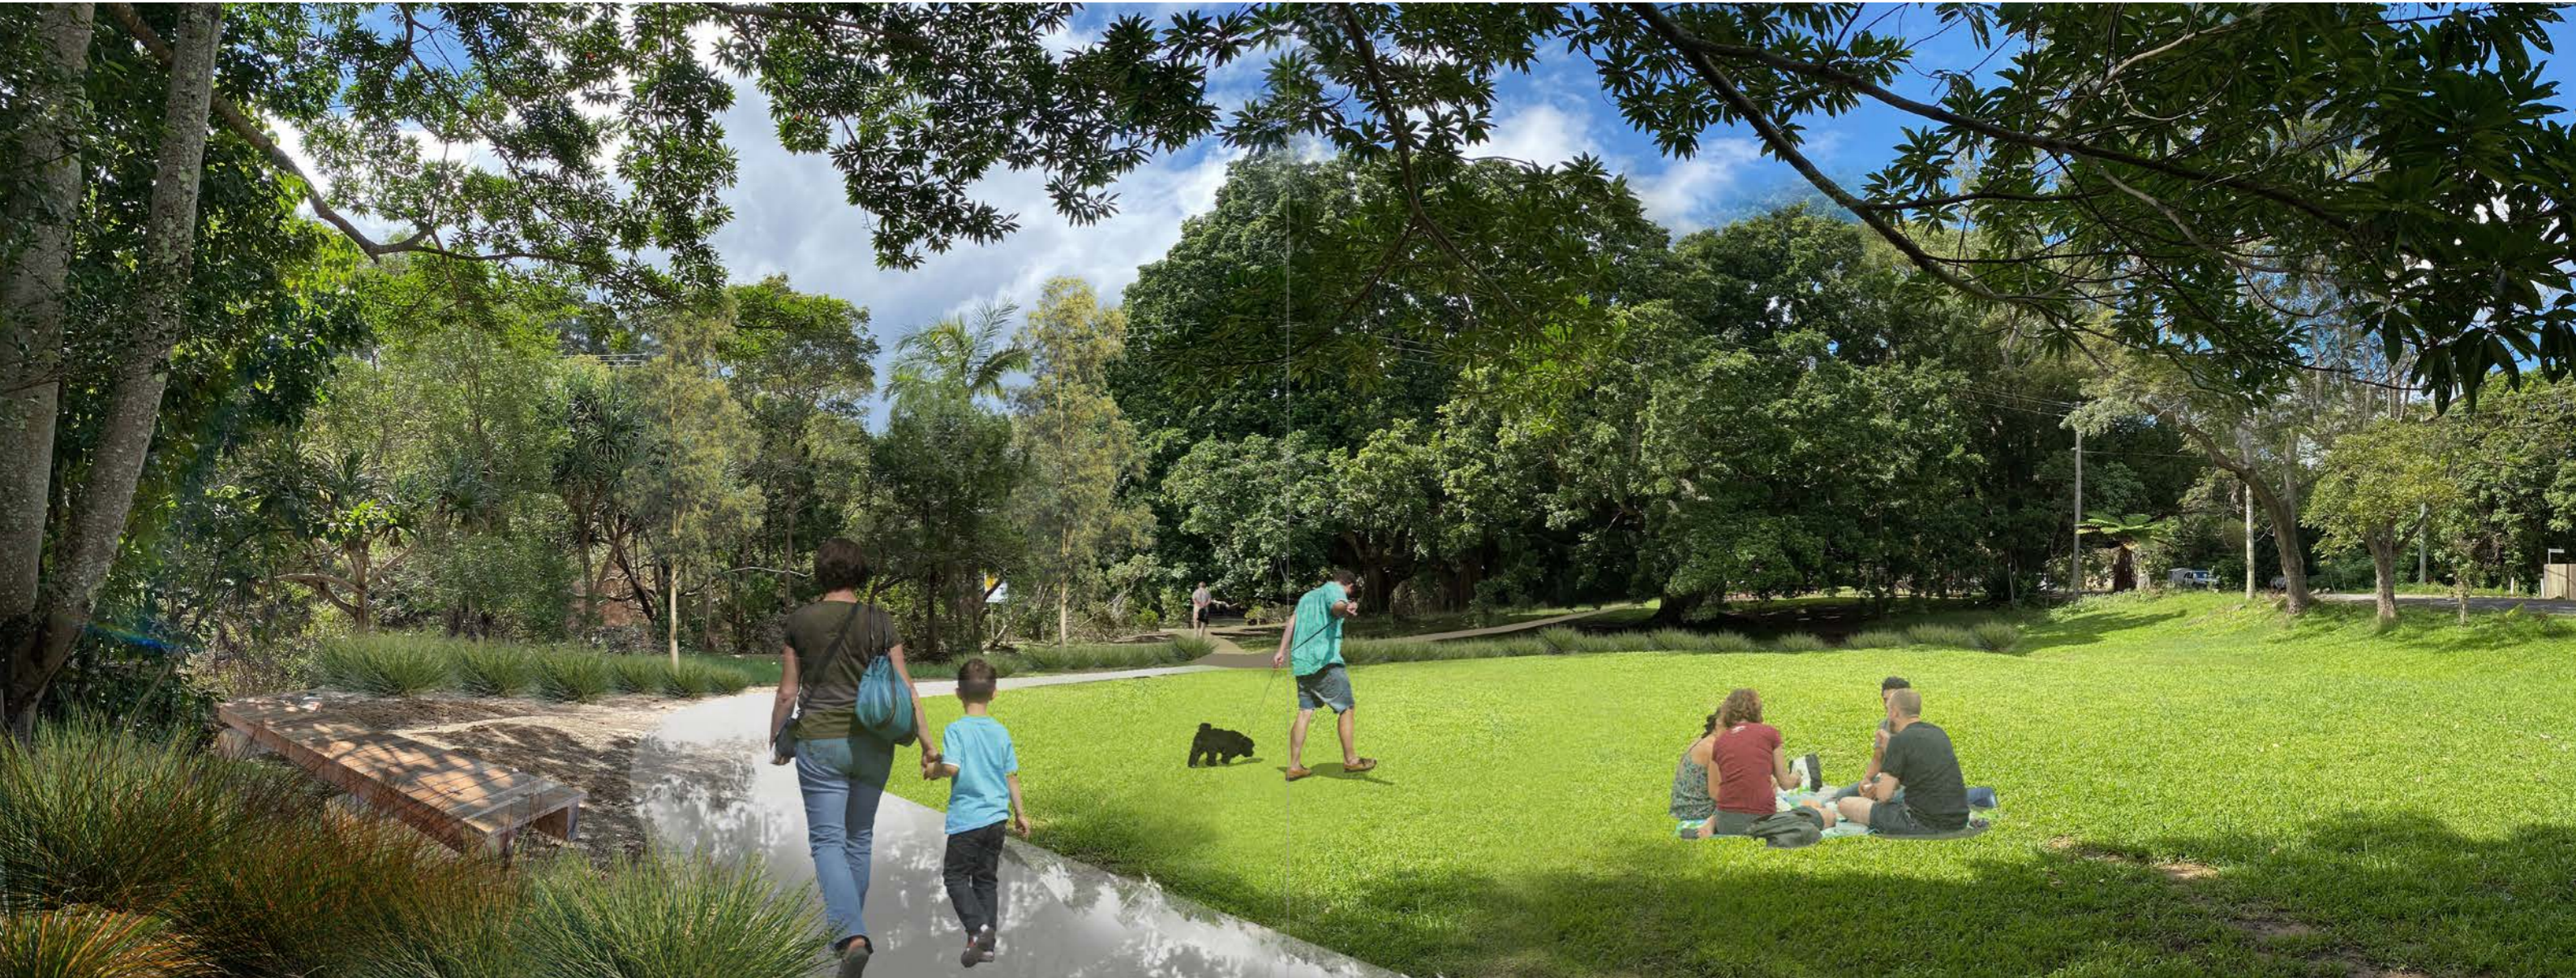
VIEW
Looking east across the Heritage Park open space from the Arboretum arbour-drainage and riparian management planting, informal open space, new paths linking along the open space areas to the play area and parkland areas beyond

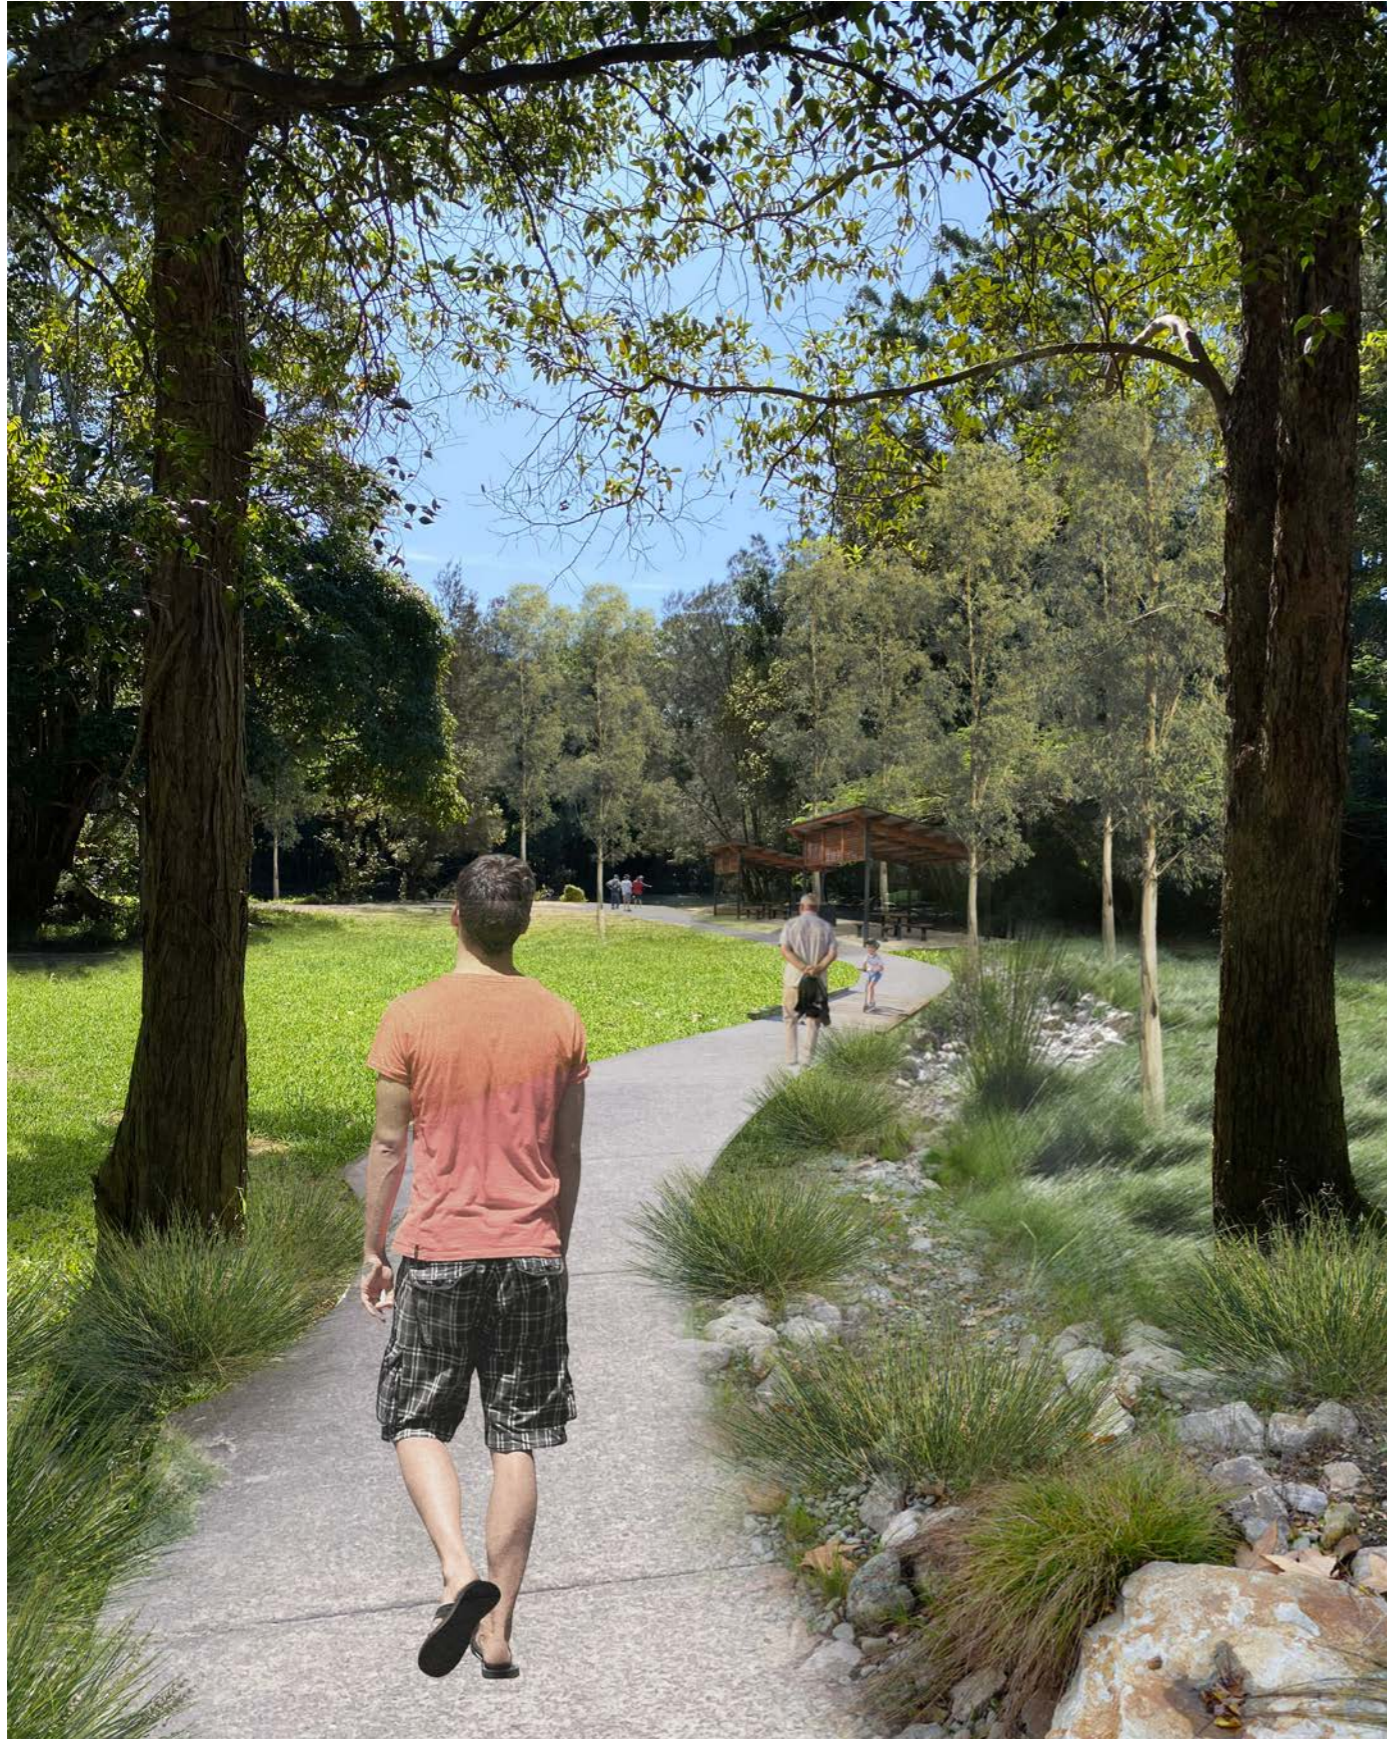
VIEW
 'Green spine' pedestrian entry to the Heritage Park- drainage upgrades, open space, shelters and riparian / river access node treatments

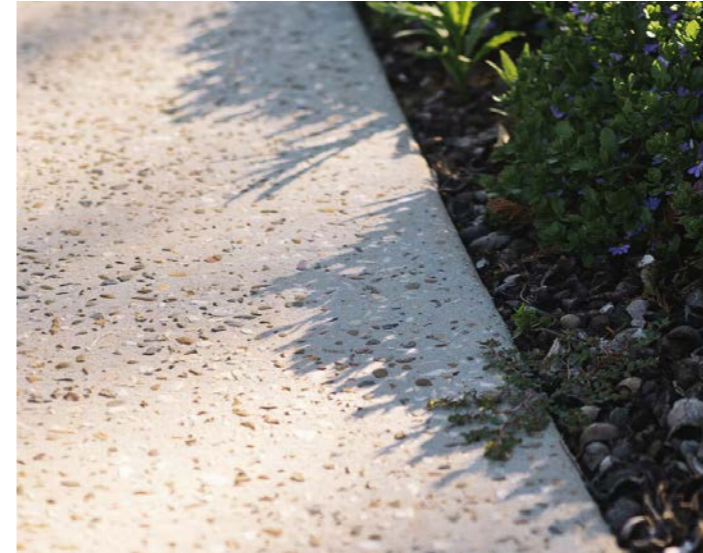
HARD SURFACES
 Concrete & decomposed granite / compressed gravel
