HERITAGE PARK

LANDSCAPE MASTER PLAN

Prepared by Plummer & Smith Pty Ltd for Byron Shire Council

This document is a Landscape Master Plan report outlining landscape treatments and design strategies for Heritage Park, Mullumbimby. The plan seeks to promote environmental, cultural, and open space outcomes in a space that is a celebration of the diverse local community.

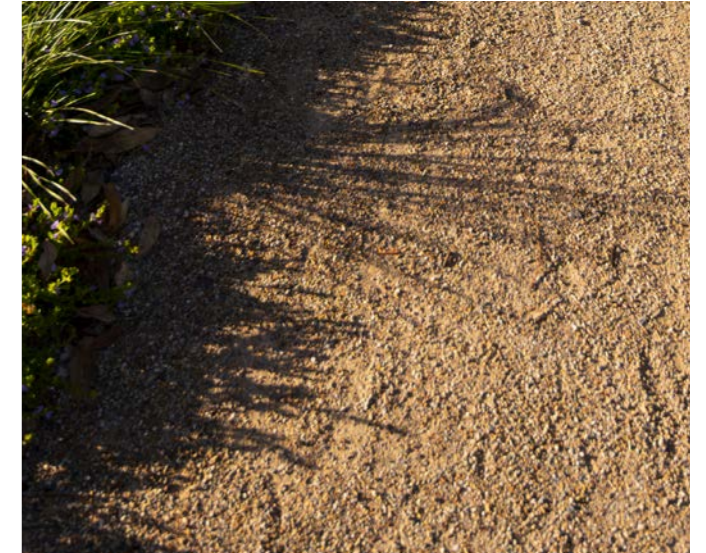
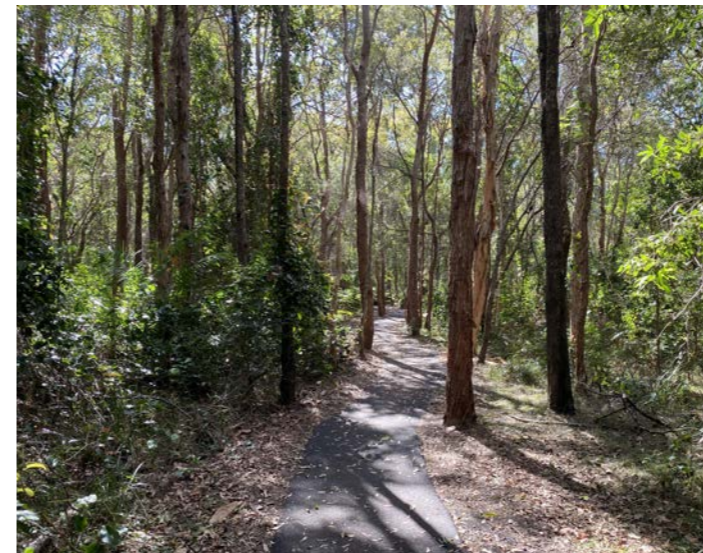
PATH SURFACES THROUGH ARBORETUM
 Accessible but flexible materials that require limited excavation and can be designed around tree locations- example images of walking tracks in Pottsville Environment Park and Daintree Rainforest

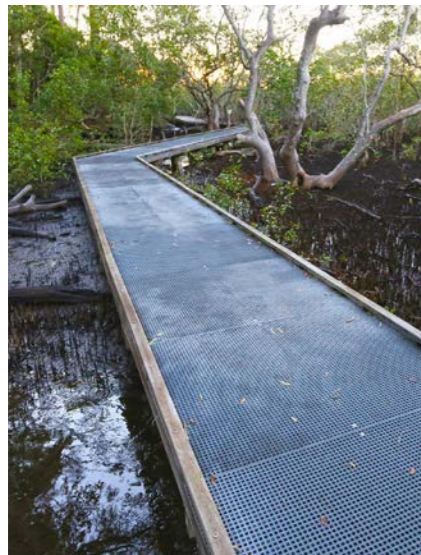
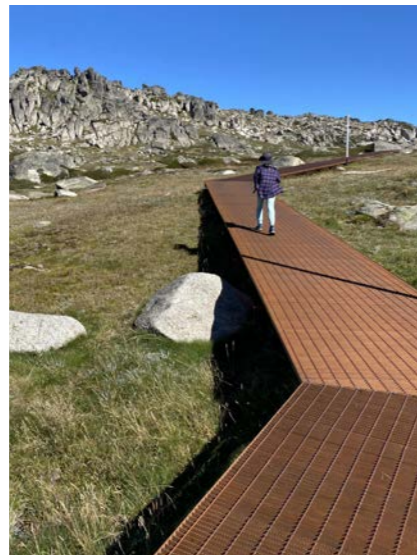
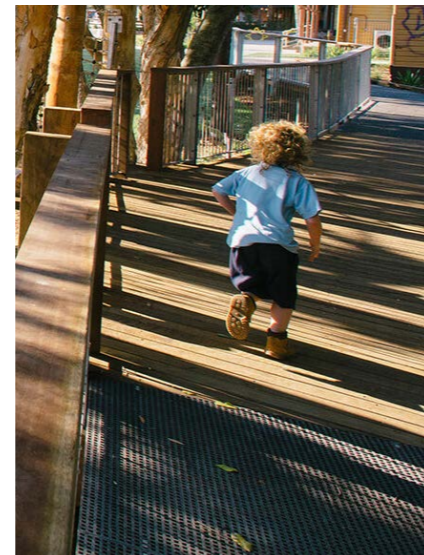
BOARDWALK MATERIALS
Simple hard wearing, long lasting, and low maintenance materials

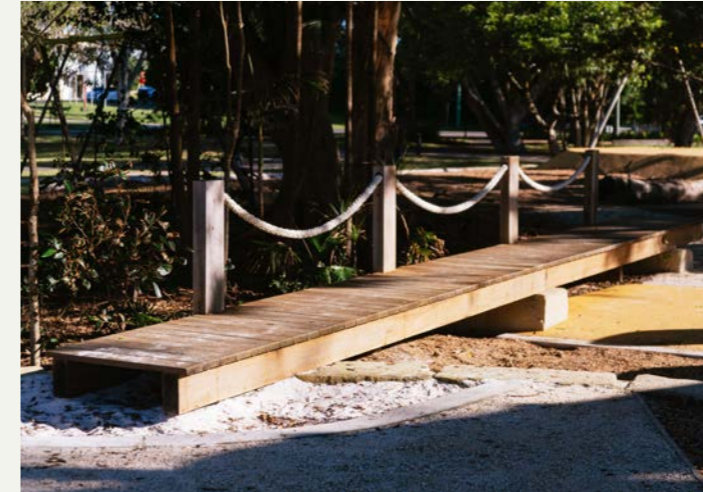
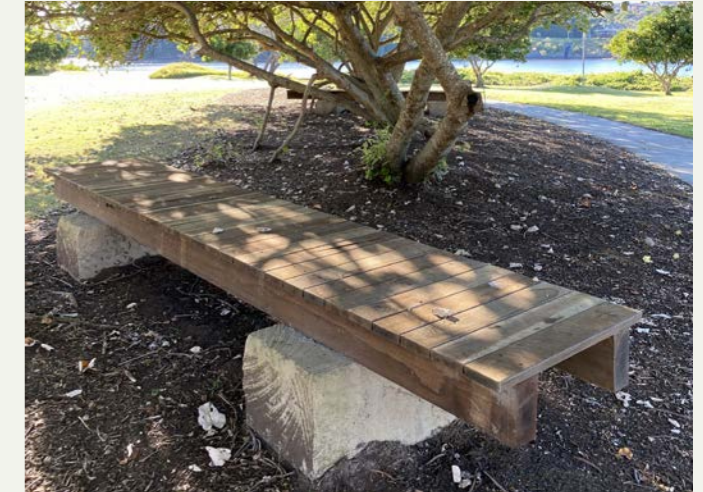
INFORMAL SEATS AND PLAY PLATFORMS
Large format and flexible furniture elements- natural materials

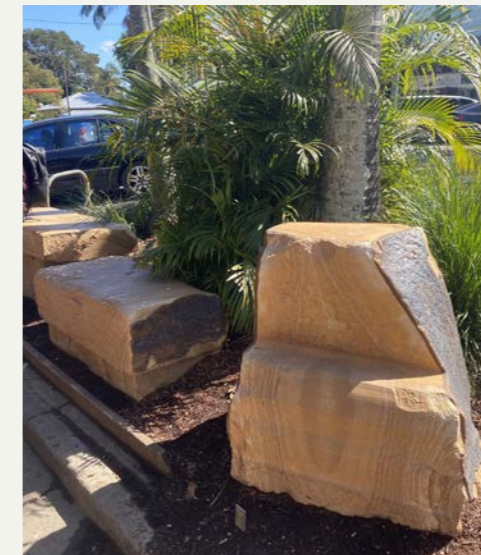
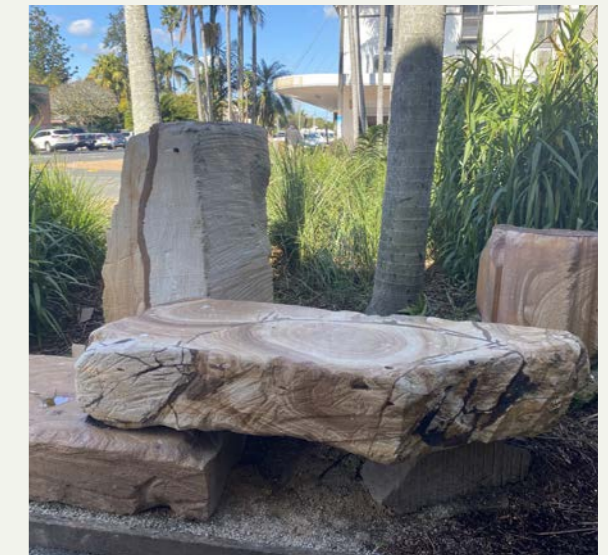
FEATURE SANDSTONE SEATS
Opportunities to extend bespoke furniture treatments of the main street into Palm Park to increase the connection between the two spaces

17. Entry, interpretive and wayfinding signage
18. Sandstone seats bringing the creative language of furniture palette of Mullumbimby main street into the park

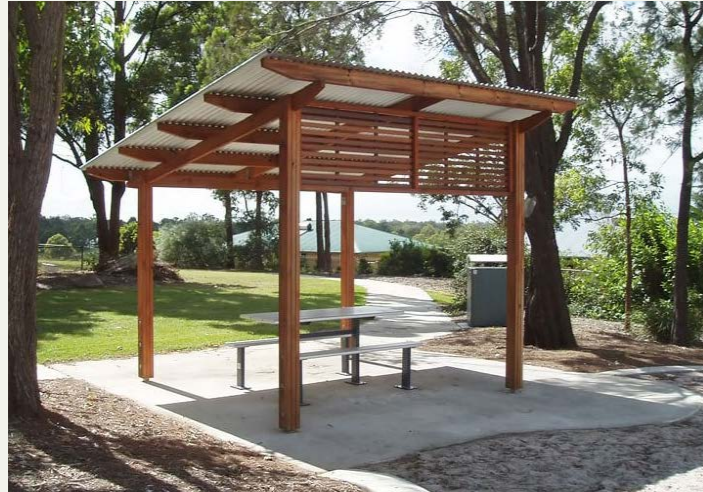
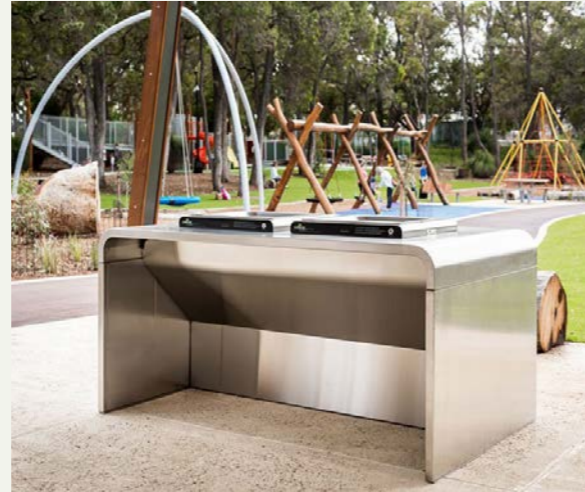
PARK SHELTERS & BBQ's
Usable facilities with hard wearing and low maintenance materials

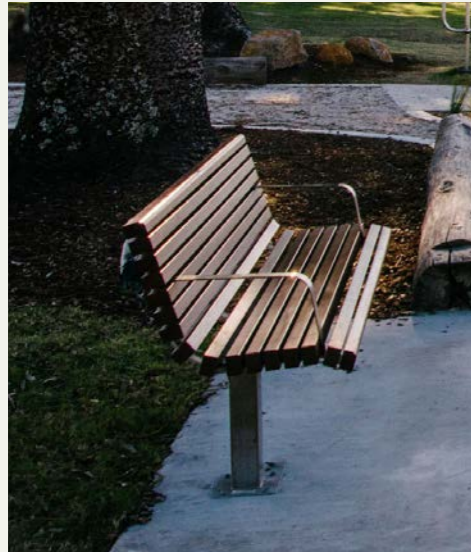
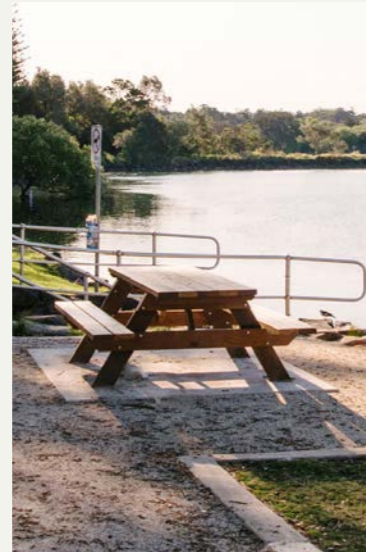
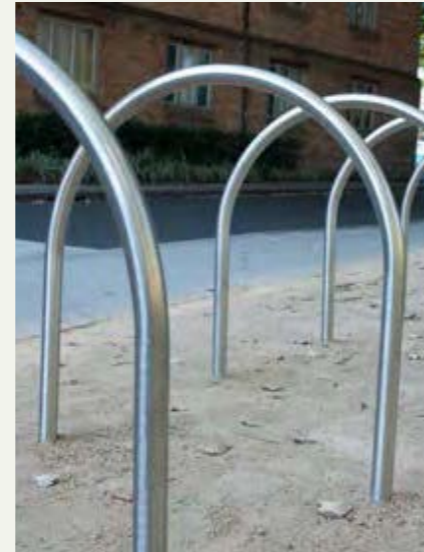
PICNIC TABLES, SEATS & BIKE RACKS
Simple hard wearing, long lasting, and low maintenance materials

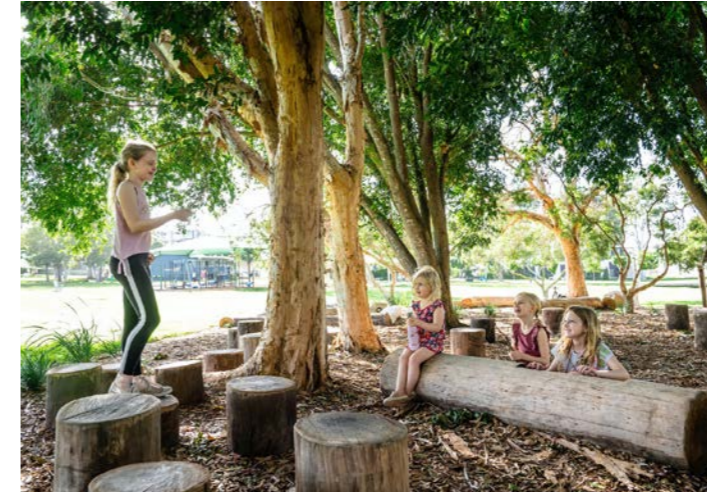
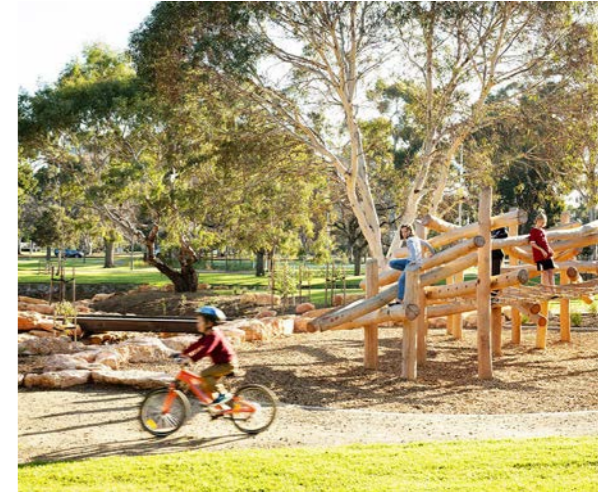
NATURE PLAY EXAMPLES

9. Decomposed granite/gravel path
10. Nature play upgrades and additions to existing play space- viable play elements retained (such as rope climbing structure) and degraded elements upgraded

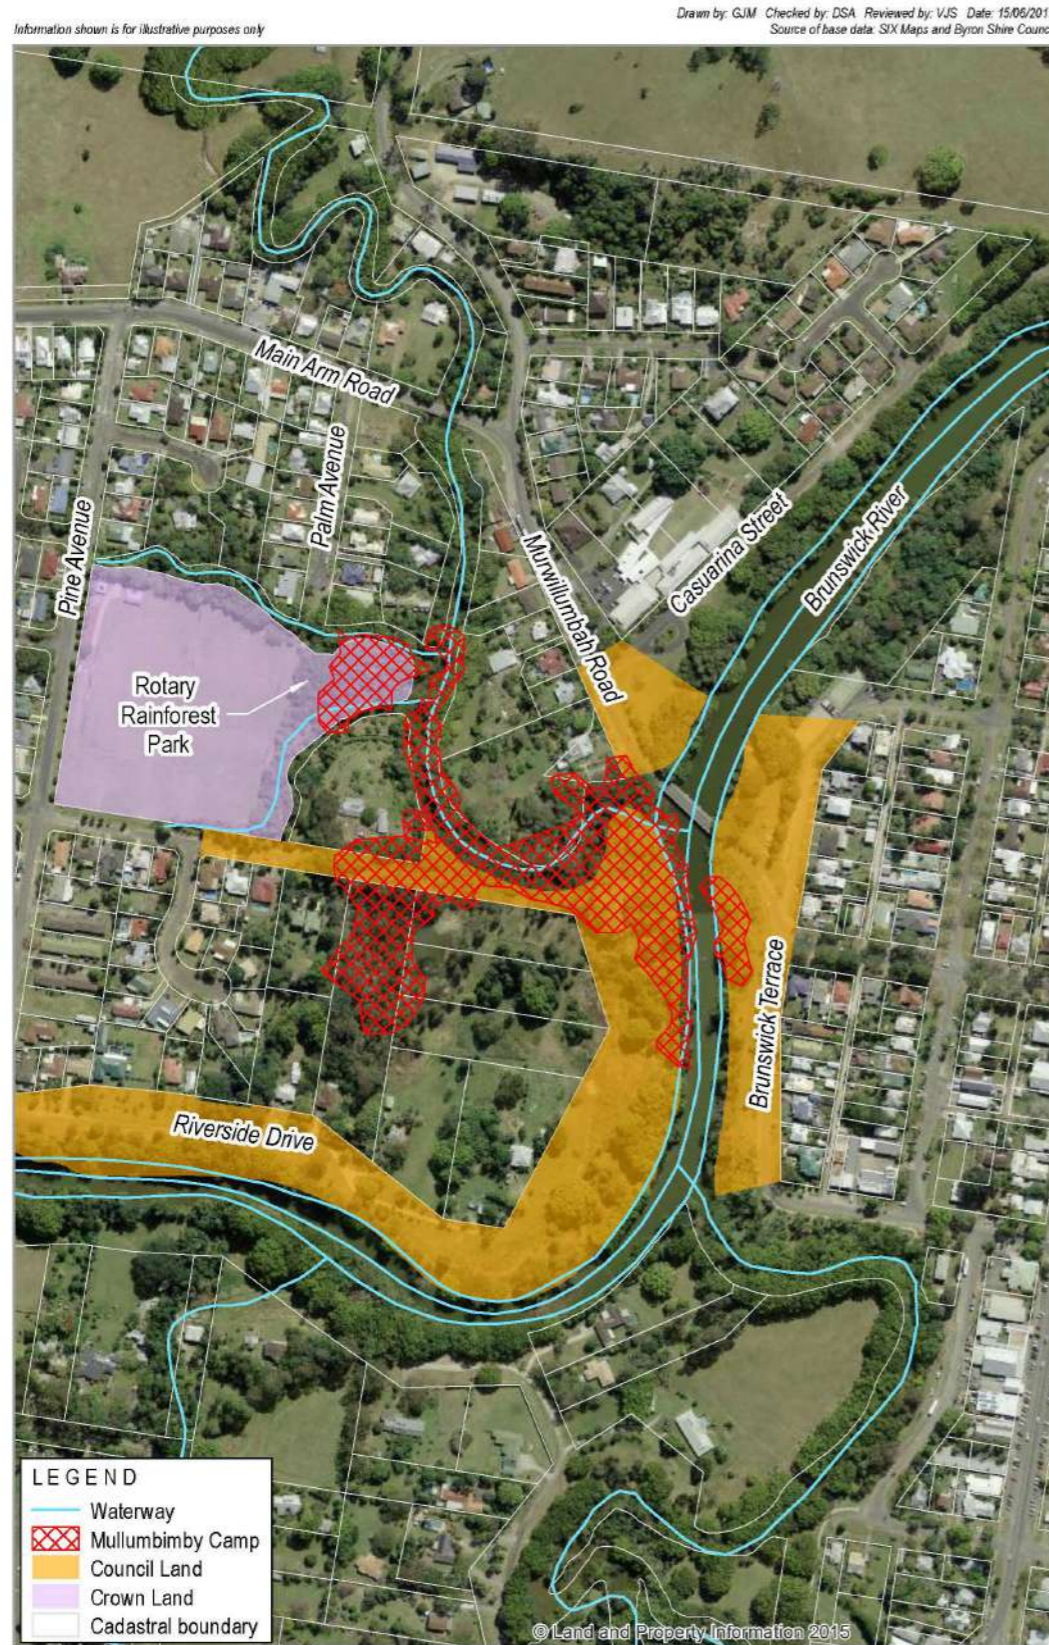
Mullumbimby Flying-fox Camp Location and Maximum Footprint

The biodiversity report identified vegetation within the park that provides habitat for several threatened fauna species, including a colony of Grey-headed Flying-foxes and Black Flying-foxes. Specifically this vegetation and habitat was identified within Palm Park which extends onto adjoining land around the Brunswick River and Mullumbimby Creek. All works within the masterplan and future detail design will be required to adhere to recommendations and considerations within this report.

Disclaimer: the fauna habitat locations are likely to change/move through the surrounding vegetation. It is essential that the location of the Flying-fox habitat is confirmed prior to any future detail design with recommendations in the Biodiversity report followed.

Flying fox location observed on site during this project. Refer to biodiversity report and appendix B.
