Byron Shire ICOLL Water Pollution Source Tracking and Control Programs for Belongil Creek, Tallow Creek and Ti-Tree Lake

Stage 2 Study

Final Report

August 2023

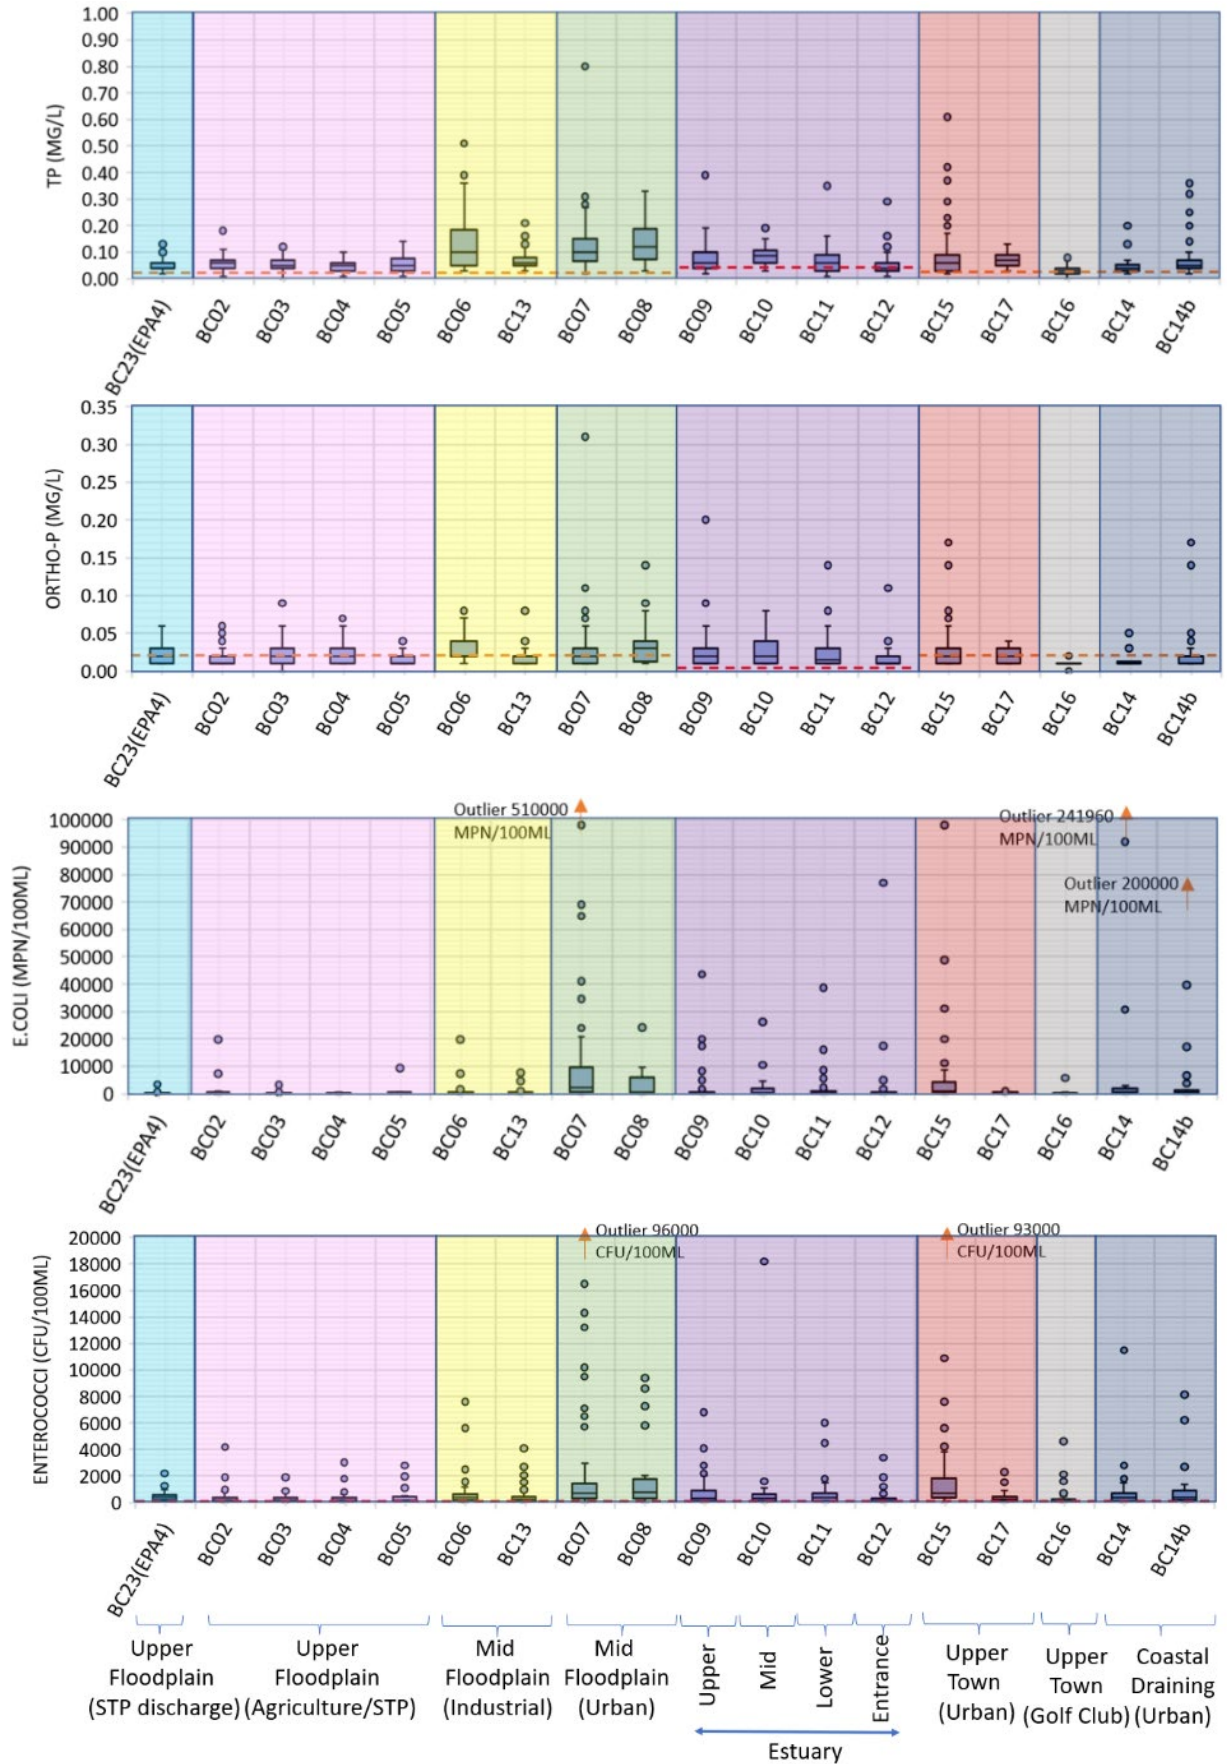
Figure 20: Belongil Creek water quality data 2016-2022 (enterococci, *E. coli*, TP and Ortho-P).

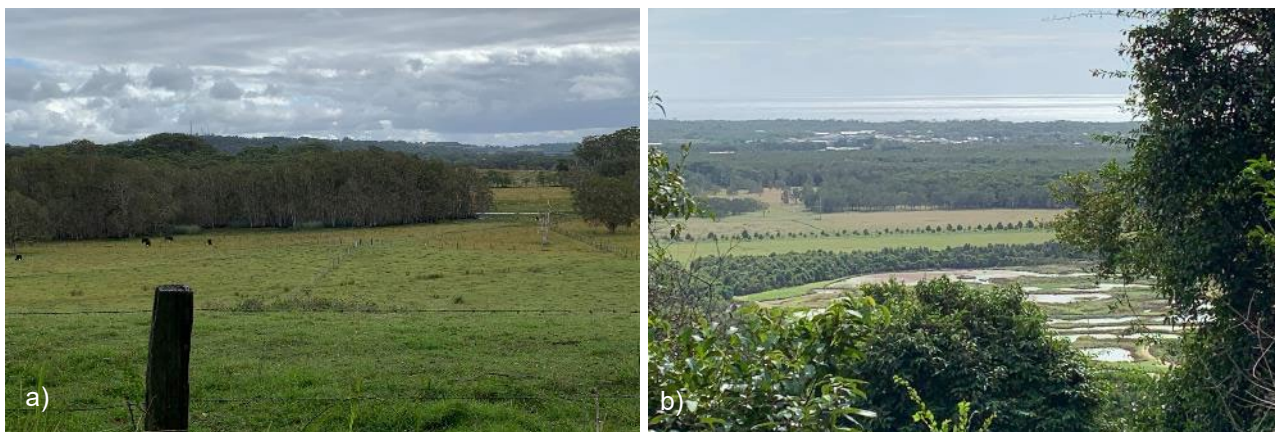
Access to the mid catchment rural areas was limited due to private ownership and lack of public roads. Observations were recorded from vantage points along public roads (Plate 7).

Plate 7: a) Mid catchment grazing land, Skinners Shoot b) View of rural landuse and vegetated areas in the mid catchment from St. Helena Road.

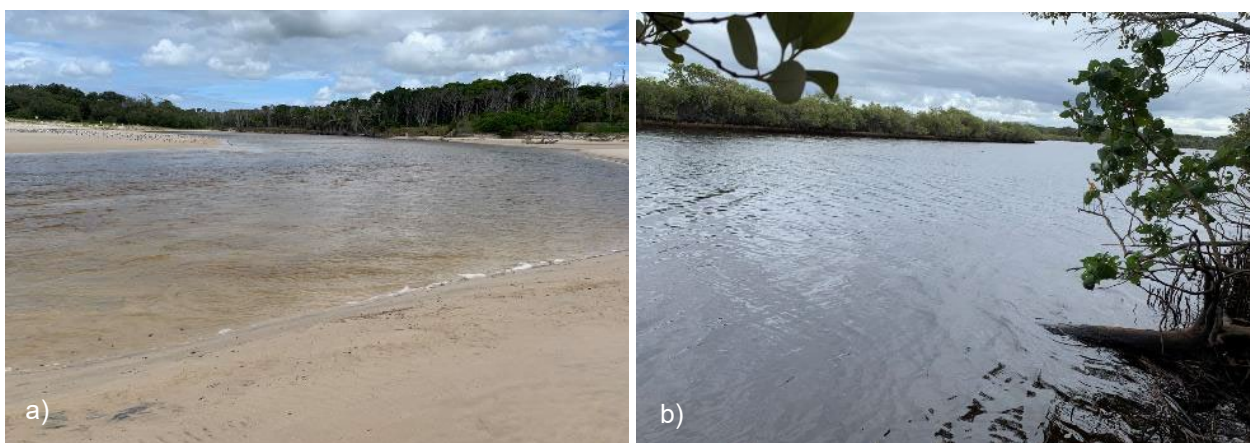
The Belongil Creek estuary sites inspected all showed improved water quality conditions with higher dissolved oxygen levels and lower turbidity compared to the sites further upstream. The creek entrance was open to ocean at the time of the site inspection and the creek was flowing strongly downstream.

Plate 9: a) Belongil Creek mouth on Belongil Beach b) Lower estuary at Manfred Street

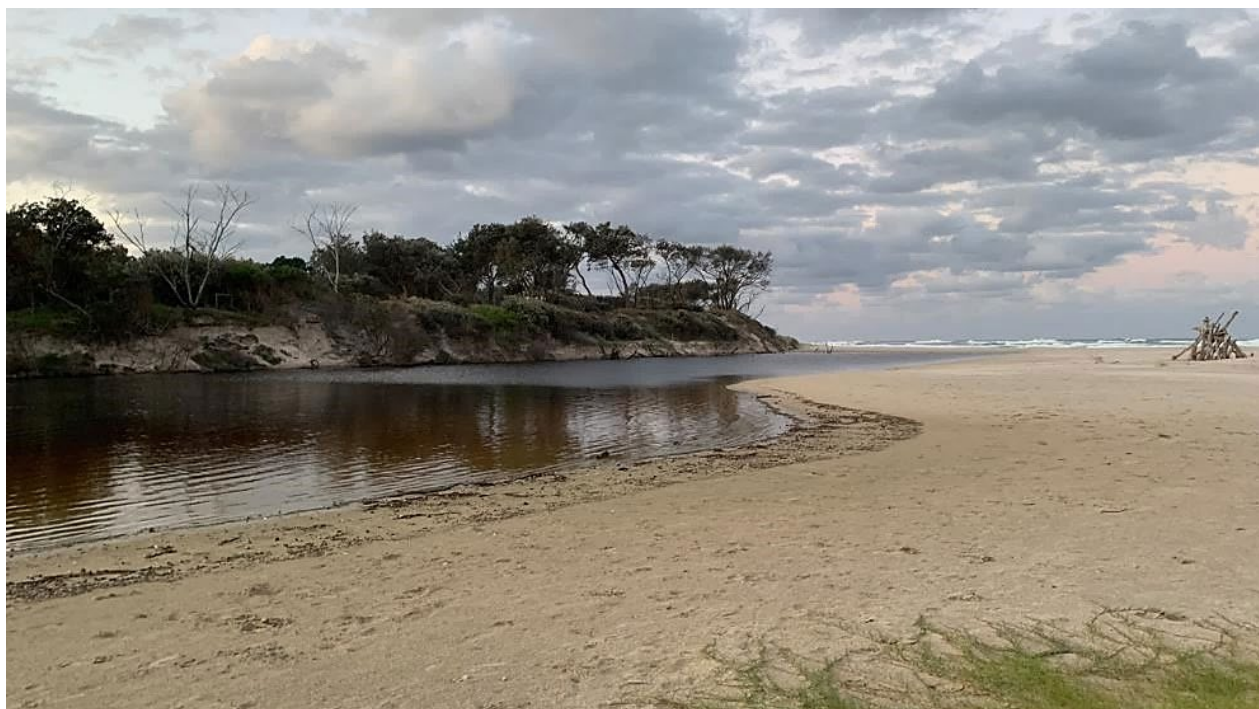
Plate 10: Tallow Creek Entrance, April 2023

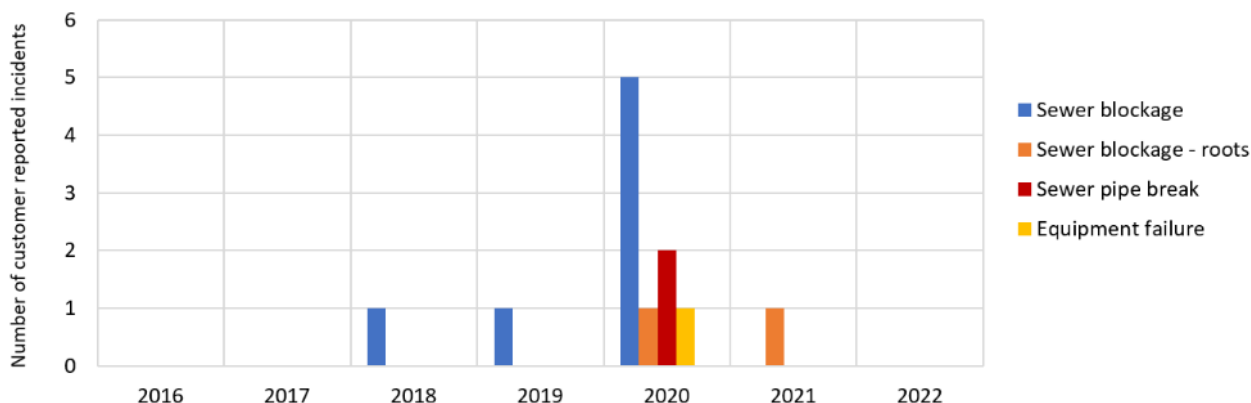
Figure 27 shows the number and type of customer reported sewer overflow events from April 2016 – April 2022 in the Tallow Creek catchment. There was a total of 12 customer reported incidents over this six-year period. The majority (7) were caused by sewer blockages/ chokes, two were caused by tree root blockages, two were due to sewer pipe breaks and the remainder were due to other equipment failure (1). The highest number of reported incidents by customers occurred in 2020 (total of 9) which was substantially more than in any other year and is likely due to the higher than average rainfall experienced in 2020 leading to overloading of the sewer system. Council staff responded to all incidents and completed inspections, repair and clean up actions as required. Some incidents occurred within private properties and property owners were responsible for corrective actions. There were no incidents during 2016-2022 in the Tallow Creek catchment that met the criteria requiring Council to report the incident to the NSW EPA (i.e. no environmental damage occurred as a result of discharge to the environment).

BSC also provided information on the impact of major flooding events (in March / April 2022) on sewer infrastructure in the Byron Shire. There was one major incident noted, with relevance to the Tallow Creek catchment, a pump station overflow due to flooding and subsequent equipment failure. Pump station SPS3016 on Beachcomber Drive, Byron Bay was ‘heavily impacted’ by the flooding event (BSC, 2022b). The event resulted in discharge of raw sewage to the hind dune area immediately behind Tallow Beach within Arakwal National Park. NPWS reported that this incident heavily impacted the Arakwal National Park due to the flow of sewage through the National Park bushland and into Tallow Creek, as well as pooling and settling of sewage along the flow path after the cessation of flow (Norman Graham, pers. comm., 2 August 2023).

Figure 27: Number of customer-reported sewer overflow incidents in the Tallow Creek catchment April 2016 – April 2022

Sewer overflow incidents represent a short-term but potentially high impact point source of pollutants to stormwater drains and downstream Tallow Creek. Review of BSC water quality monitoring data (Section 5.2.2 identified evidence of poor water quality runoff from urban areas (i.e. nutrients, turbidity and elevated levels of bacteria). Intermittent sewer overflow incidents are likely to be a contributing factor to poor stormwater quality at times in the Tallow Creek catchment. Management action should be prioritised to address sewage infrastructure impacts on the Tallow Creek ICOLL, a highly sensitive downstream receiving

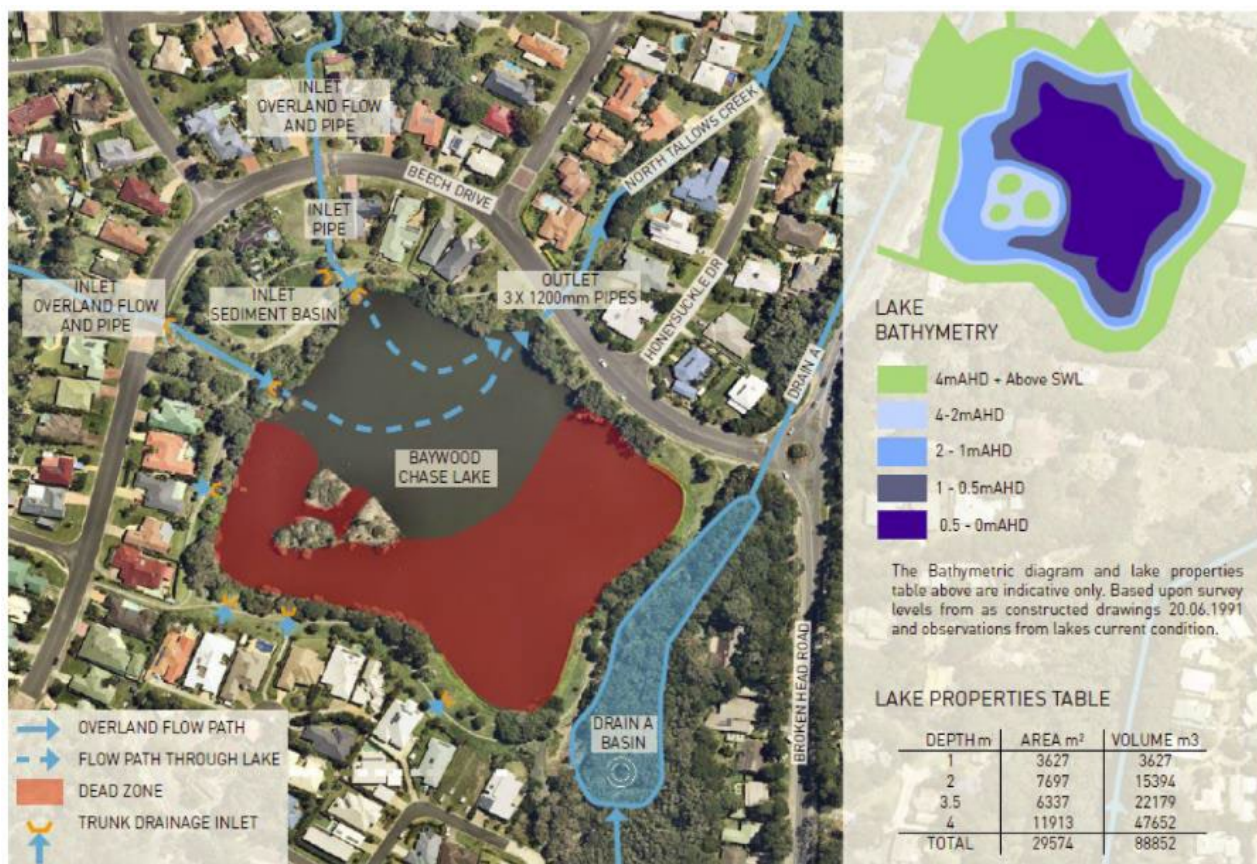
The artificial lake was constructed in 1990 as an ‘end of pipe’ stormwater retention device as part of the Baywood Chase development. It receives stormwater inputs from surrounding urban areas with little upstream treatment prior to reaching the lake. The lake covers an area of approximately 3 ha, has a flat central basin approximately 4m deep, steeply sloping batters and three small islands constructed on the western side which are roosting sites for a large number of Ibis and other birds. There is also a small inlet sediment basin on the northwest side of the lake, which was constructed to capture and treat first-flush flows from the north (AWC, 2018). Other stormwater treatment devices include two small bioretention systems and a GPT (although not actively maintained) and on the southern side of the lake (AWC, 2018).

The lake is thought to be poorly mixed, and previous work identified two distinct zones: a mixed zone to the north with flows entering from stormwater drains to the west and northwest; and a ‘dead zone’ to the south with little mixing (Figure 28). Although it is noted that the extent and presence of the two zones is likely to change depending on seasonal conditions and inflows to the lake (AWC, 2020b). Results of water quality sampling in December 2019, during drought conditions, indicated highly stratified conditions that were homogenous across the lake. Surface waters were supersaturated in dissolved oxygen with a pH of 10 (driven by an algae bloom) whilst bottom waters were anoxic with pH of 6.5. Nutrient concentrations (particularly phosphorus) were also considerably higher in bottom waters, with sediments the likely source (AWC, 2020b). An investigation into the issues and options for improving management and rehabilitation of the lake was undertaken by AWC in 2018. Addition of recycled water to the lake to improve flushing and water quality was the primary recommended action of the draft management plan (AWC, 2018). This option is no longer considered feasible, however the management plan includes a number of other recommendations considered in Section 5.4.

Figure 28: Hydrodynamics of Baywood Chase Lake showing mixed and dead zones and bathymetry.

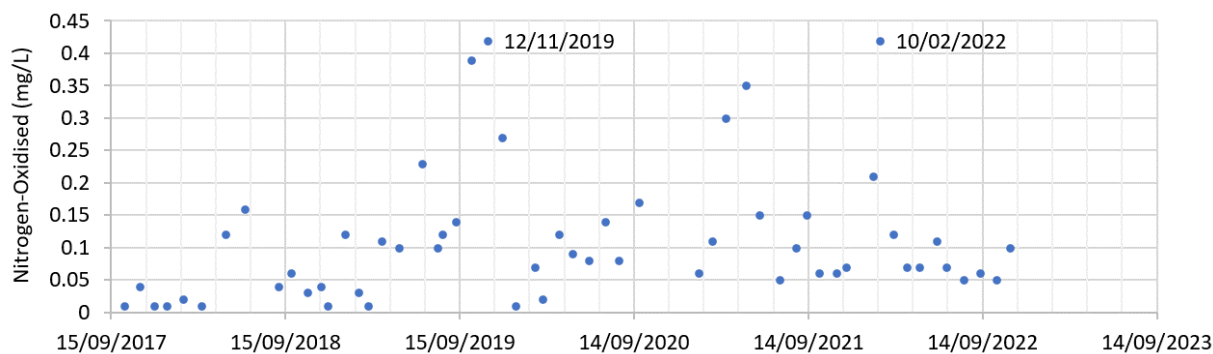
- Oxidised nitrogen (NO_x - bioavailable forms of N) were noticeably higher at site TC19 than at the other sites (including T20 Baywood Chase Lake outlet) and warrants further investigation of potential pollution sources at this location (e.g. potential sewer leaks/overflows, excess fertiliser use etc.). Figure 32 shows all NO_x results at TC19 from September 2017 to November 2022 showing consistently elevated levels and occasional spikes of NO_x occurring in November 2019 and again in February 2022. The consistently high NO_x results indicate an ongoing issue at this site. This is consistent with field observations in April 2023, when this location was choked with *Salvinia* covering the entire water surface indicating nutrient enrichment /eutrophication (Plate 12).

Figure 32: Oxidised nitrogen at Site TC19 from September 2017 to November 2022

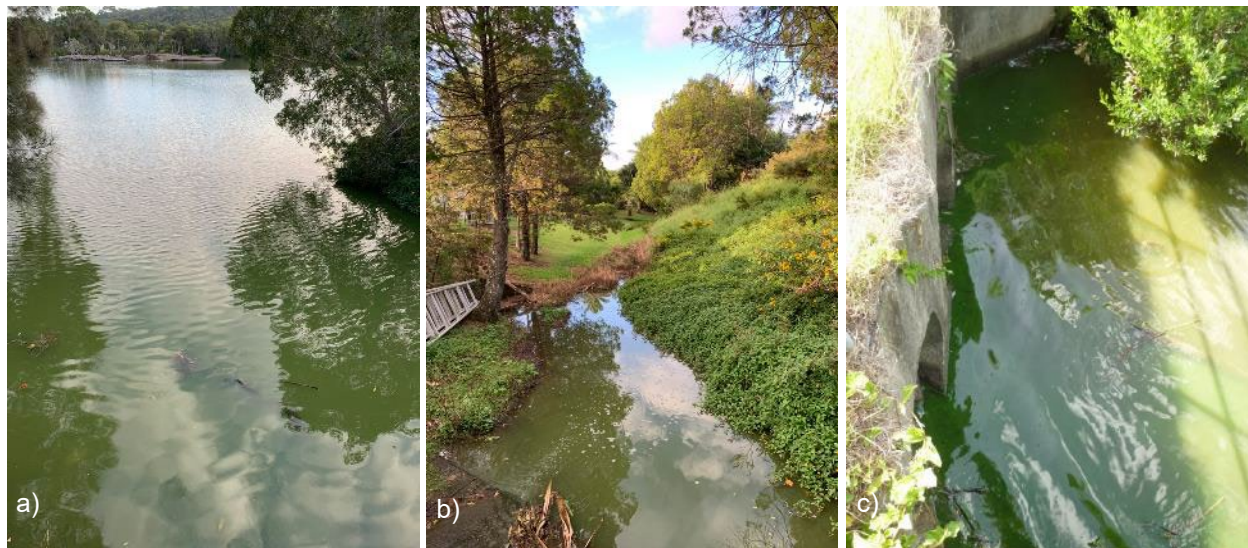
Plate 11: a) Baywood Chase Lake looking south to islands b) Immediately downstream of lake outlet c) Lake outlet in 2018 during previous study (AWC, 2018)

nutrient enrichment (e.g. excess algae and aquatic plant growth). Baywood Chase Lake, in particular was showing signs of eutrophication including very high dissolved oxygen conditions (106.5 % saturation), high pH (9.85), high turbidity (76.6 NTU), and a green tinge to the water (Figure 12) indicating an algal bloom. A foul odour was also noted around the lake and while no testing for algal species was undertaken, it is possible the bloom was cyanobacteria as has been identified previously on several occasions.

| ID | Rank | Water Quality Pollutant Source | Current/ planned management | Potential management option for consideration | Feasibility | Acceptability | Cost | Approvals | CA* score | Responsibility | Further consideration in Stage 3 |
|---|---|---|---|---|---|---|---|---|---|---|--|
| | | | | Partial infilling or complete removal of lake and replacement with high efficiency treatment system and additional public open space. | 3 | 2 | 0 | 0 | 5 | BSC | Yes |

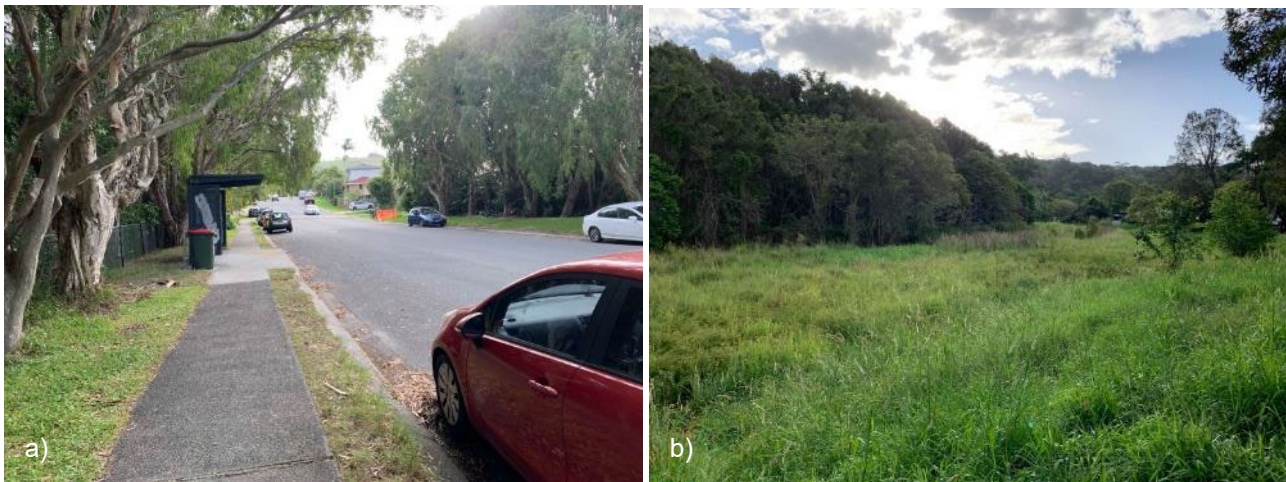
Plate 13: a) Typical curb and gutter roadside Beech Drive, Suffolk Park b) Stormwater swale bordering a parcel of urban bushland, Beech Drive.

The majority of urban areas observed during site inspection in Suffolk Park were characterised by curb and gutter stormwater infrastructure (Plate 13a) draining to open stormwater drains and/or vegetated swales and drainage basins. A large, vegetated swale was inspected along Beech Drive which was in generally good condition (Plate 13b).

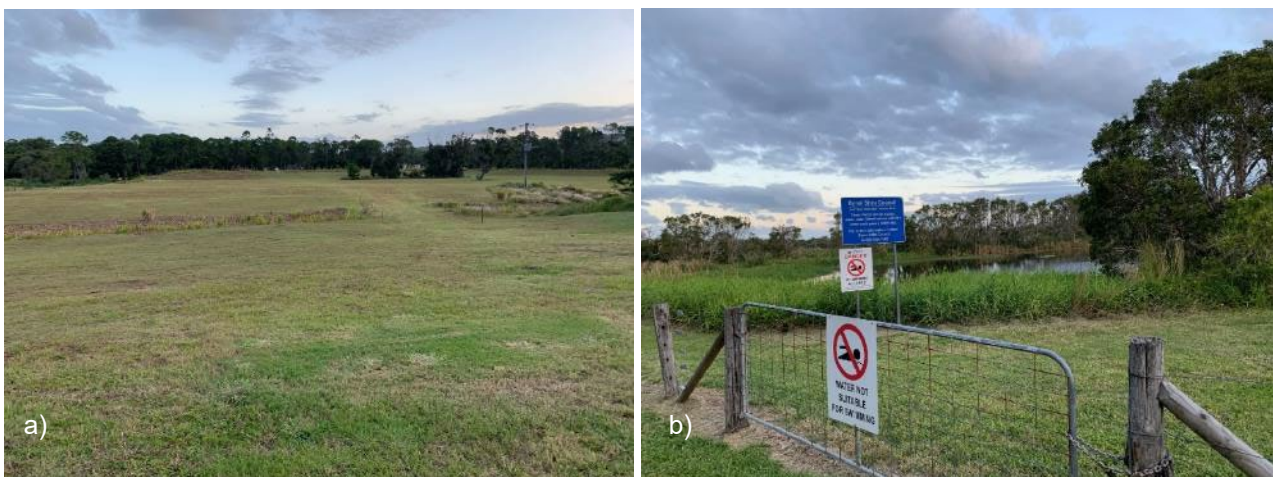
Plate 14: a) Remediated land at site of former STP / landfill site b) Decommissioned South Byron STP sewage ponds adjacent to mid estuary reaches of Tallow Creek.

The site of the former South Byron Bay STP was visited (Plate 14). The former STP has been remediated and there are plans to remediate the ponds (though bank reprofiling, revegetation and fencing) in the future. No water quality sampling was undertaken at the ponds due to restricted access to the waterbody. The ponds appeared to be in good condition with well vegetated riparian zones, clear open water and emergent macrophytes along the edges. There were no signs of algal bloom conditions or Salvinia infestations observed during site inspection. Abundant wildlife was noted in and around the ponds.

| ID | Rank | Water Quality Pollutant Source | Current/ planned management | Potential management option for consideration | Feasibility | Acceptability | Cost | Approvals | CA* score | Responsibility | Further consideration in Stage 3 |
|---|---|---|--|--|---|---|---|---|---|---|---|
| D | 7 | Decommissioned South Byron STP site | <ul style="list-style-type: none"> Ongoing investigations to assess impact on Tallow Creek | Further testing of sites in Tallow Creek was recommended by Cavvanba (2023) to confirm that groundwater is not having an influence on nutrient and heavy metal concentrations in Tallow Creek. | 1 | 2 | 3 | 1 | 7 | BSC | Yes |

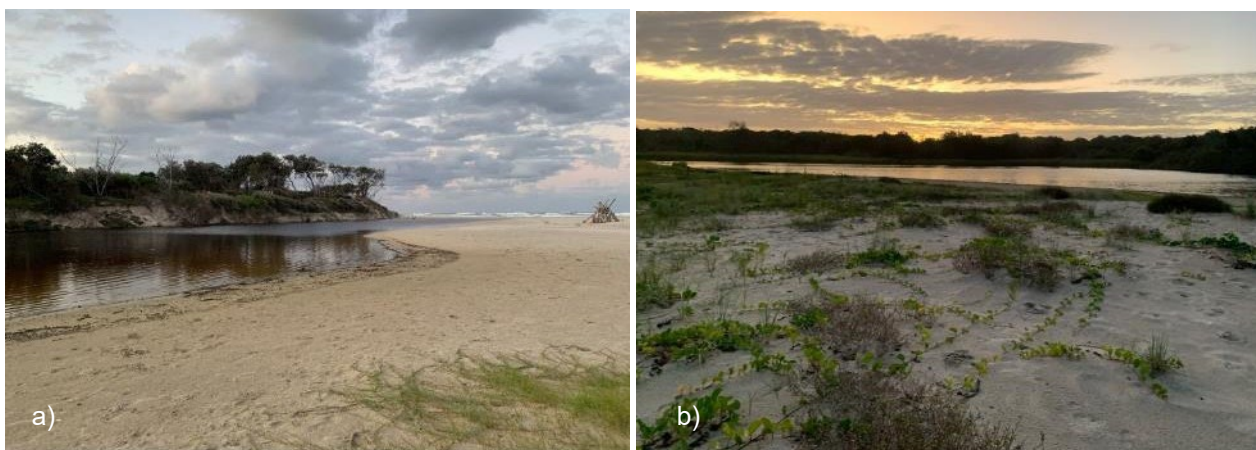
Plate 17: a) Tallow Creek mouth on Tallow Beach b) Lower Tallow Creek near entrance

The lower catchment area bordering Tallow Creek estuary was dominated by natural vegetation. Water quality conditions observed in these reaches were vastly improved compared to the upstream areas. Water was typically tannin-stained, clear (low turbidity and improved dissolved oxygen levels at 60-90% saturation). There was little evidence of litter or *Salvinia* / algal blooms within the estuarine sites at the time of the site visit (Plate 15, Plate 16). The creek entrance was closed at the time of the site inspection with very little downstream flow evident (Plate 17).

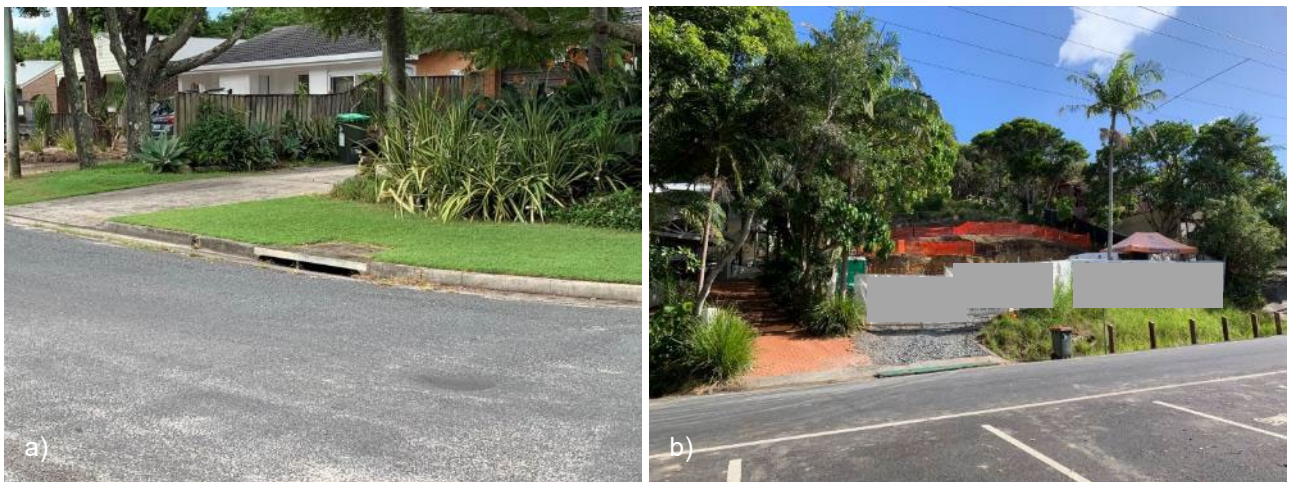
Plate 19: a) Typical curb and gutter roadside MacGregor Street, Suffolk Park b) Building construction along Broken Head Road (business signage has been obscured).

The small area of urban residential development at Suffolk Park bordering the northern upper catchment boundary for Ti-Tree Lake were characterised by curb and gutter stormwater infrastructure (Plate 19a). Sheet metal, wood and other building waste was observed dumped along the track within the Ti-Tree Lake Aboriginal Area. Other waste including chairs, mattress, bottles and plastic was also observed along the track.

Urban areas of Broken Head in the south, did not have formalised stormwater infrastructure with roadside swales conveying stormwater to nearby bushland (Plate 19a). A building construction site was observed along Broken Head Road with recent soil excavation of the hillside evident (Plate 19b).

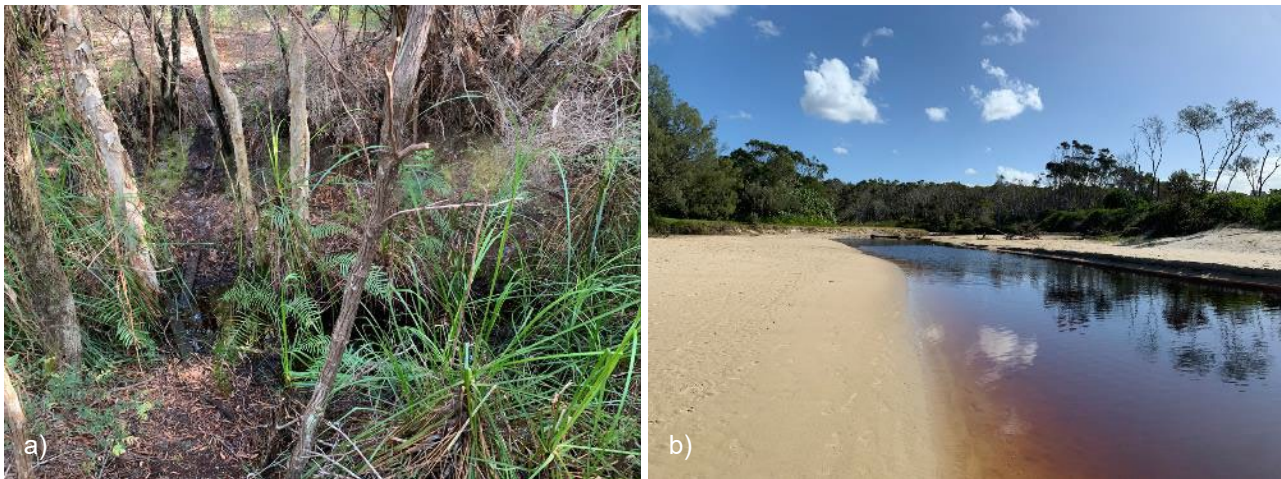
Plate 21: a) Small tannin-stained waterway draining to Ti-Tree Lake b) Ti-Tree lake entrance on Broken Head Beach

Water quality was assessed in-situ within a small tannin-stained waterway draining from Suffolk Park to Ti-Tree Lake (Plate 21a). The water was clear (turbidity 2.4 NTU), acidic (pH 4.07), with low dissolved oxygen (7.4 % saturation) likely to reflect the high level of organic matter present and lack of flow. Water at the ICOLL entrance on Broken Head Beach was also tannin-stained and clear (Plate 21b).
