Main Beach Shoreline Project

Baseline Understanding Report

Findings of a baseline and literature assessment on the coastal protection structure at Main Beach, Byron Bay

Report No: E2020/ 30756

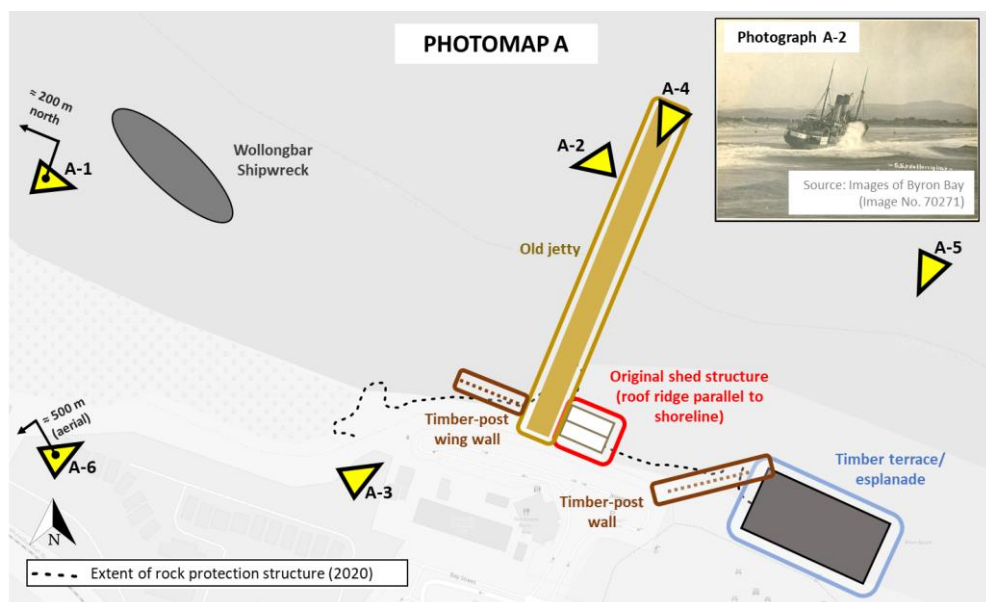
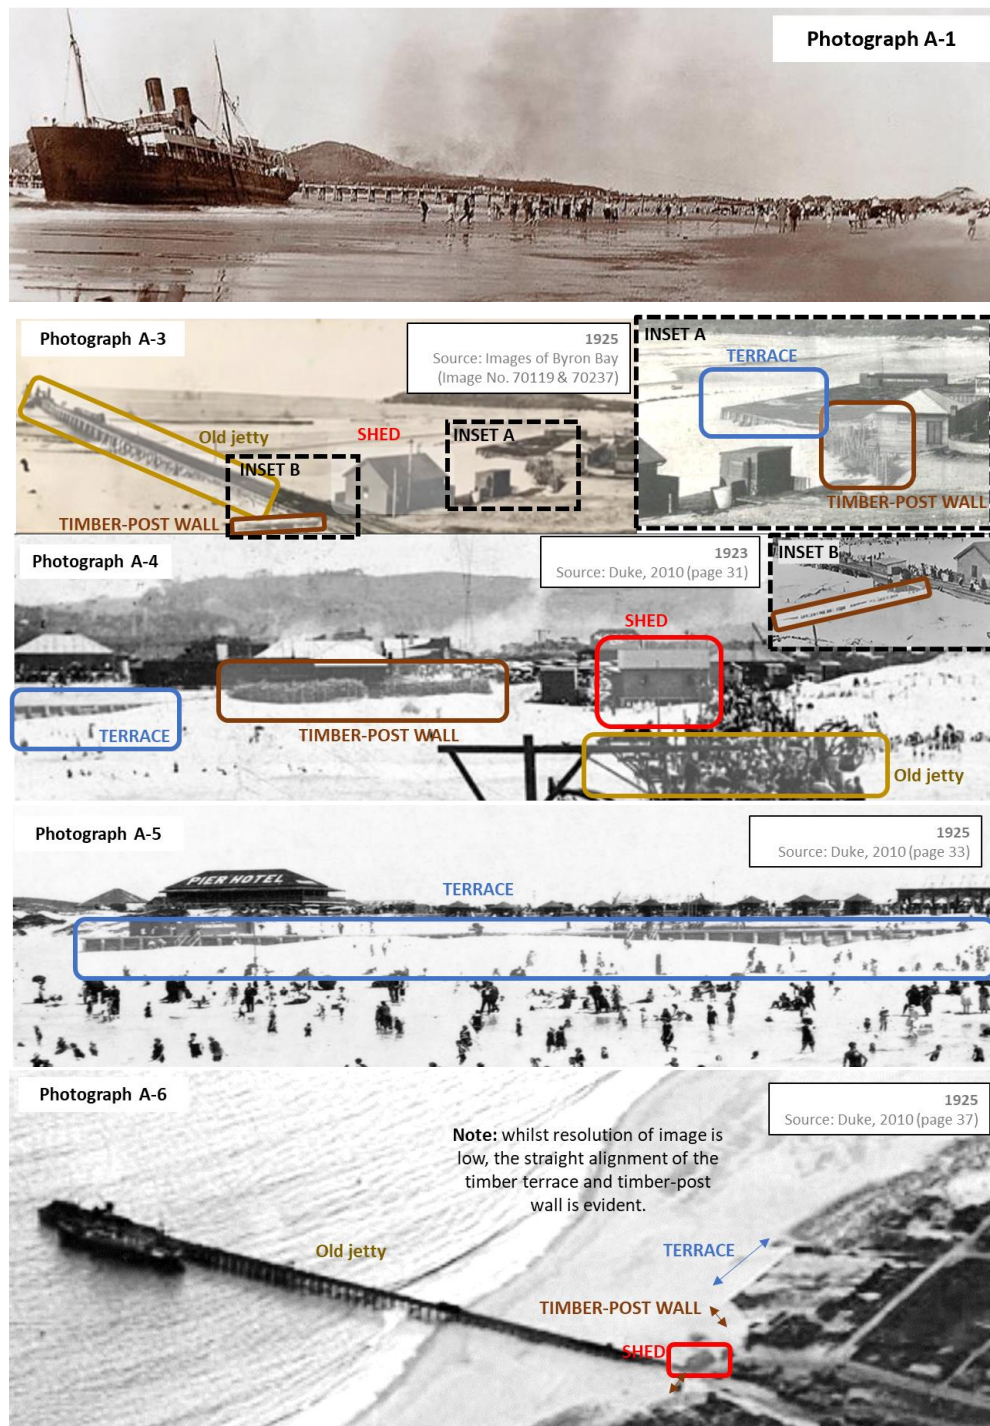
Figure 3: Photomap A and associated photographs showing the structures that existed in the period preceding 1921.

Note: it can be seen from photographs A-4 and A-5 that the piles of the seawall along the seaward edge of the timber terrace are spaced at approximately 2-3 metres. The timber-post wall comprises tightly spaced posts.

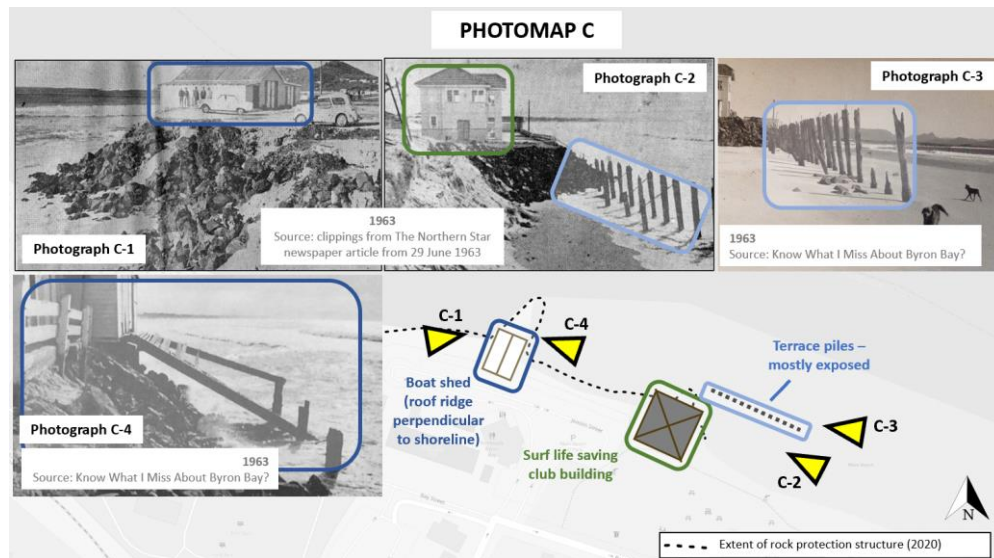
Figure 7: Photomap C and associated photographs showing the structures that existed in the period surrounding 1963.

- 1960** Construction of Brunswick River entrance training walls approximately thirteen kilometres to the north of Jonson Street.
- 1963** A newspaper article appears in *The Northern Star* on the 29 June 1963 and reports on around 400 feet (122 metres) of rock placed to provide temporary protection against heavy seas and erosion (see Figure 7). The temporary works were only expected to hold for six months to a year and the article discusses plans for implementing more permanent measures. Several photographs are available around this period which also show the terrace piles to the south of the surf life saving club which had become exposed because of the erosion.

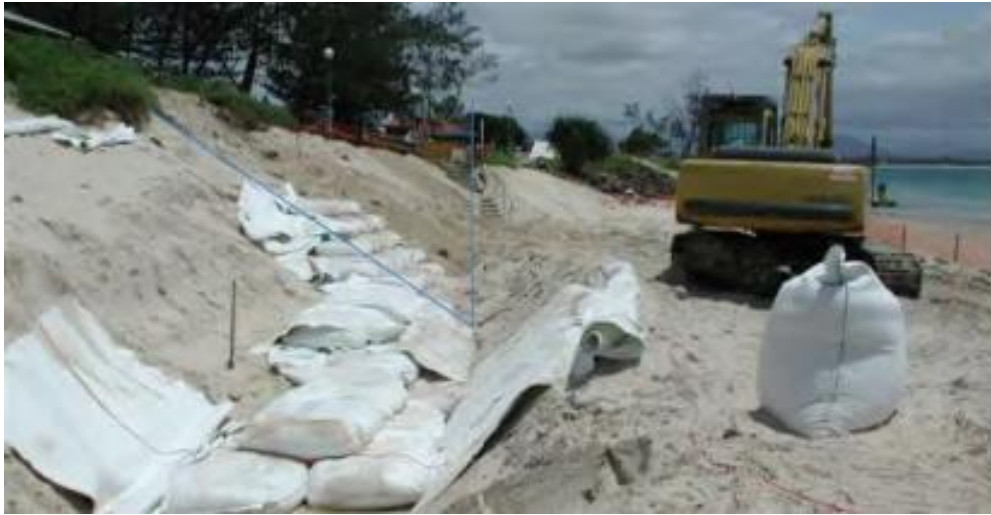
Figure 14: Photograph showing the construction of the interim geotextile revetment in front of the SLSC in 2002 (source: BSC).

2002 An interim single-layer geotextile container revetment was constructed by BSC at the Byron SLSC. The structure was built with slopes of 1V:2H and a crest level of 3m AHD. Also constructed by BSC at this time were interim works (geotextile container revetments) at Border St, Don St and Manfred St beach access ways, Belongil Beach.
