# 2023 Annual Water Contamination Report

Myocum Landfill

## Byron Shire Council

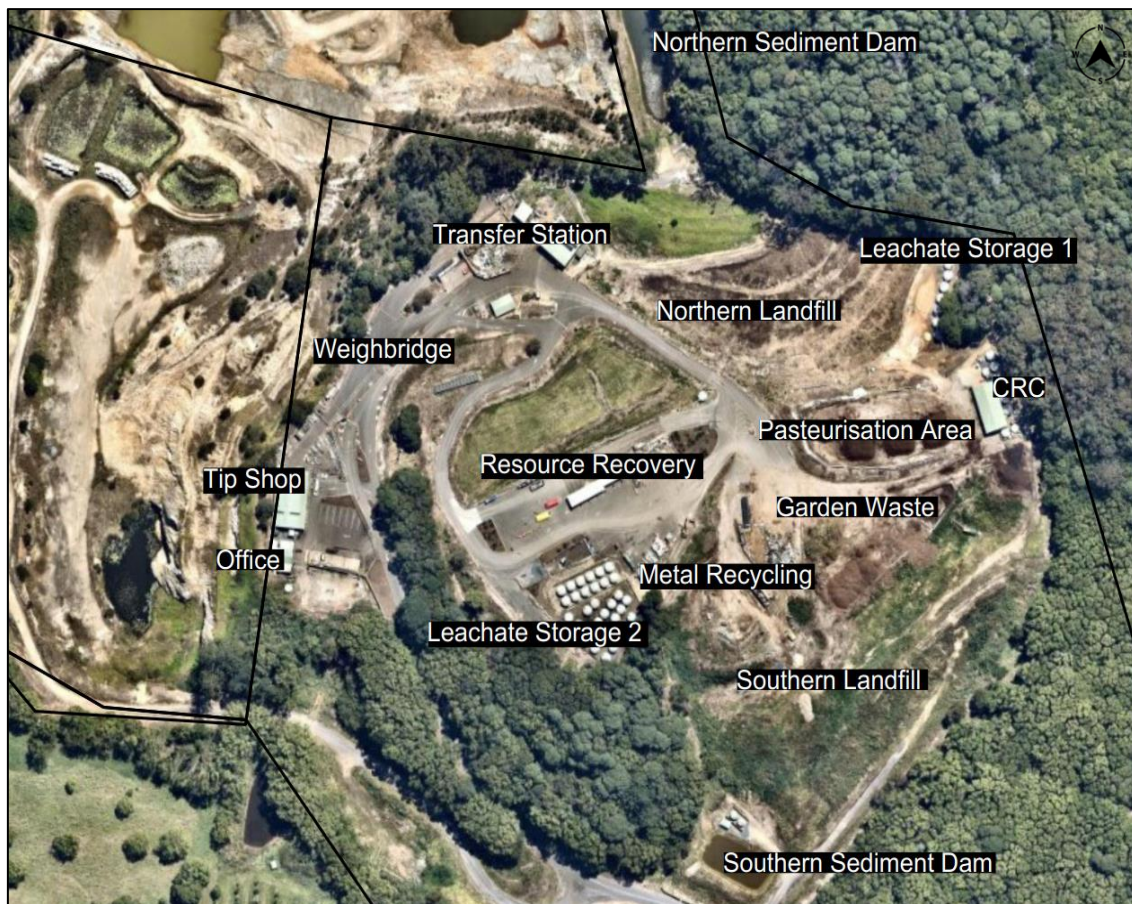
The layout of the Myocum Landfill is shown in Figure 2-2, showing:

- The original northern landfill area;
- Southern expansion area;
- Landfill infrastructure;
- Resource Recovery infrastructure;
- Site sheds and offices; and
- Neighbouring land uses and receiving environments.

Figure 2-2: Layout of Myocum Landfill (Image Source: NearMap 3 October 2021)

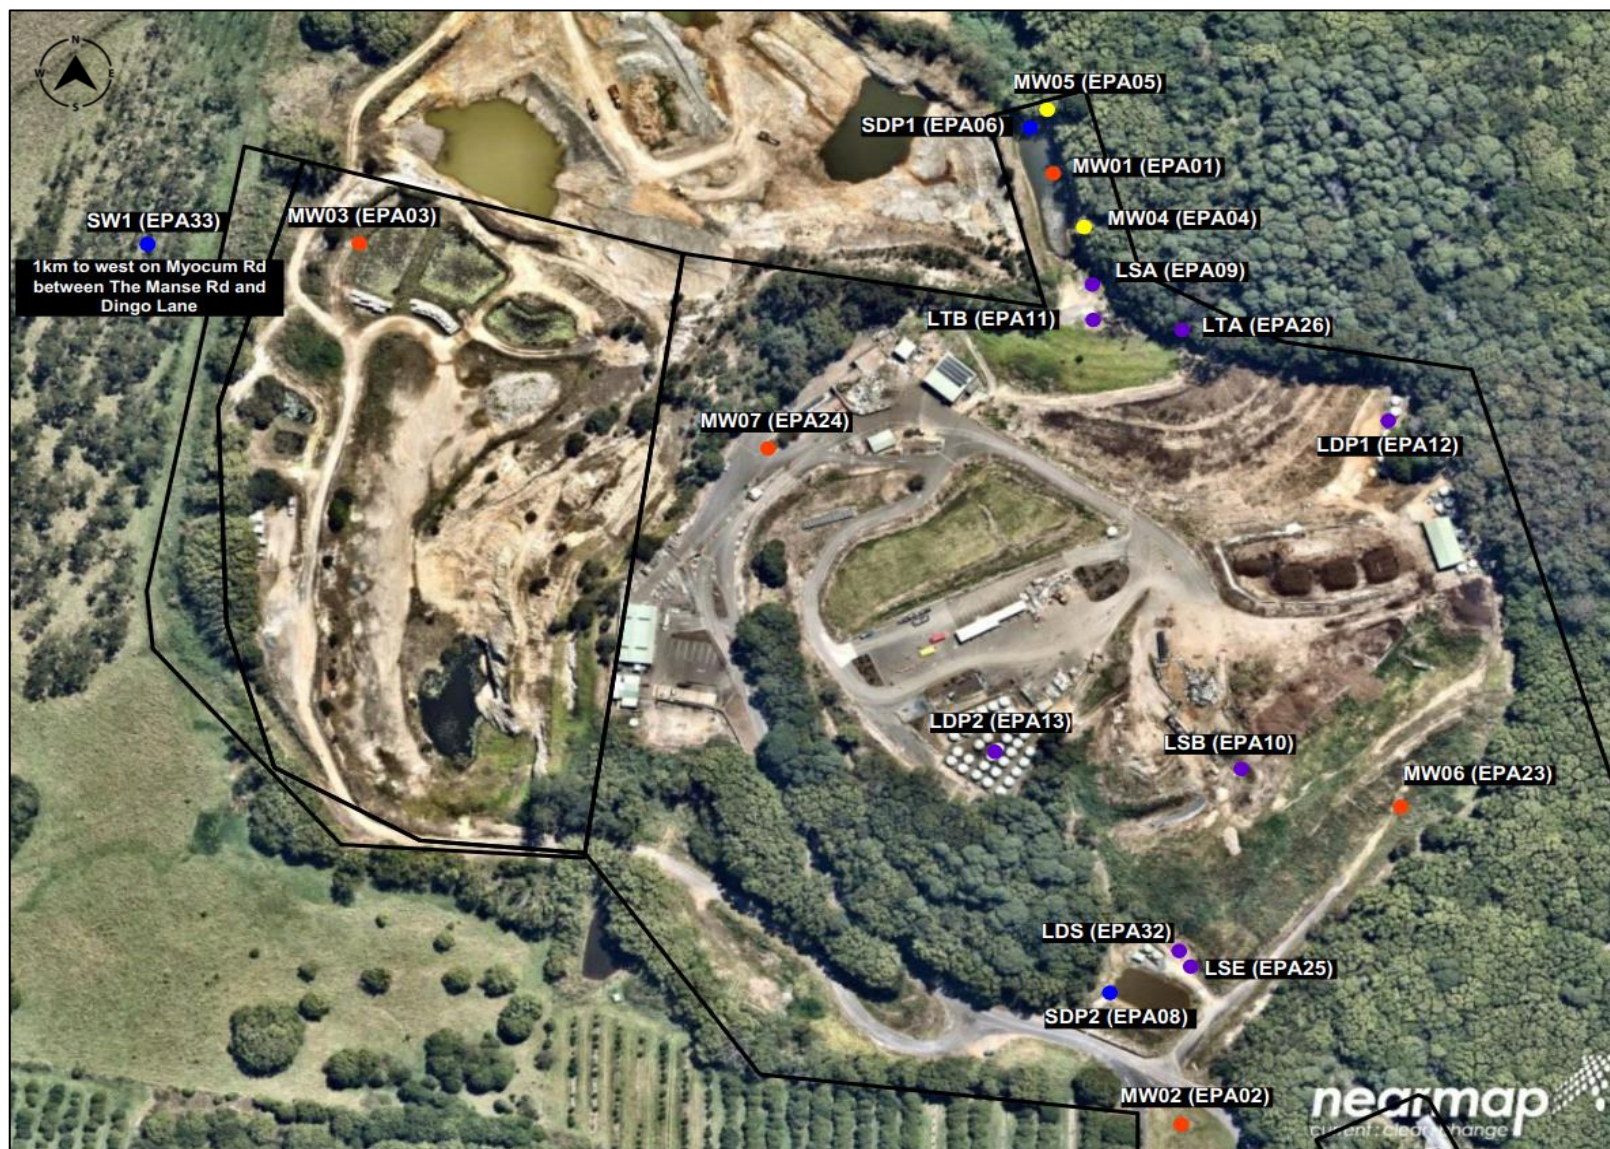
In accordance with EPL 6057, BSC monitors water quality parameters in both the Regional and Alluvial Aquifers along with surface waters to the north and south of the landfill. Figure 2-3 displays the location of monitoring sites within and adjoining Myocum Landfill. Table 2-2 details relevant EPA and BSC Monitoring Point identification, general location and specific ground/surface water systems monitored. Water quality samples from the regional and alluvial aquifer monitoring sites, surface water monitoring sites and leachate monitoring sites were obtained on the:

Figure 2-3: Myocum Landfill Monitoring Points (Image Source: NearMap 3 October 2021).
